PLAYGROUND SAFETY INSPECTION

PUMA PARK PLAYGROUND  
TRURO, MA

INSPECTED NOVEMBER 28, 2017

INSPECTED BY LEE ARCHIN, CPSI, & MICHAEL COHEN

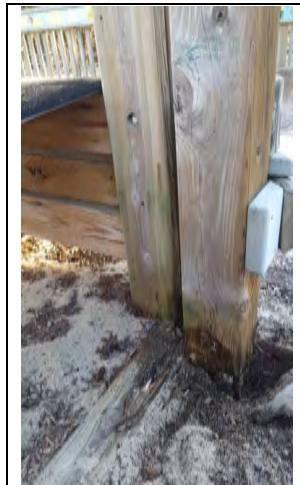
#### **6 x 6 Posts**

Substantial rot and decay was found in a few of the 6x6 posts. This rot was always at or below finished grade (i.e., the top of the safety surfacing). Note that we did not excavate to expose the posts below what was visible. We did not observe any posts that appeared structurally unsound where failure was at all imminent

Above grade, most of the posts have dried and show longitudinal splits/checks.

The tops of the 6 x 6 posts were all capped with plastic tops or otherwise covered (e.g., by platforms) and so there was no decay of the end-grain.

Expose and check all the posts below grade. If structurally sound, the decayed posts can be repaired.

Depending on the position of the posts, some decayed posts can be replaced entirely. We recommend using structural plastic posts for this.

Posts that are sound and have minimal or no decay should at least be thoroughly treated with a wood preservative and sealed.

For the worse posts that cannot easily be replaced, we recommend using a wood restoration product<sup>1</sup> to stabilize and repair the decay. Note, the same products can often be used also to fill longitudinal cracks.

Before installing any poured-in-place rubber safety surfacing, it is important to ensure all the posts at and below grade are stable. Once the rubber is in place you will not have access to the bottom of the posts. Therefore, in addition to the repairs outlined above, we recommend wrapping the base of all the posts with structural plastic lumber (1x6 or 2x6) to ensure the rubber has a stable boundary.

Posts thus repaired will still require maintenance to preserve their appearance and stability. It is important to keep the posts well sanded and re-sealed once a year.

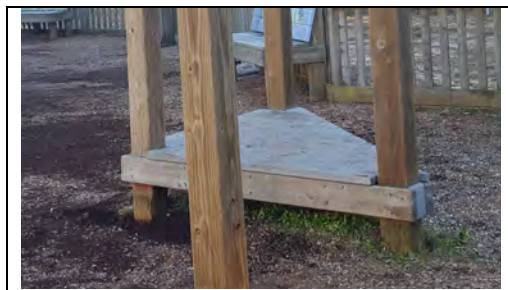
### **Decking**

All the decking is Trex. It has worn well.

Using an appropriate solution and process, possibly including power washing, clean the Trex to remove dirt.<sup>2</sup>

Check for and repair any screws that are not countersunk.

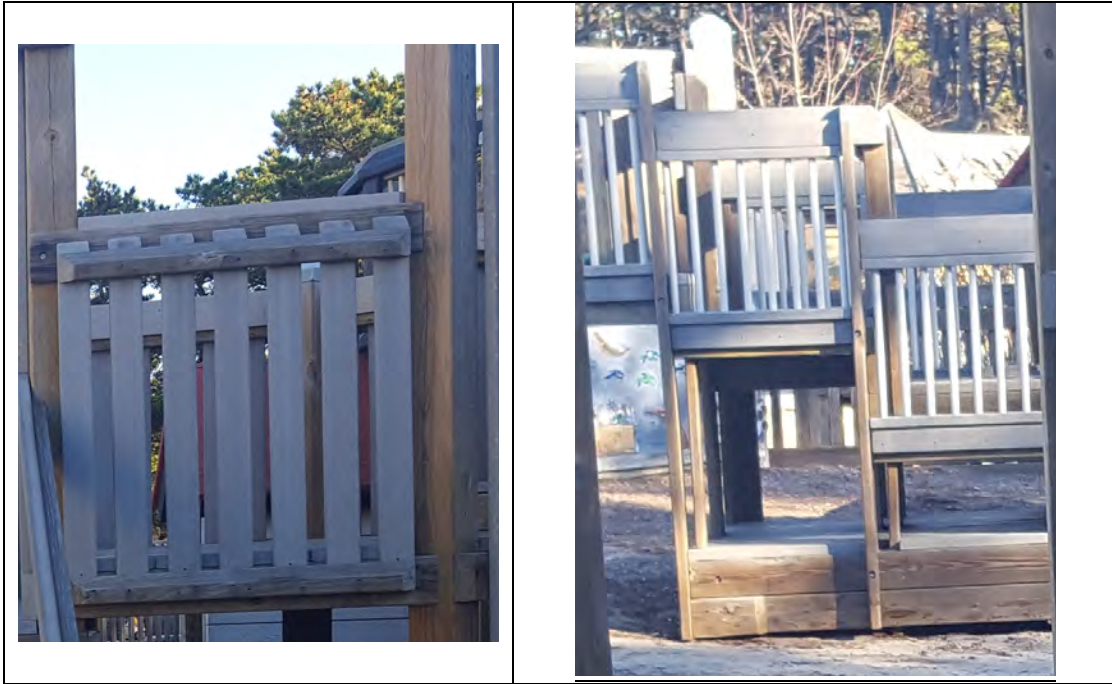
### **Guardrails and Barriers**

The guardrails (i.e., handrails) are mostly Trex and are in good condition. The few wood rails have an additional layer of Trex to prevent splinters.

The barriers are Trex 2x4s in the 5-12 area and  $\frac{3}{4}$ " pipes in the 2-5 area. These are all in good condition.

Repair any broken pieces as necessary. Clean, and seal these elements the same as with the framing and poles. (See above.)

To reduce such maintenance, and also to eliminate splinters, as well as improving lines of sight and adding new, permanent color, we recommend you consider removing and replacing all the guardrails, balusters and 2x posts with plastic lumber. This would best be undertaken as part of a larger renovation.

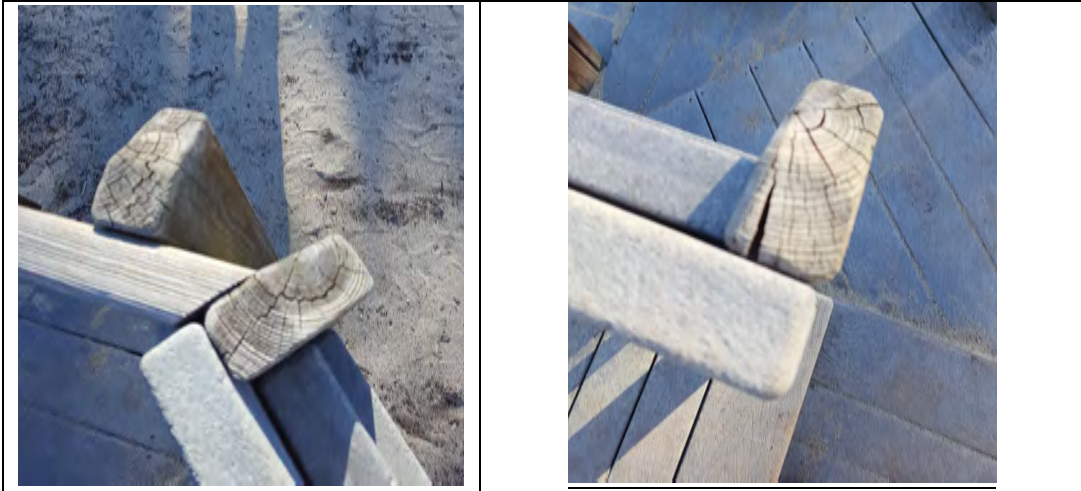
**Other dimensional lumber elements<sup>3</sup>**

The other wood (i.e., not posts, framing) is structurally sound and in fair condition.

Exposed end grain, especially when vertical, shows more weathering damage, although there are very few instances of significant splitting, cracking, or cupping.

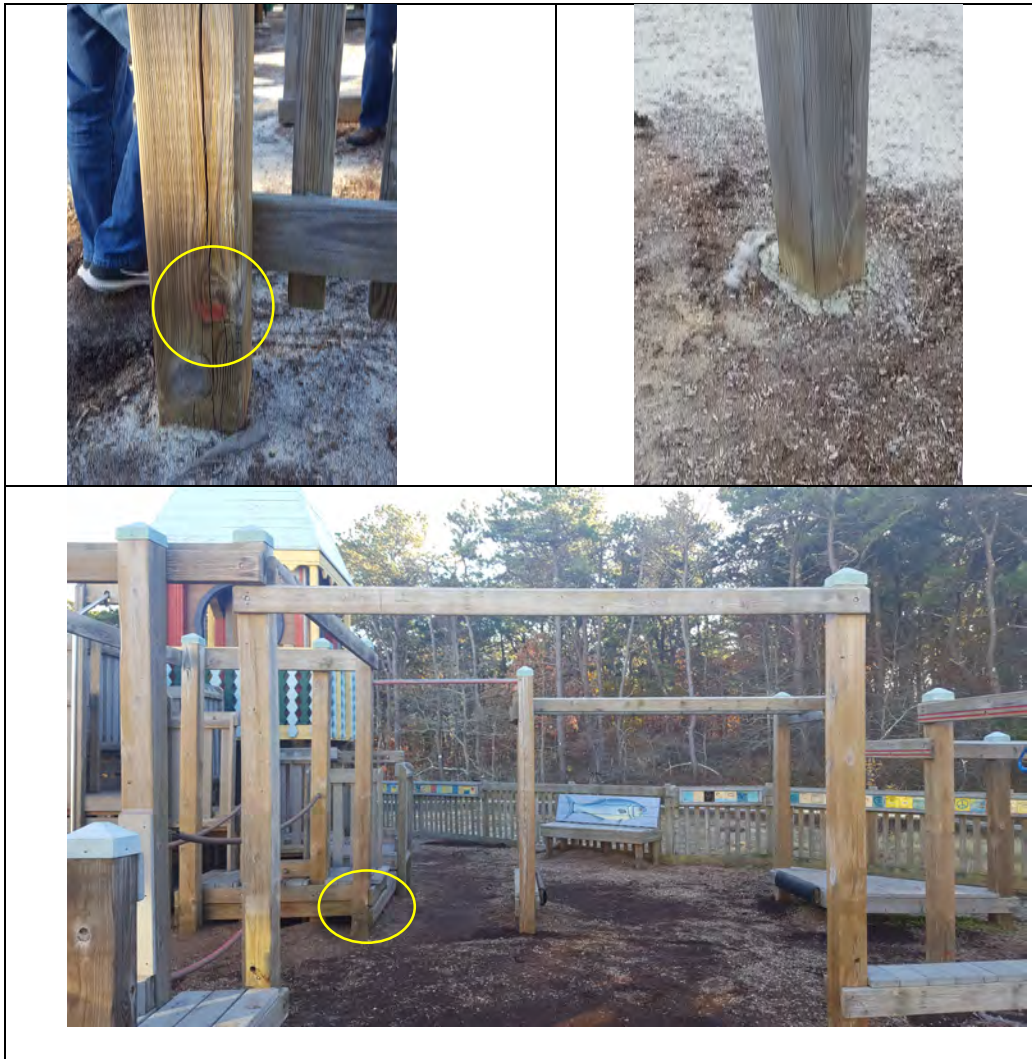
## Safety Surfacing

The safety surfacing is engineered wood fiber, EWF.

The wood fiber is several inches low throughout the playground. In many areas, the underlying geotextile fabric is visible, meaning the EWF is almost entirely gone. More problematic yet, there is a lot of exposed concrete that should be entirely below the EWF.

The condition of the safety surfacing represents a **Priority 1 hazard. (ASTM 13.2)**

The EWF should be 12" deep. Red stripes painted on the poles to indicate the correct depth remain visible, if faded, on some poles.

Repaint the painted depth markings to facilitate future maintenance. If necessary, measure up 12" from the bottom of the EWF to locate new stripes. Add engineered wood fiber until the compacted depth is 12" throughout.

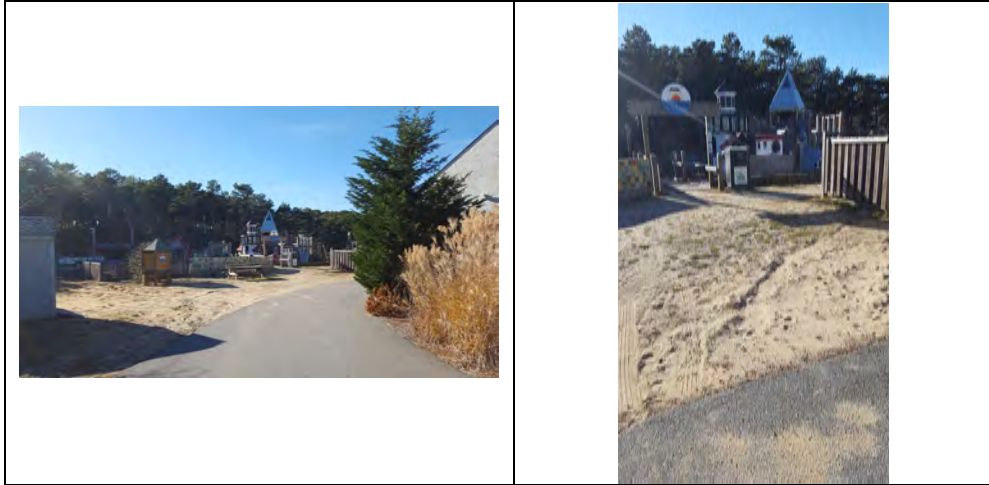
## Element: Parking Lot to Playground Entrance

1. The hard, accessible surface from the parking lot does not continue to the playground entrance. The non-asphalt portion is sandy and is not an accessible surface.

1. Install an accessible path to the playground entrance.

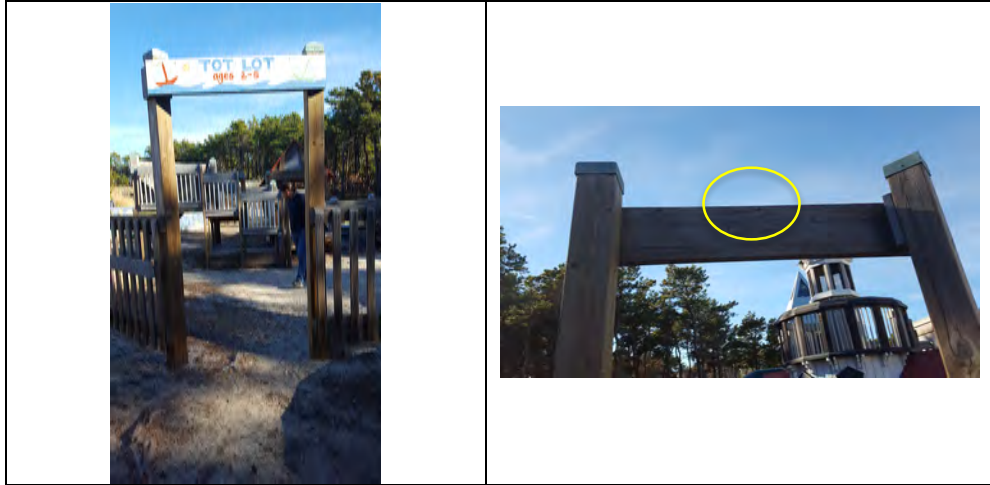
Element: Tot Lot Entrance

1. The sign does not communicate a supervision recommendation.
2. There are two screws protruding through the back of the sign. **Priority 1**

1. Add "Adult Supervision Required" to or near the sign. See ASTM Section 14 for complete signage requirements.
2. Remove the screws.

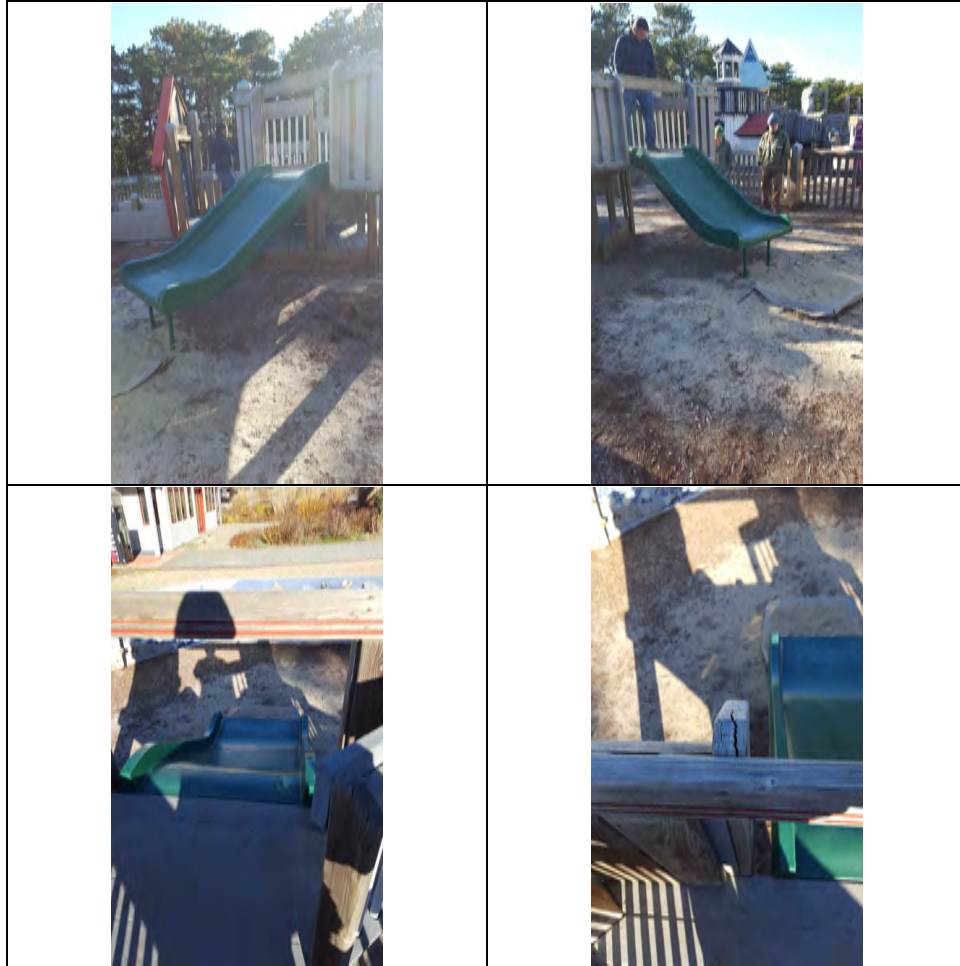
Element: Tot Slide

1. The slide exit is too high because the EWF is too low. (Priority 1)
2. The vertical 2x6 post adjacent to the slide entrance has split.

1. See recommendations on safety surfacing above.
2. Replace the 2x6. Consider using plastic lumber.

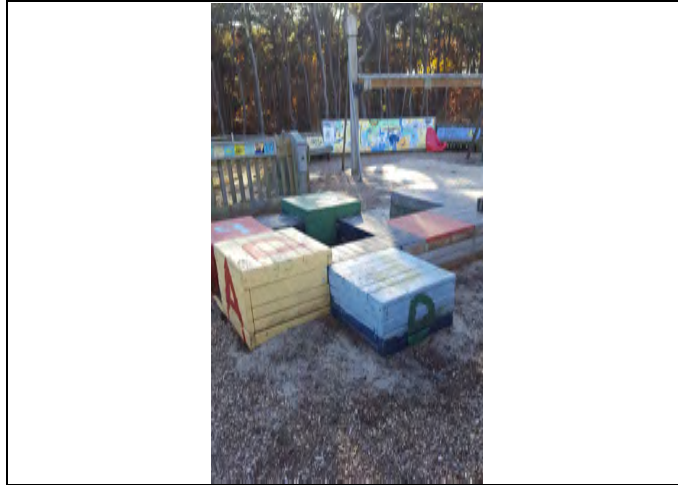
Element: Stepping Blocks

1. The green block is too close to the phone box. There should be 6' minimum clearance and there is only 68".
2. Some screws are not well set. (Priority 2)

1. Move the phone box around the corner of the fence, being sure to maintain at least 6' clear from the blocks. (This will involve some new PVC pipe and fittings.)
2. Check all screws and make sure the heads are countersunk.

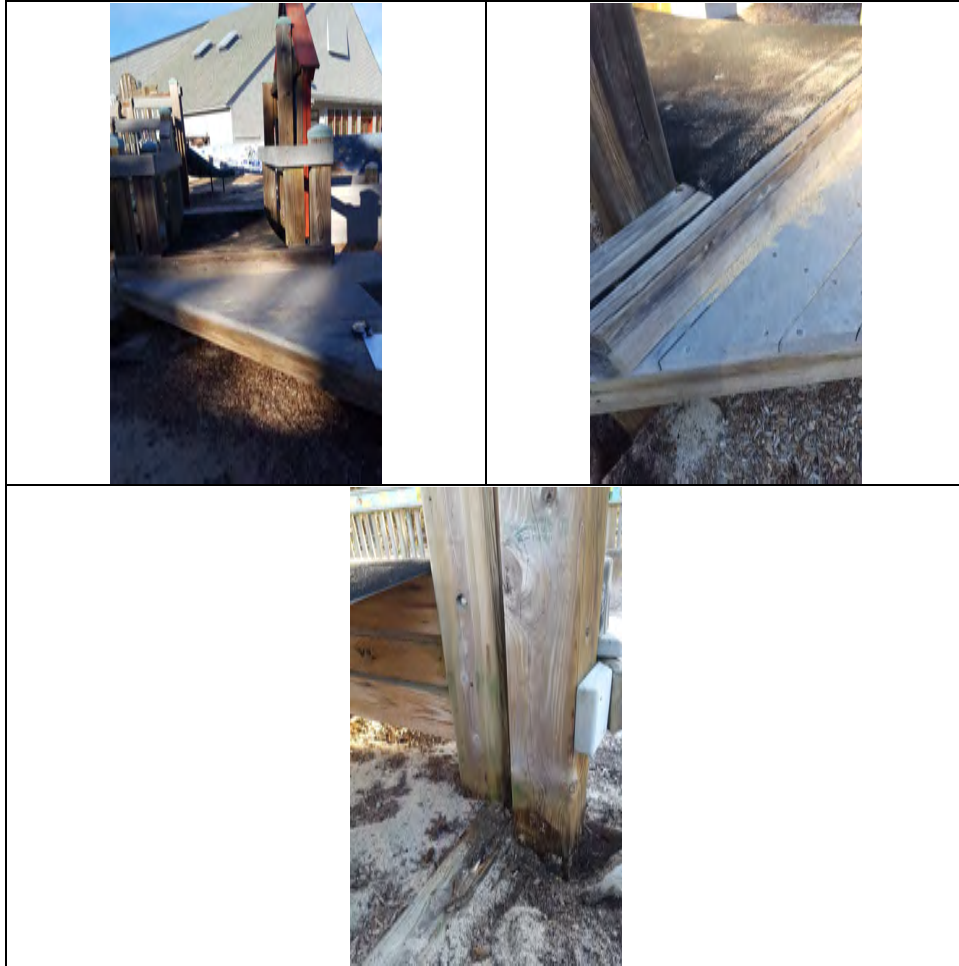
## Element: Tot Rubber Bridge

1. The base of one vertical 6x6 post and a horizontal 2x4 have been uncovered and exhibit significant rot and decay. **(Priority 2)**
2. The wooden beams holding the rubber to the platforms have worn, dried and cracked. **(Priority 3)**

1. Replace or repair the damaged wood.
2. Replace the wood with structural plastic. Consider installing new rubber at same time.

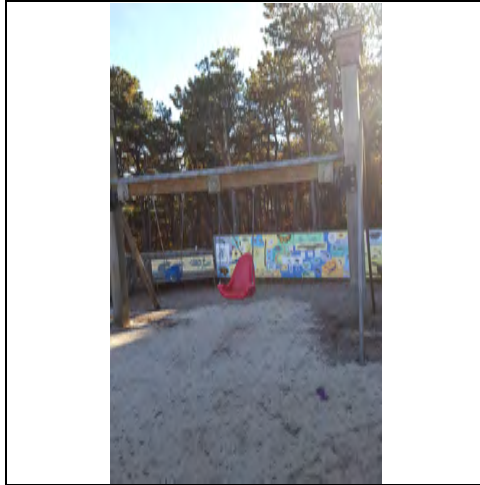
Element: Tot Swings

1. Concrete is exposed around the base of the posts. (Priority 1)

1. See Safety Surfacing above. Close the area around the swings until this problem has been rectified.

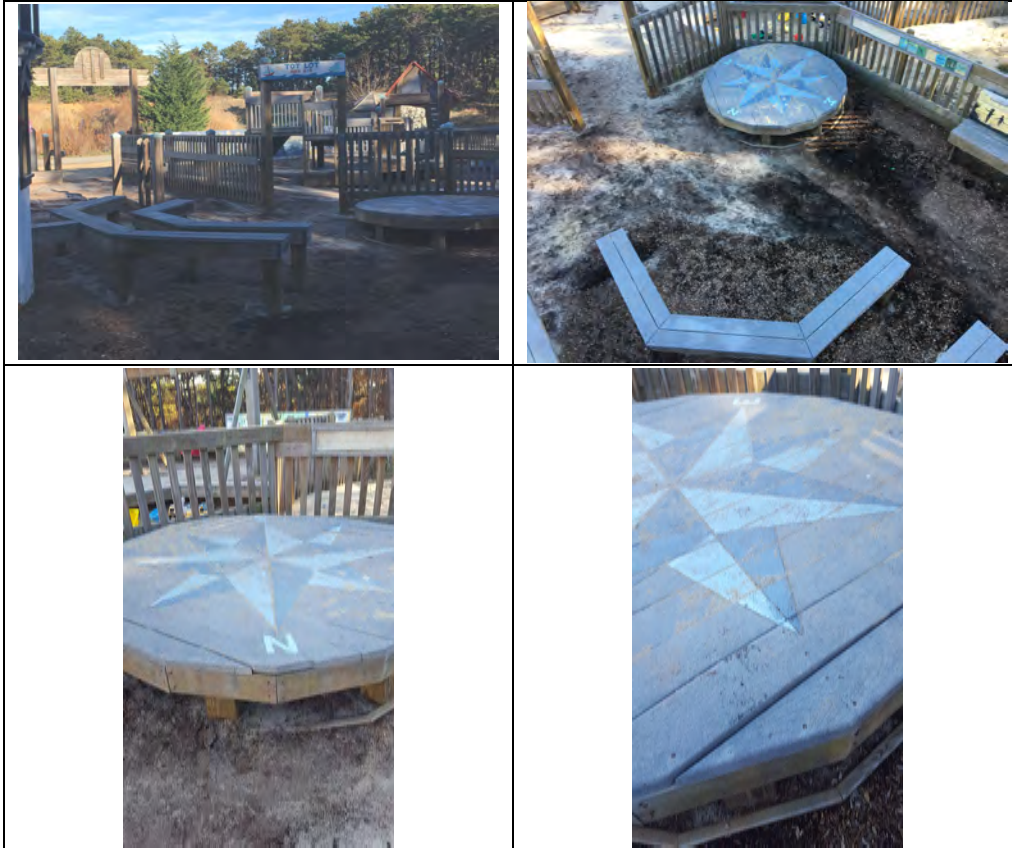
Element: Stage and Seating

1. Some decking of the compass stage needs to be refastened.

1. Refasten the raised decking.

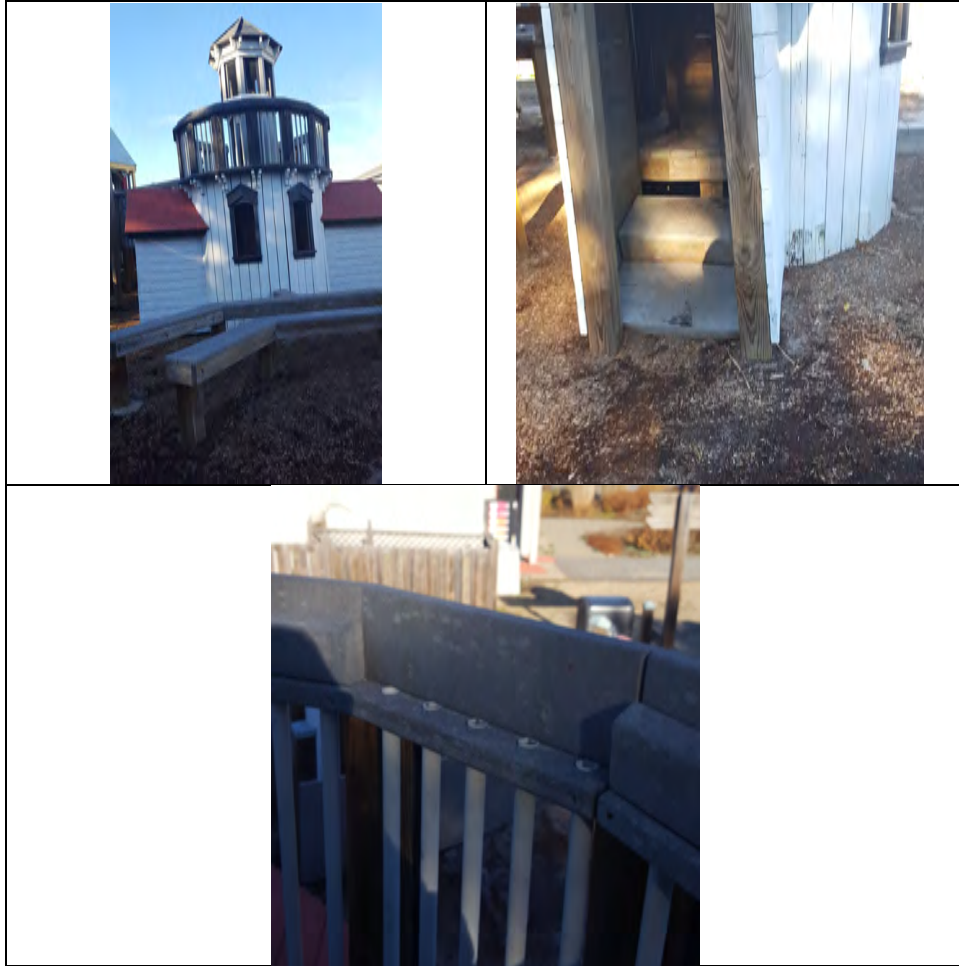
## Element: Lighthouse

1. The steps on one side of the lighthouse have collapsed. (Priority 1)
2. One segment of the 2x4 Trex cap over the pipe balusters is missing. (Priority 2)

1. Raise the steps to their original, level position and refasten securely to walls. Consider installing 2x4 legs to grade for positive support.
2. Replace the missing 2x4 cap.

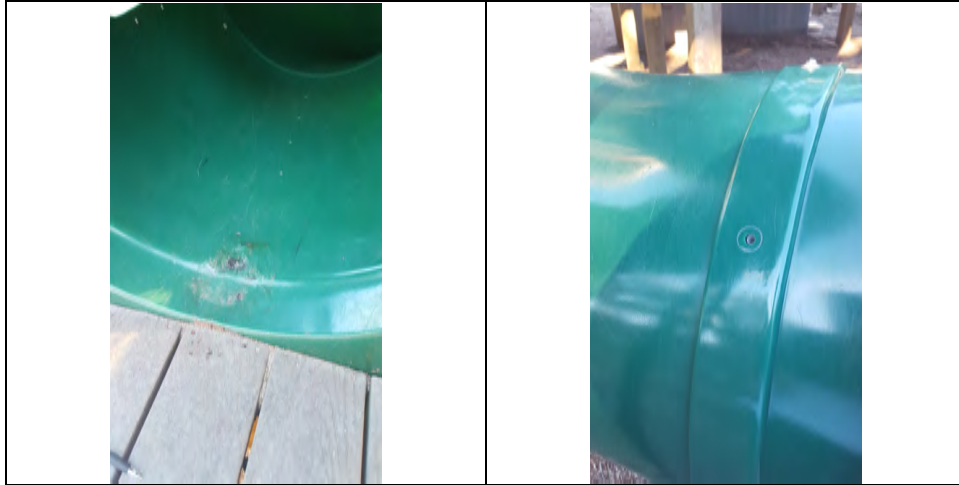
Element: Circular Slide

1. The entrance segment seems to have been burned.
2. There is a missing connector at the exit segment.

1. Consider refinishing this entrance area by lightly sanding and then very carefully applying light heat.
2. Replace the missing connector. (PBD can supply this if needed.)

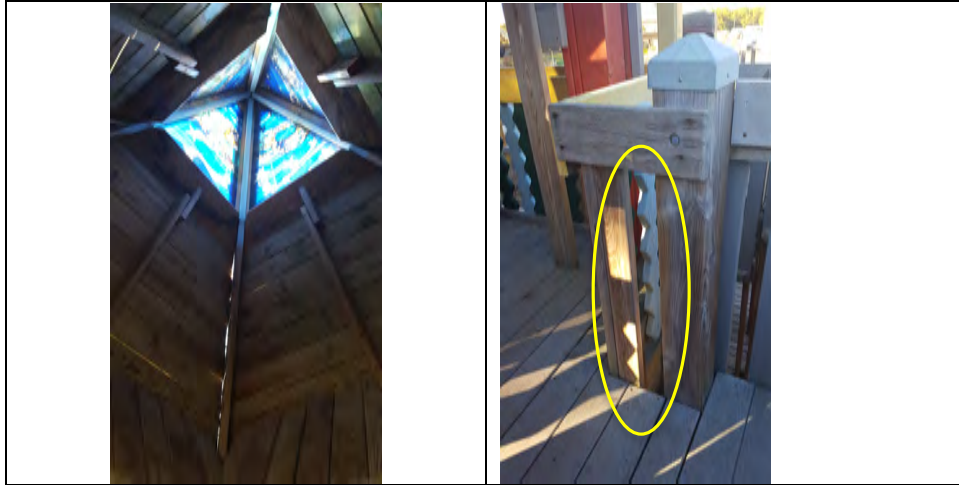
Element: Tower with roof with glass panels

1. The space between the 6x6 post and the 2x4 corner baluster is a head trap. (Priority 1)

1. Attach a vertical 2x4 baluster (ripped if necessary, minimum width 1.5") in this space from handrail to platform framing.

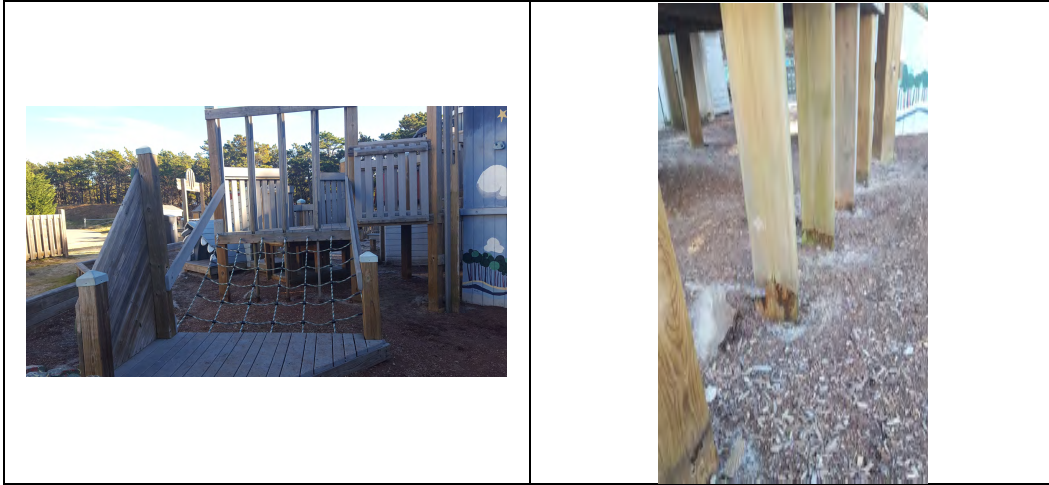
## Element: Cable Cargo Net

1. The 6x6 posts and especially the 2x6 posts show extreme rot and decay.

1. Repair the 6x6 posts as recommended above. Cut the vertical 2x6 posts flush with the lower edge of the framing of the platform. "Dog ear" the resulting ends with a 2"x2" miter and round all newly cut edges. Dig out and remove the horizontal 2x6 grade beam that runs from 6x6 to 6x6.

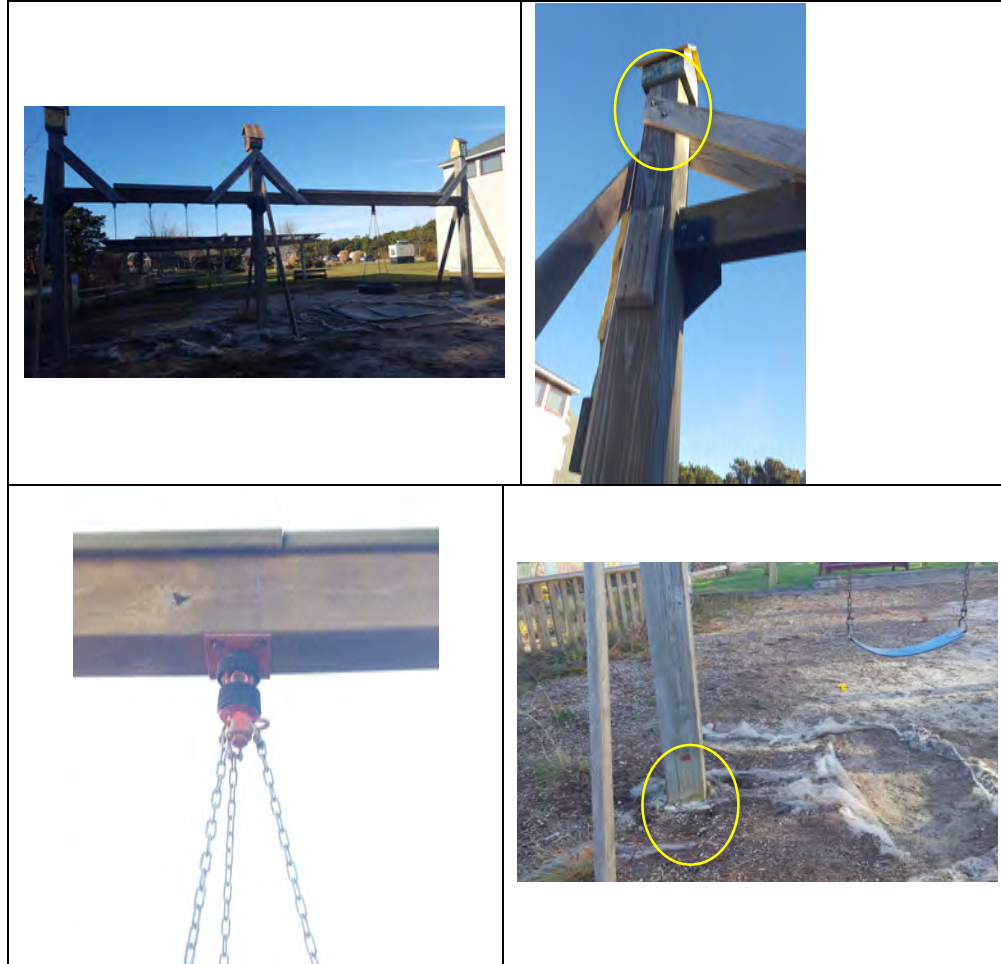
## Element: Swings

1. The diagonal braces above the beams have protruding excess bolts. These are both protrusion and entanglement hazards. **(Priority 1)**
2. The safety surfacing is gone and there is exposed concrete. **(Priority 1)**

1. Cut off excess bolts and cap the nuts with a 2x4, similar to the cap over the nuts of the steel swing beam brackets.
2. See Safety Surfacing above. Close the area around the swings until this problem has been rectified.
