North
Truro
Air
Force
Station

WALSH WAY PROPERTY ASSESSMENT REPORT

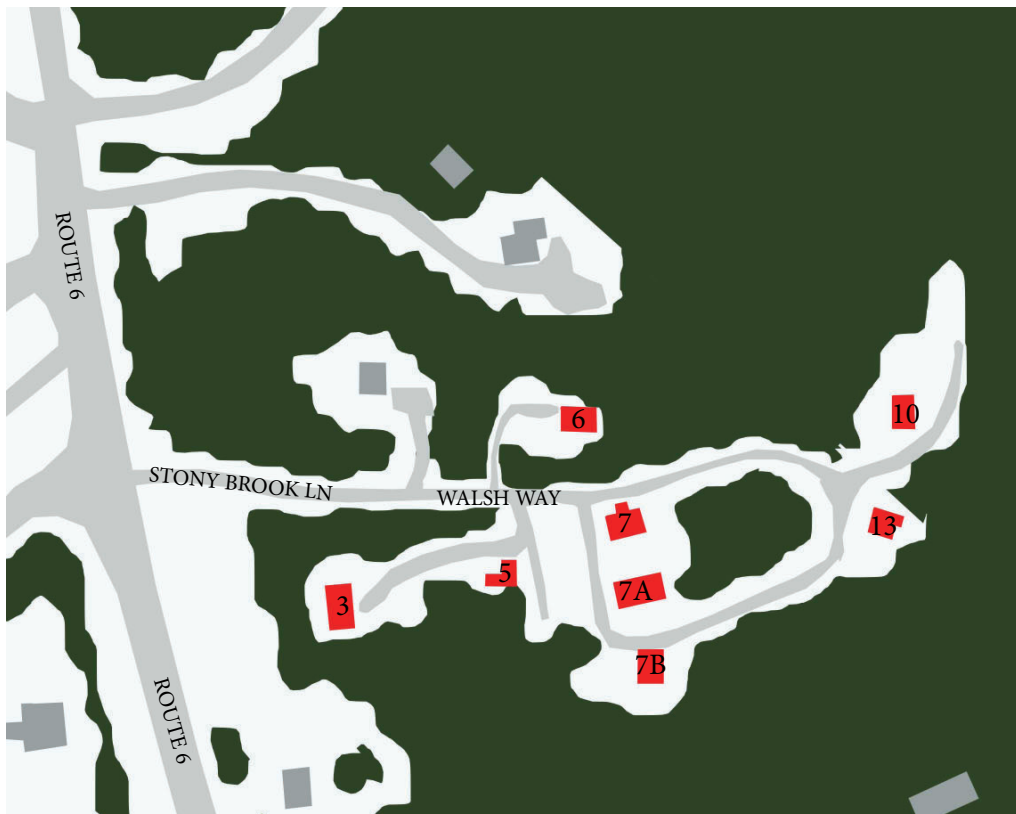
Walsh Parcel Key Plan

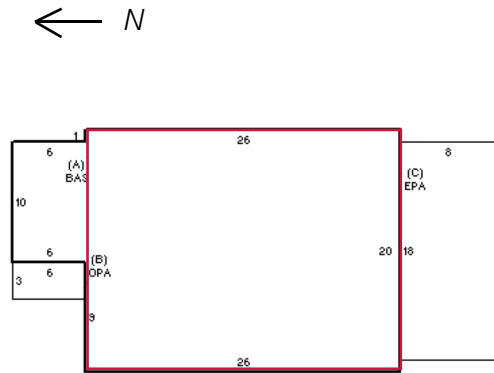
Original building structural core outlined in red

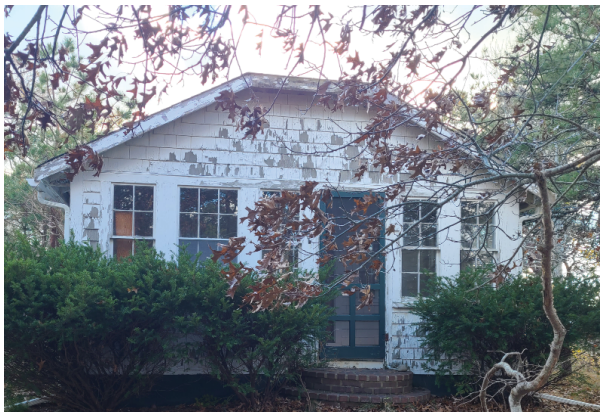
Front addition. Brick mortar steps, and peeling paint on shingle siding and fascia, rake, door and window trim

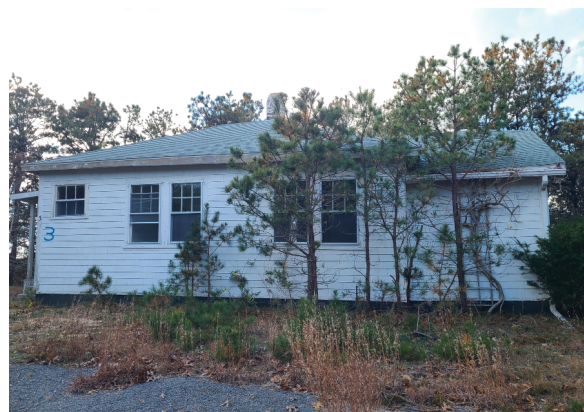
Side elevation with missing rain gutters and overgrown foundation plantings

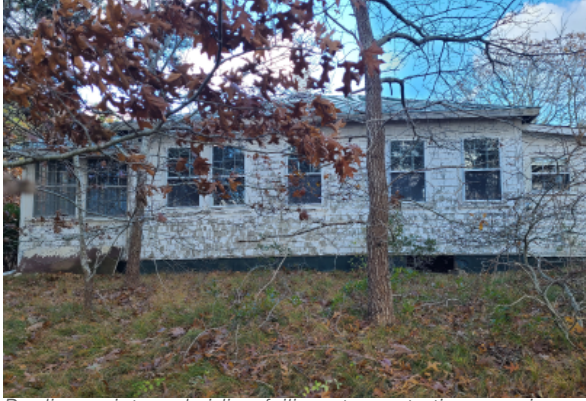
Peeling paint, and siding failing at penetration openings and rotting at the roof line. Additions to the left and right.

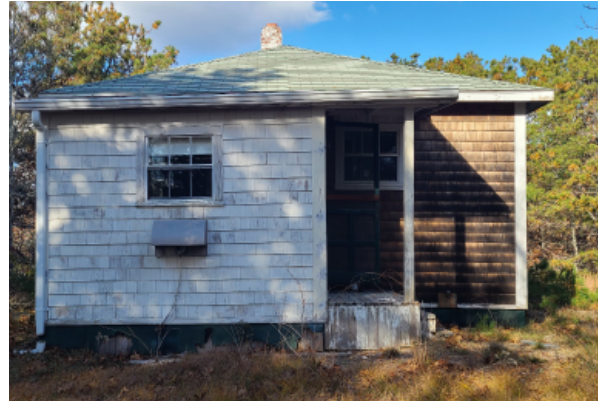
Rear elevation of kitchen addition accessed by decaying wood stairs.

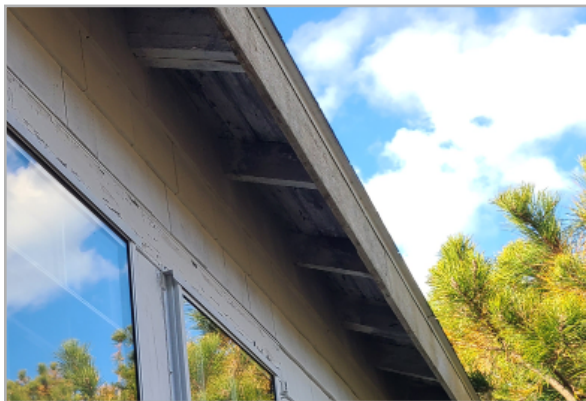
Exposed roof rafters at eave show signs of rot, and peeling paint on fascia board.

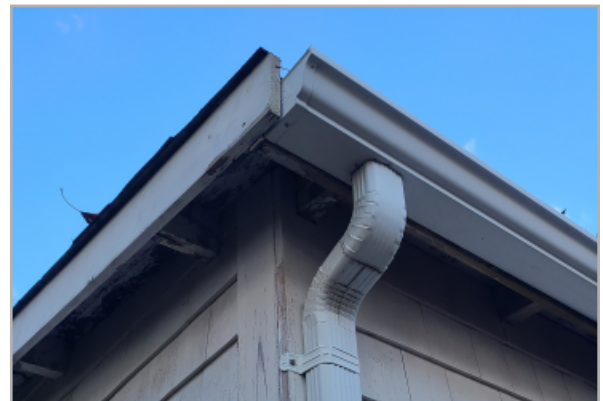
Rake trim at asphalt shingle termination is failing.

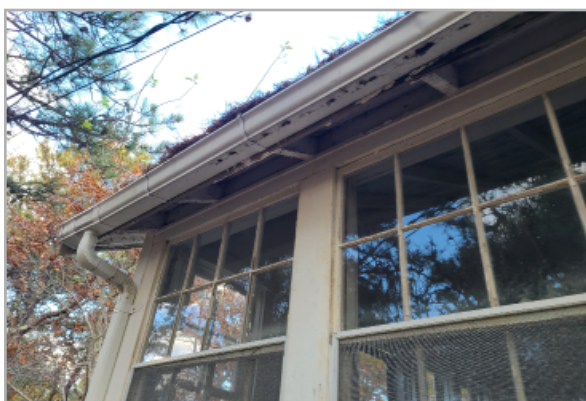
View of exposed and rotting eave with aluminum gutters sagging from the weight of accumulated organic matter supporting live vegetation.

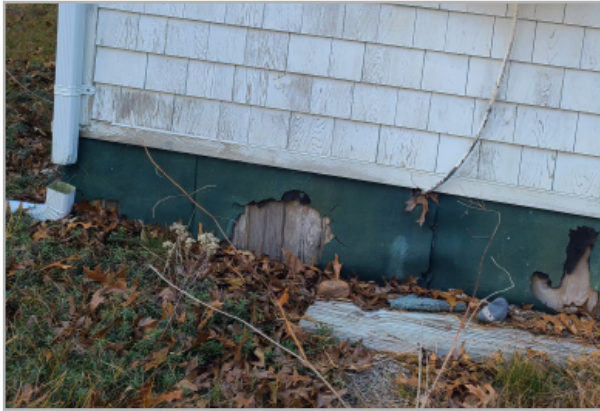
The foundation skirt has rotted through a damaged membrane layer.

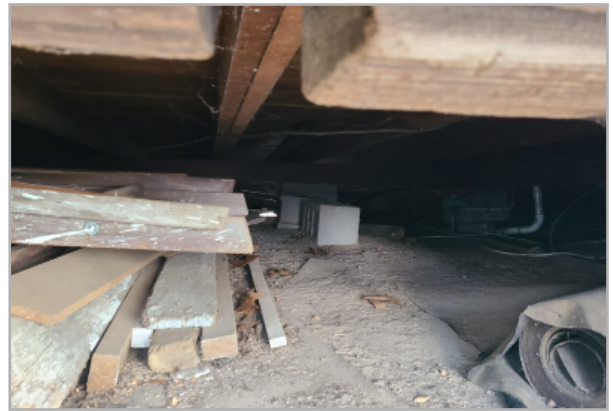
View to crawl space showing notched 2x6 beams and 2x6 wood floor joists. The exposed underside of this and many of the other cottages creates a potential habitat for wildlife.

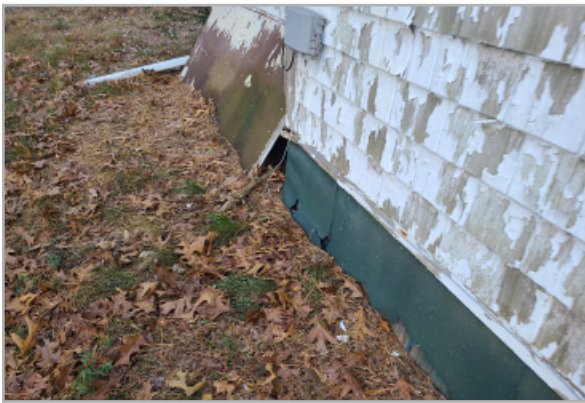
Deteriorated painted plywood foundation skirting.

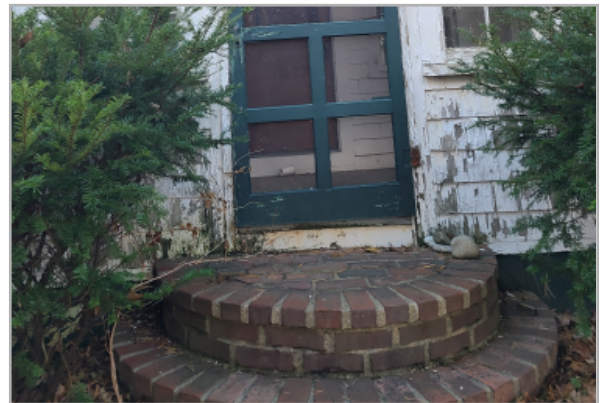
Brick steps at front entry. Note rotting shingles at bottom courses to brick.

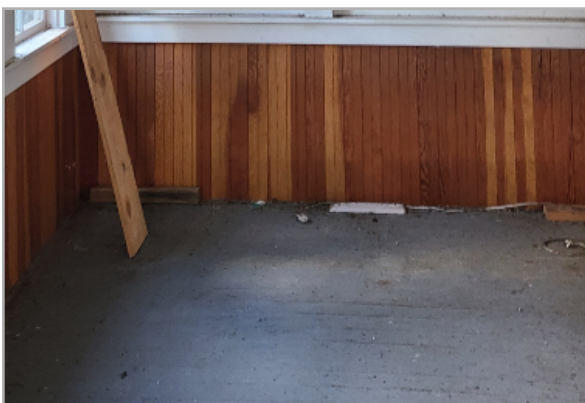
Painted sloped wood flooring at front entrance porch with stained bead board cedar wall panels.

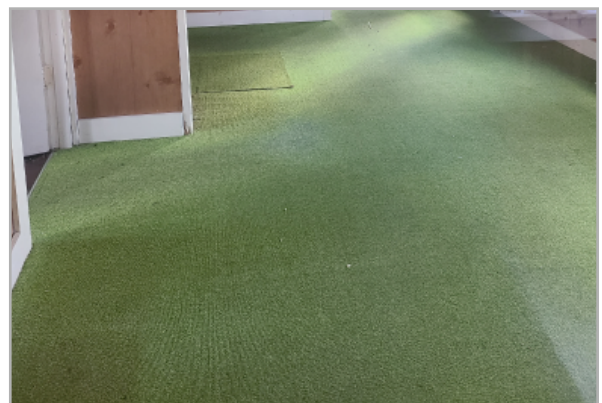
Synthetic grass carpeting covers a severely uneven wood floor surface due to sagging, undersized floor joists and foundation settlement. .

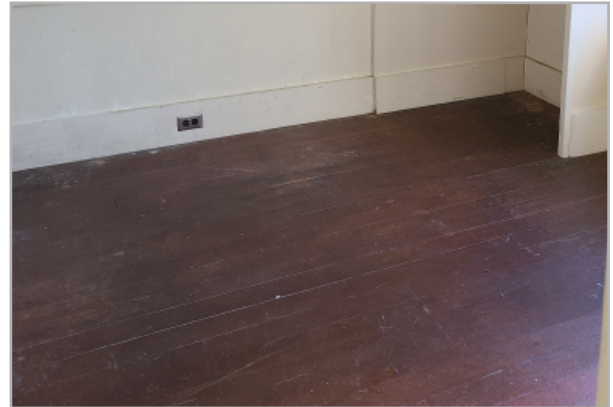
Wood flooring in bedroom is in fair condition. Non-grounded electrical outley located in baseboard.

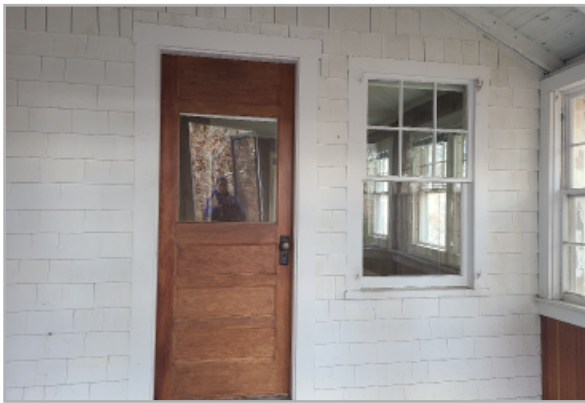
View from front porch additon to main entrance.

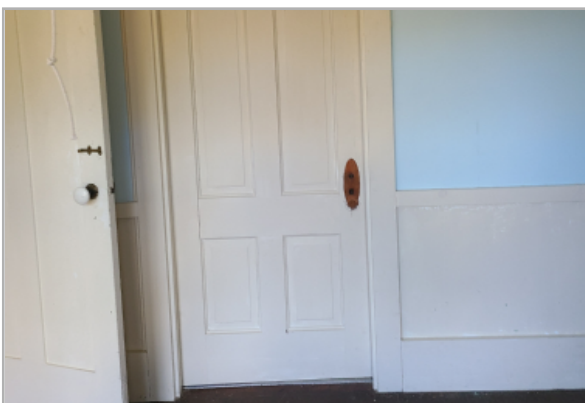
Paster walls with chair rail, trim at door, and contrasting colors. Paint is faded and there are some areas of minor damage due to age. Most interior door opening widths provide less than a 32" clear opening and as such would not be considered ADA compliant.

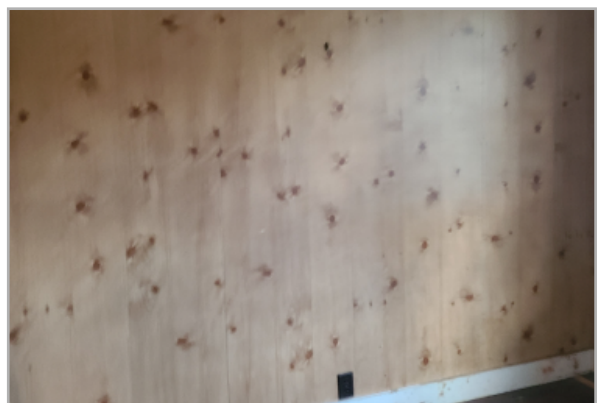
Wood panel walls, naturally stained with a contrasting base board. There are signs of mold and mildew growth in some areas.

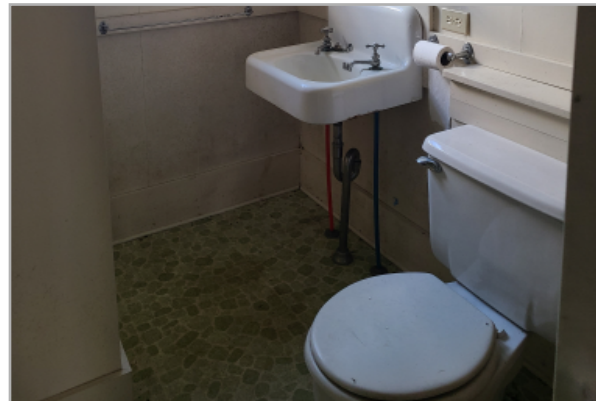
Wall hung sink with separate hot and cold faucet fixtures. Hazardous non-GFCI, non-grounded electrical outlet next to sink.

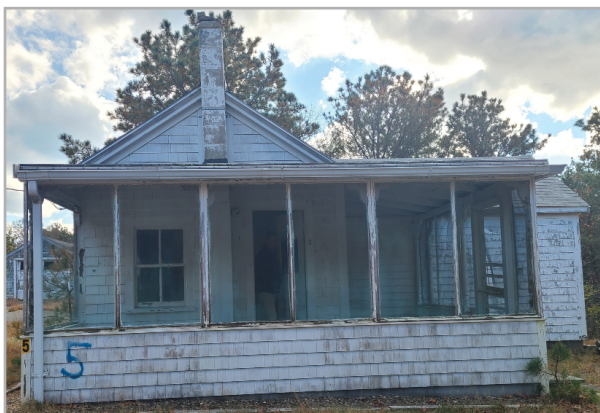
Front of cottage where a covered porch wraps around one corner. The screens and low walls are greatly weathered.

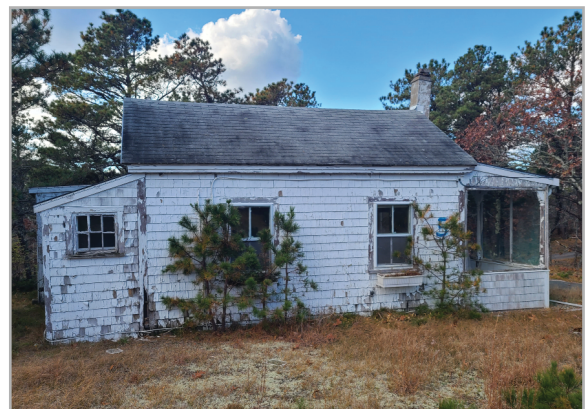
Building siding paint is peeling throughout with rotting deteriorated shingles and wood trim boards.

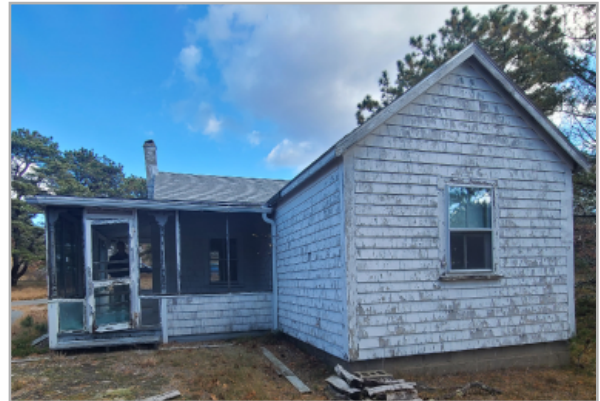
View of West face of building, the paint is peeling and chipping off of almost 90% of the surface area. The front porch addition is failing as is the masonry chimney.

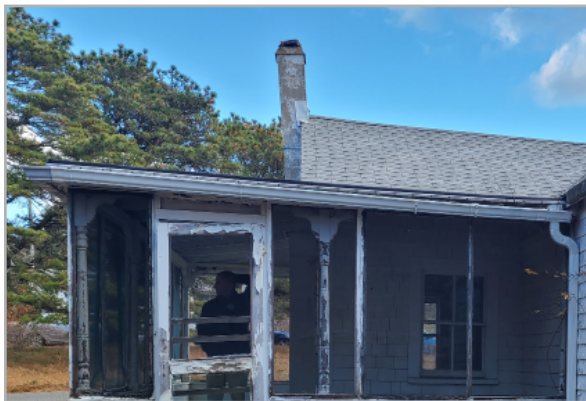
The front porch addition roof is pitched incorrectly causing water to run towards the gable end of the roof.. This entire construction has degraded and must be demolished.

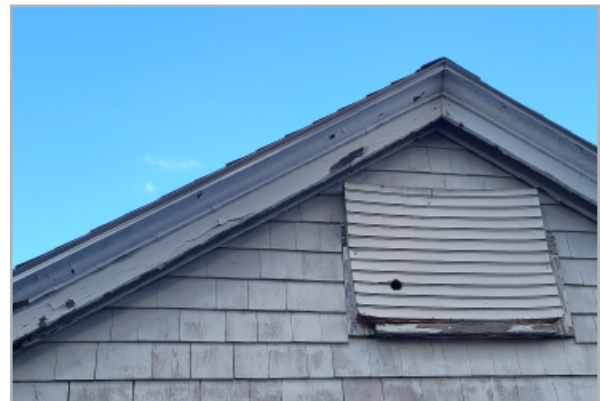
A view of the rake condition of the original roof. A louver is located at the peak, and has deflected out of its penetration. The rake shows sign of mold between the fascia board and siding.

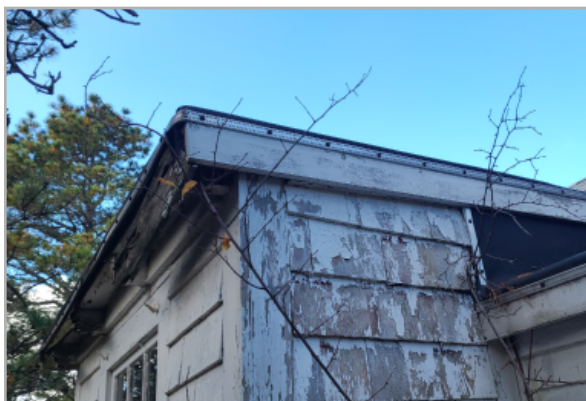
View of back additions, the membrane roof has failed and the fascia board has rotted out exposing the structure behind to the weather. The building siding has also been patched with a membrane sheet to the right.

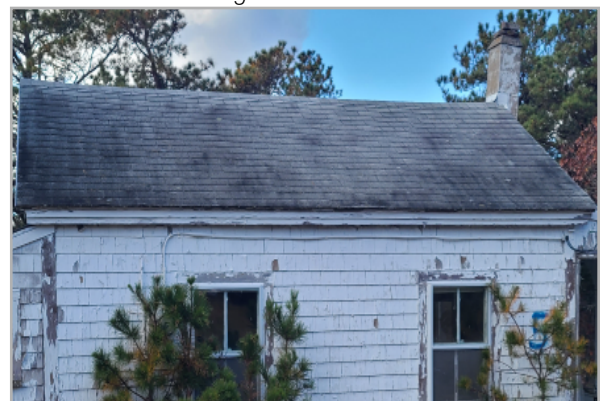
Roof with degraded asphalt shingles and visible sagging due to either damaged or insufficiently sized roof rafters.

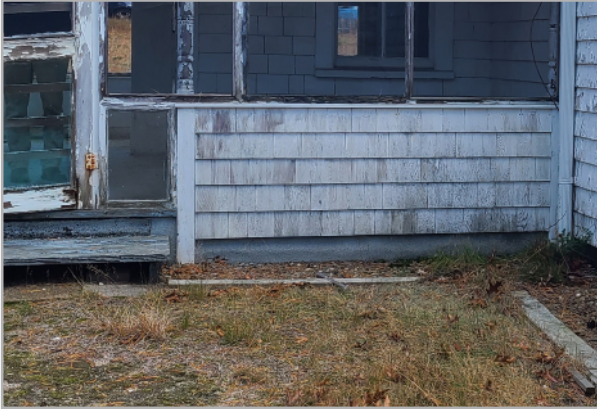
Wooden foundation under front porch addition sitting on grade.

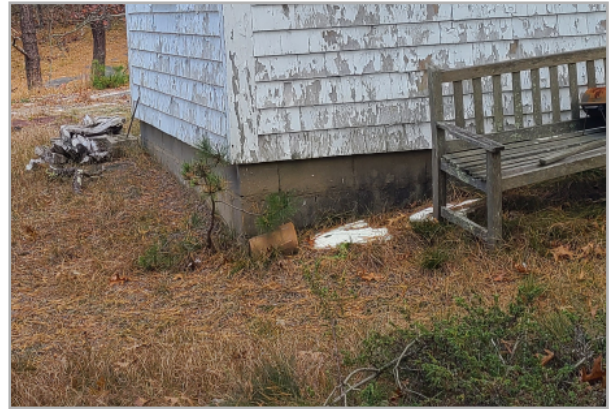
View of CMU foundation at South West corner, vegetation is beginning to encroach and the presence of a tree sapling suggests root penetration.

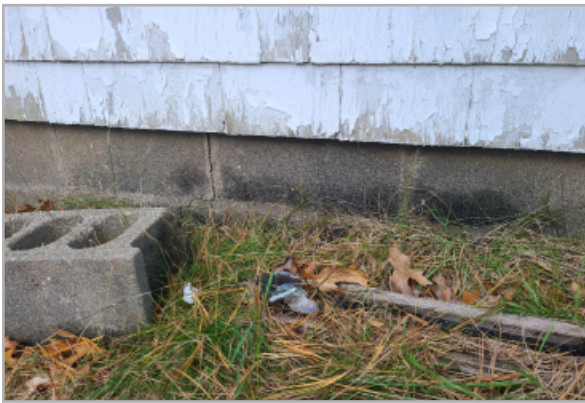
CMU foundation with discoloration indicating water damage within, and cracking in the mortar joints.

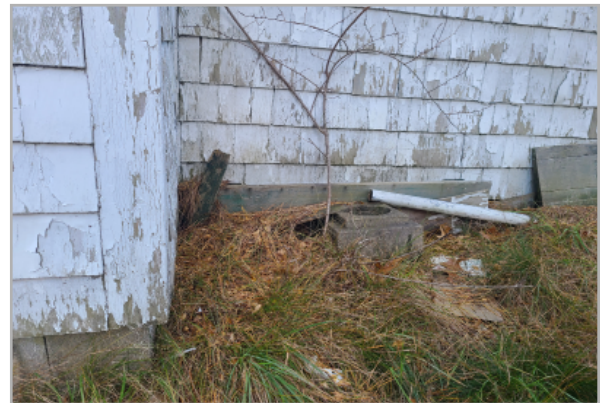
Ground and debris built up against CMU foundation and wall cladding at Southern elevation. Voids in the wall allow animals to enter and live under the building.

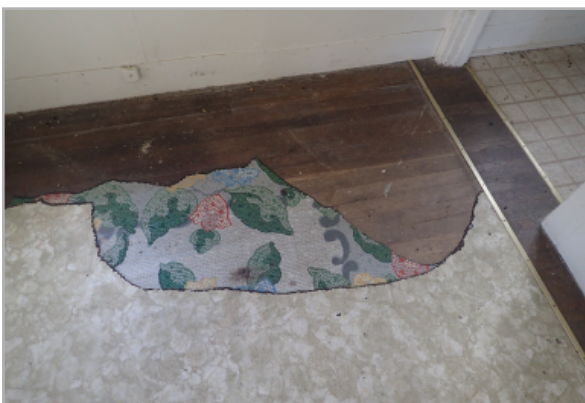
View of multiple layers of floor coverings that have crumbled away to expose the original wood floor blow. Sagging and sloping of floors and evident wall cracking suggest the foundation has settled over time.

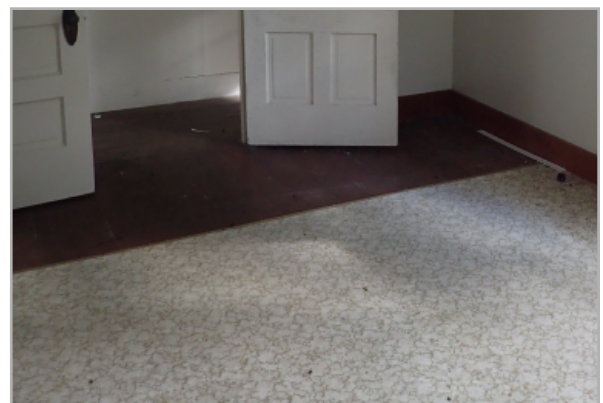
View of room floor with two types of flooring and flush doorway threshold. The flooring is chipping and damaged in areas and must be replaced.

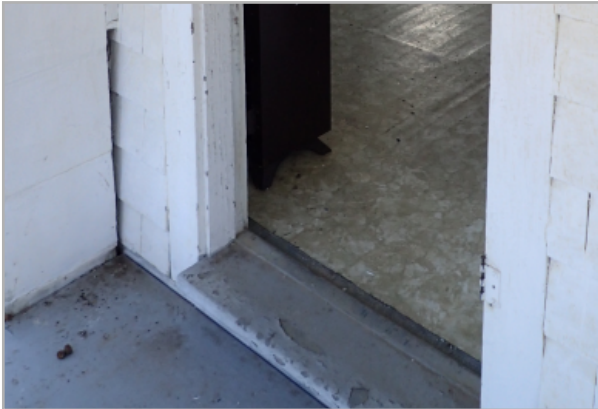
View of exterior threshold that is greater than one inch which is non-compliant with code, and deflection in the interior sheet floor finish can be observed.

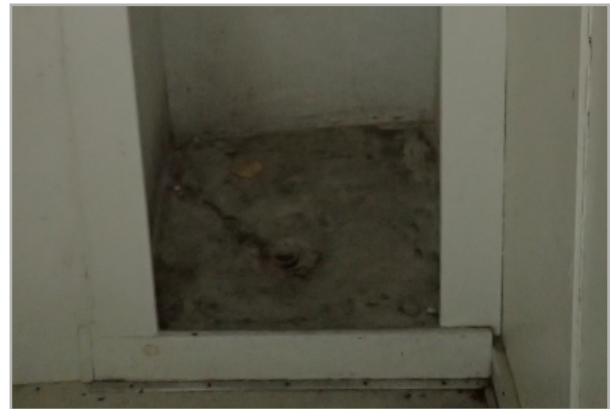
Bathroom flooring is sheet tile, and has areas of mold growth and discoloration. The floor of the shower stall and base of wall is covered with mold and mildew growth.

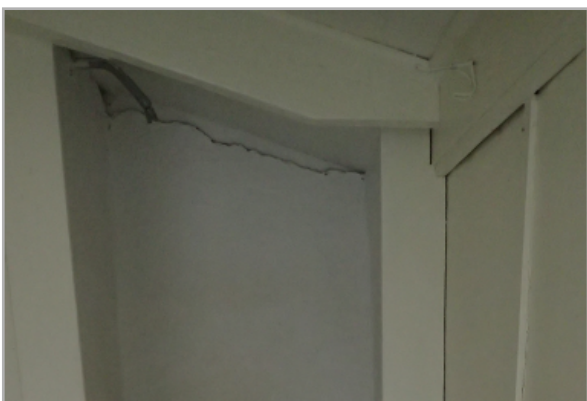
View of crumbling wall and ceiling due to insufficient moisture protection, and must be investigated for extent of damage.

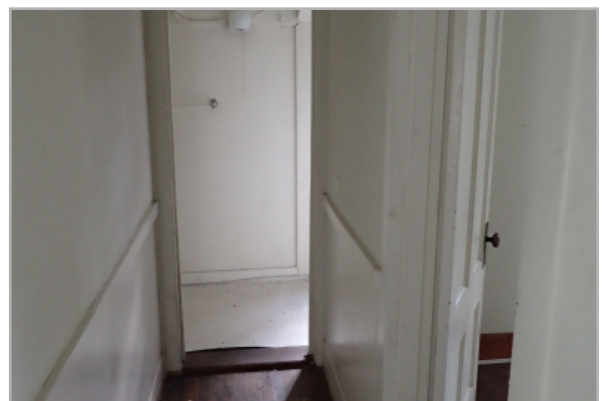
View of building hallway with painted wall panels and trim at base and about 3' that is painted to match.

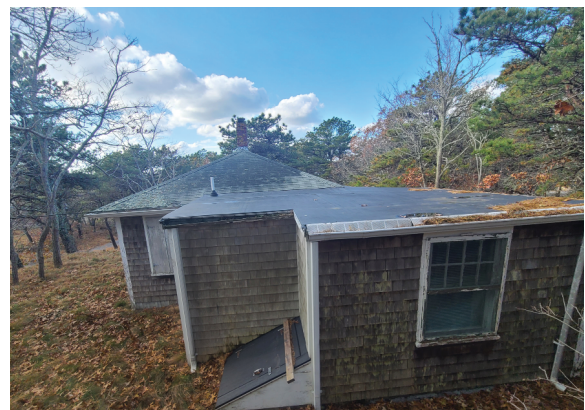
View of East elevation, there is a rear addition, with discoloration throughout siding indicating water damage.

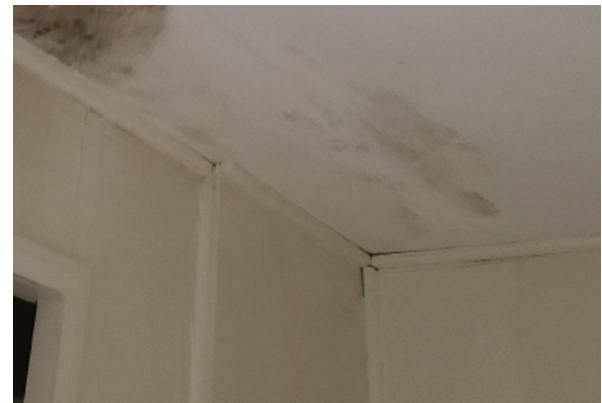
View from the interior of water damage and mold seen in the ceiling indicating multiple areas of water penetration into the roof.

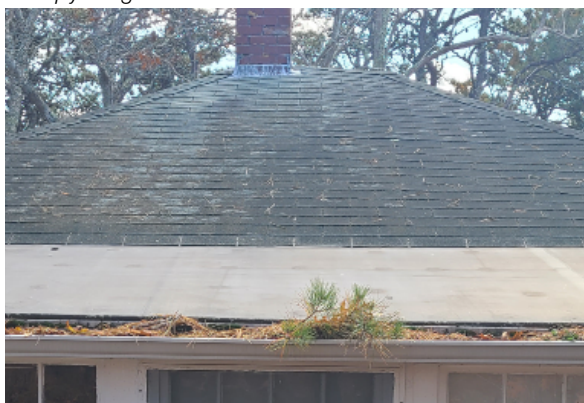
View of side addition membrane roof in relation to the original hip roof. The asphalt shingles are beyond their useful life. The gutter is filled with organic material supporting vegetative growth.

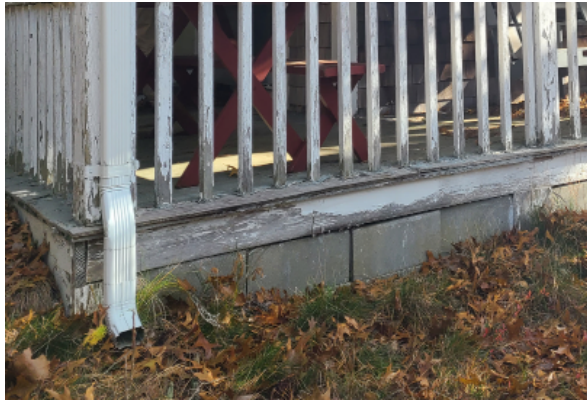
CMU on grade foundation for porch addition is an insufficient structure, and the wood framing is in contact with the ground on the northern side (left).

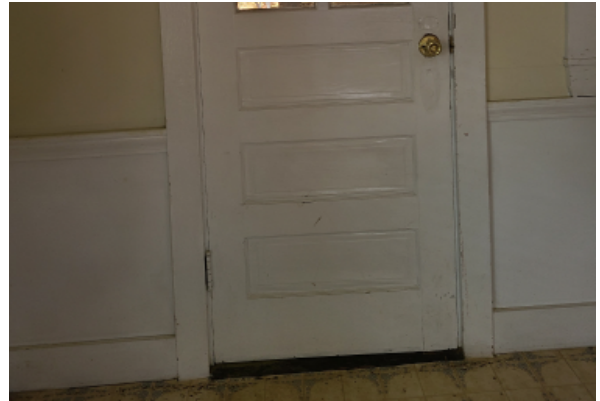
Door threshold in relation to the floor deflection, indicating a sloping settling foundation.

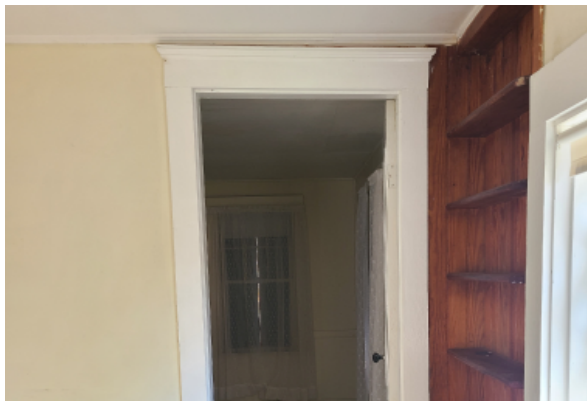
Interior door frame that is tilted, illustrating the failing foundation. This entire front room is sloping out from the central point of the inner most wall (facing here). The door opening width is 26\"/>

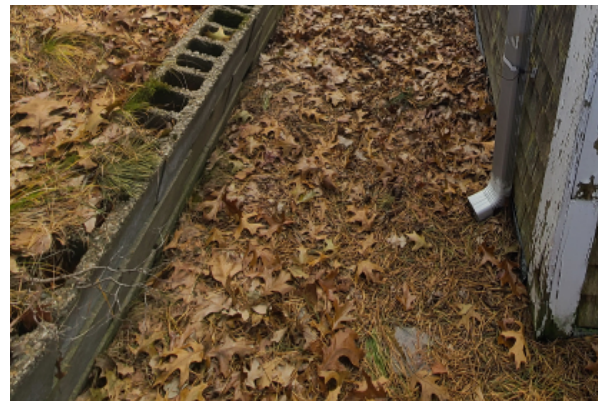
CMU retaining wall off set from foundation does not provide enough depth to keep the exterior building envelope from contacting the ground resulting in rotting and decaying of the exterior wall fabric in this location.

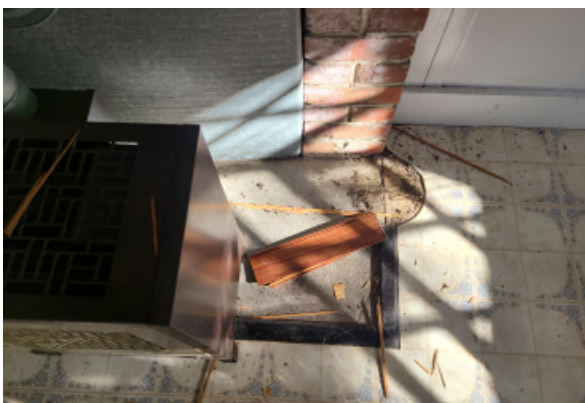
View of sheet flooring transition to stone tile of furnace hearth that is in the central inner wall location. This area has separated from the floor that has sheet on it due to the sloping of the foundation directed away from the wall at the top of this photo.

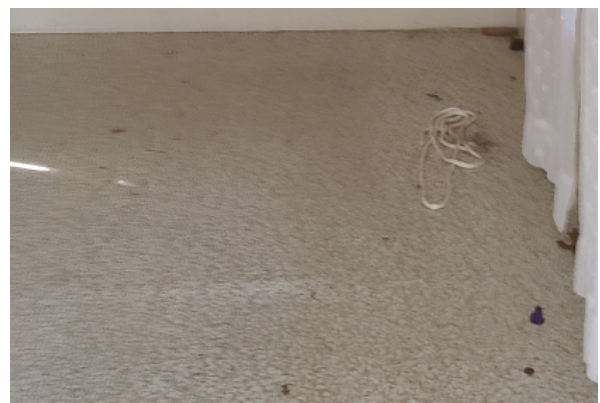
Sheet flooring with signs of degradation throughout.

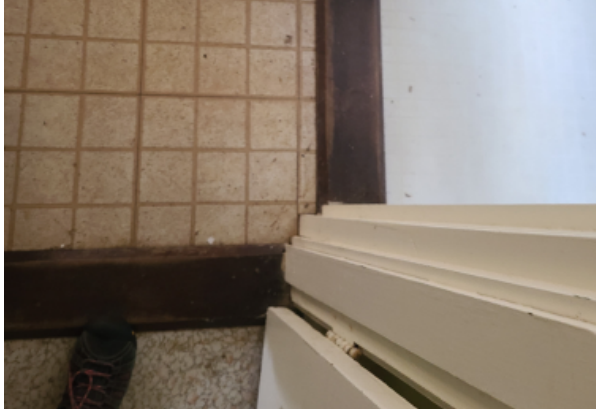
Condition of floor finish transition. Floor plan at this location is not wheelchair accessible due to configuration of cabinets and doorways and door thresholds.

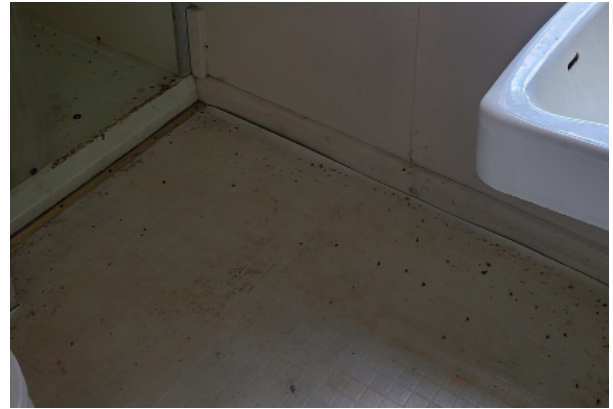
Sheet flooring in bathroom with signs of degradation throughout and crumbling at the edges. Signs of water damage are apparent at the edge of shower stall.

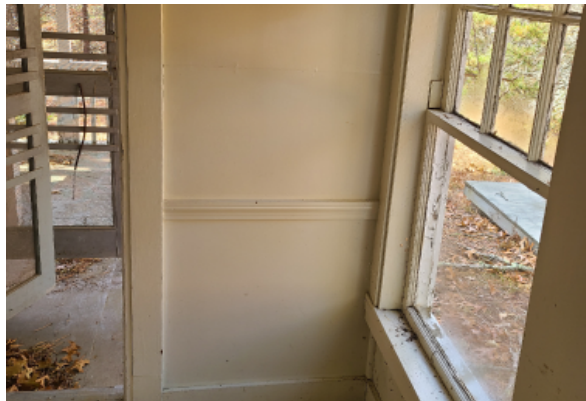
Exterior corner of side addition with painted plaster walls. The window is not protected with a storm window and is in poor condition as a result.

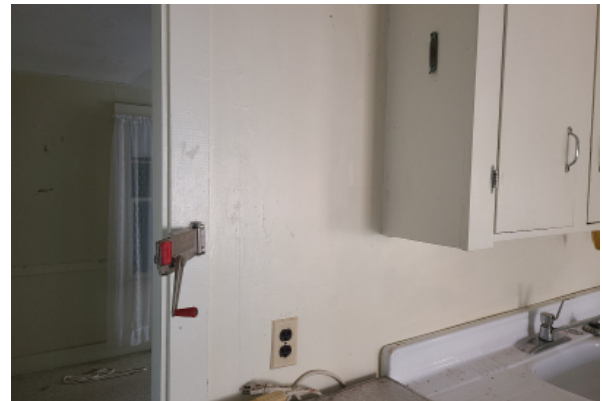
View of kitchen wall with dangerous non-GFCI, non-grounded electrical outlet next to kitchen sink.

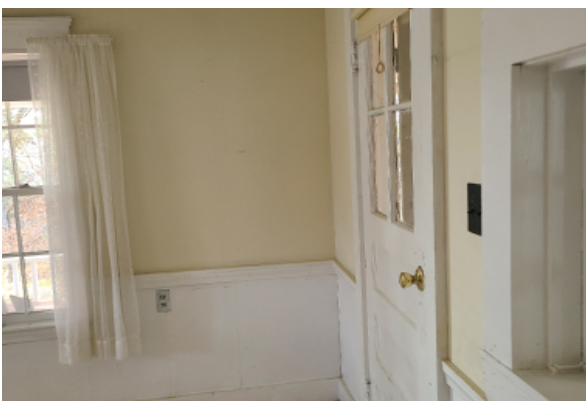
Painted plaster wall with cracks occurring due settling foundation and undersized floor joists.

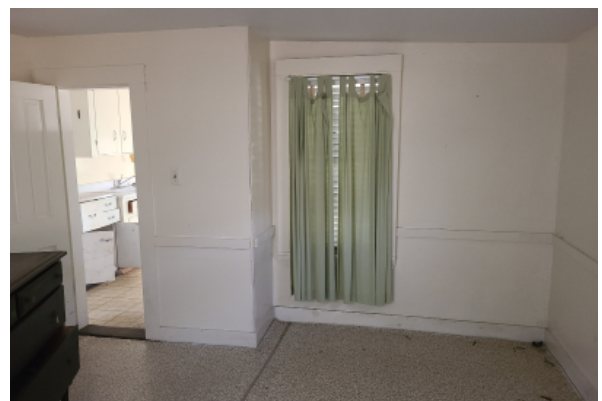
Painted plaster wall with signs of mold and mildew growth. The window in this room is now interior due to the side addition.

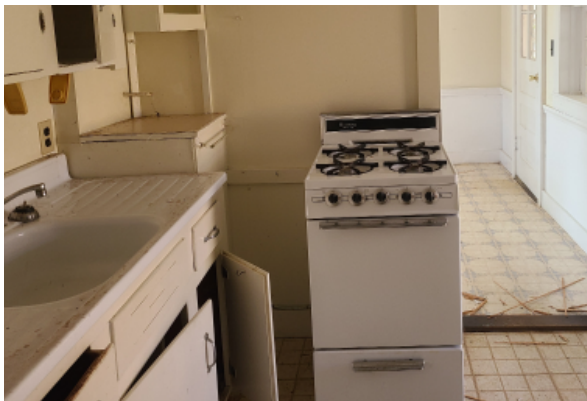
Stove/oven unit is outdated and needs replacing. There is no exhaust fan above the propane gas fueled burners.

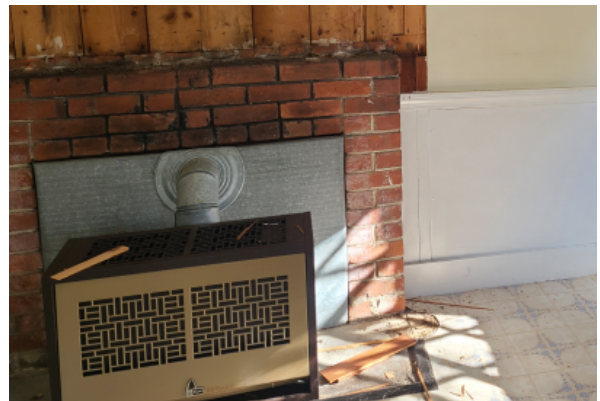
Propane fueled central heating unit with signs of water damage from the chimney.

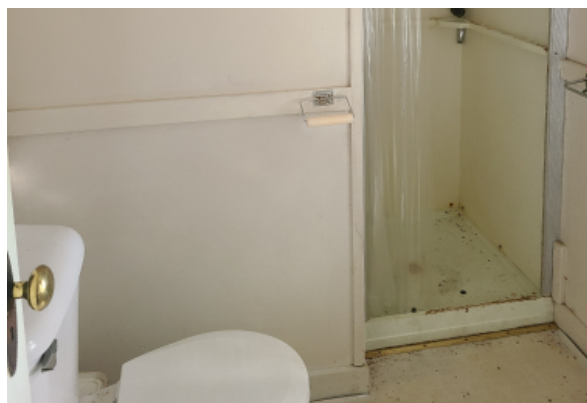
This building has a toilet, sink, and shower stall. The shower stall needs replacement due to degradation of materials.

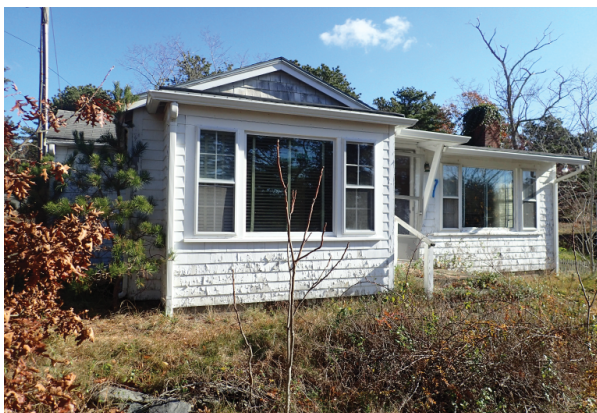
Non-compliant entry stairs at front and paint degradation.

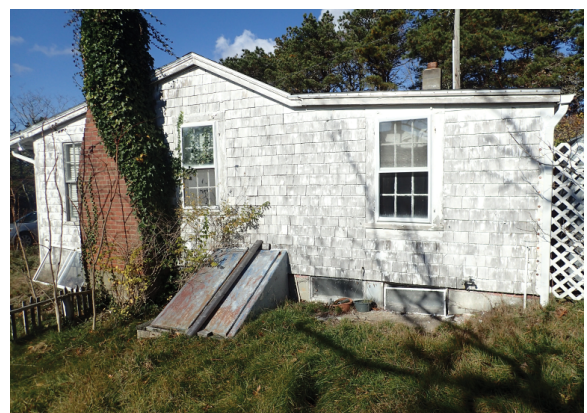
South elevation, vegetation penetration can be seen.

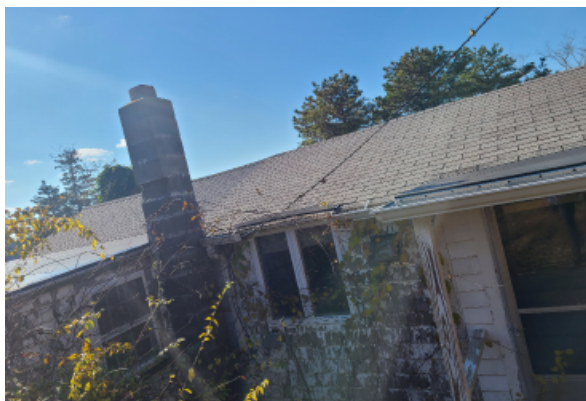
General roof condition, the shingles show little sign of deflection but their adhesion and viability are assumed to be insufficient due to age.

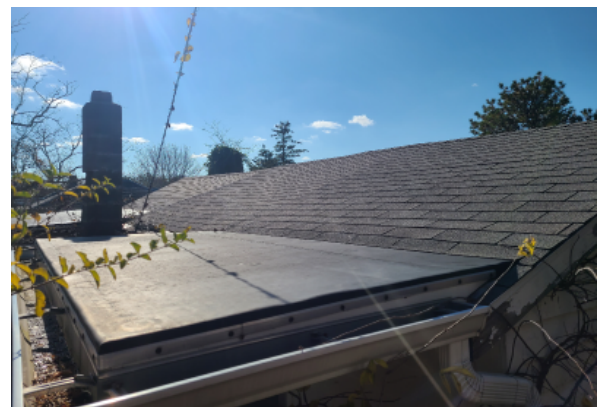
Membrane roof condition of building additions with signs of degradation.

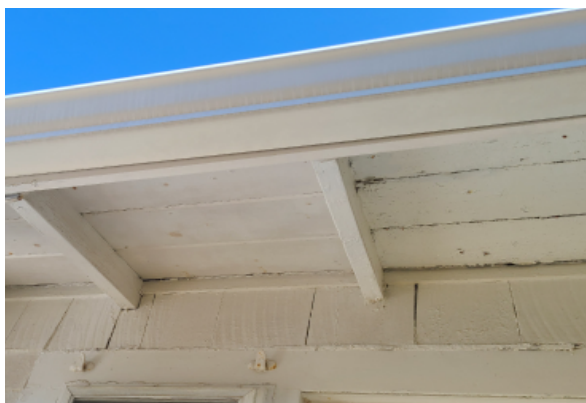
View of the roof eave condition where the paint is chipping between the sheathing boards. The peeling is not uniform throughout indicating that the roof eave may only have water penetration in just those areas.

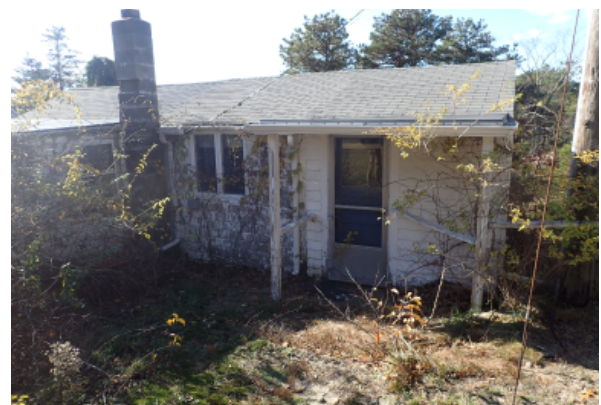
Rear elevation of the building where vegetation has penetrated the exterior chimney and into the building interior at open penetrations. Roof edge areas unprotected by a gutter lack paint and shows signs of decay.

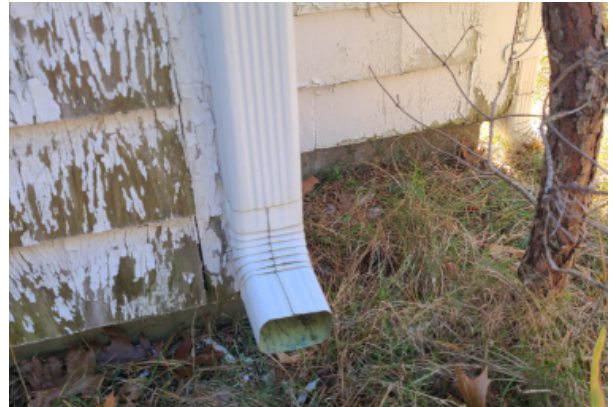
View of the base condition of a downspout where the last length of aluminum is missing. The water run off is insufficiently removed from the building footprint.

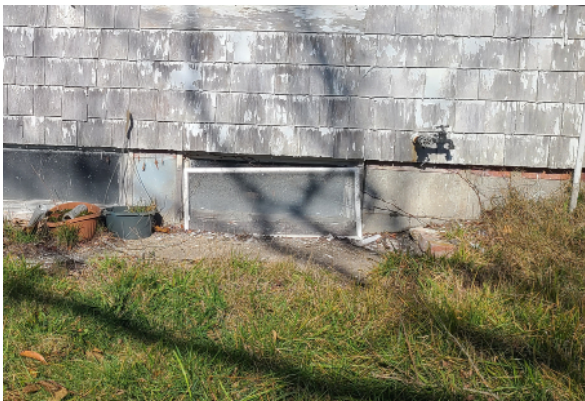
View of cracked parged CMU foundation. The basement window in this area is missing, allowing for animal habitation.

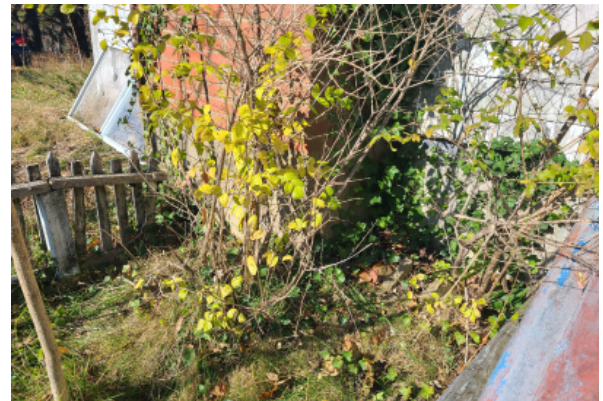
View of vegetation overgrowth penetrating chimney and wood shingle siding.

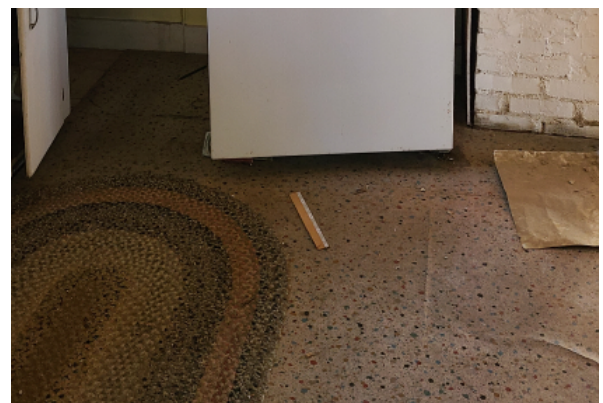
Sheet flooring that is badly worn with visibly evident floor deflection throughout.

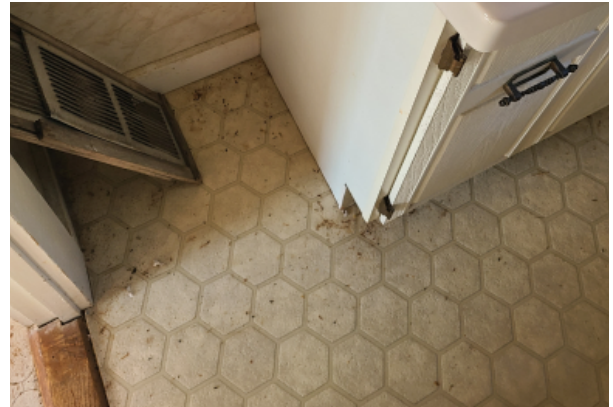
Sheet flooring that is degrading and crumbling at the edges.

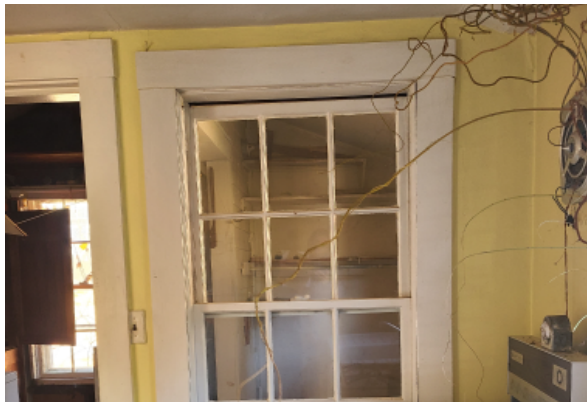
Exterior window that became interior with the side addition. To the right is a through-wall exhaust fan with vegetation penetration.

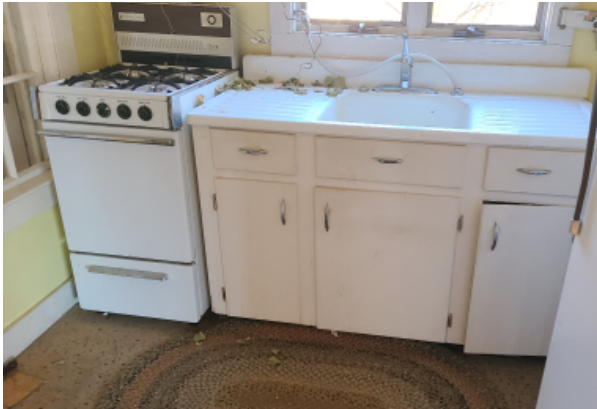
Stove/oven fixture with counter top sink fixture. The hardware on the sink is non-compliant, and the stove/oven fixture is outdated and needs replacement.

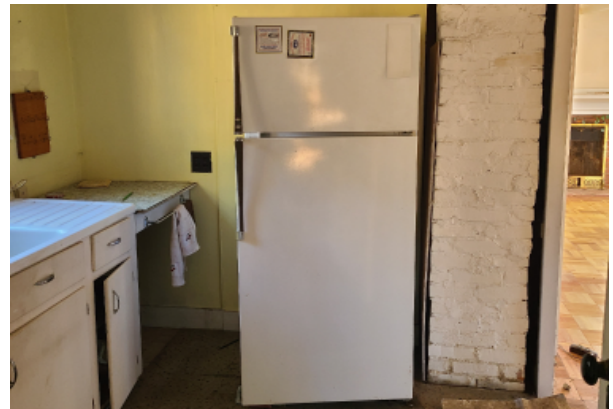
Refrigerator that is outdated and needs replacing. Beside it can be seen what seems to be an old chimney that has been abandoned.

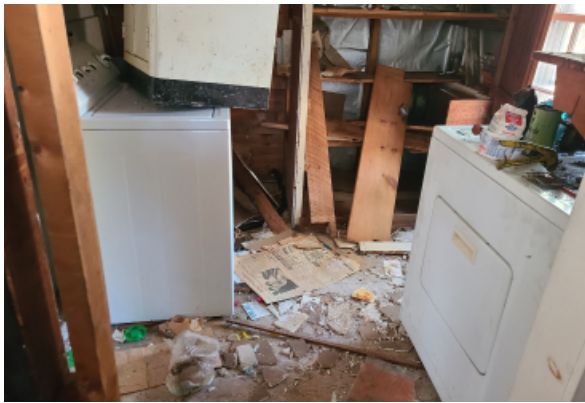
A set of clothes washer and dryer, as well as another unidentified fixture on top. The condition of these fixtures are unknown, but any utility connection must be updated.

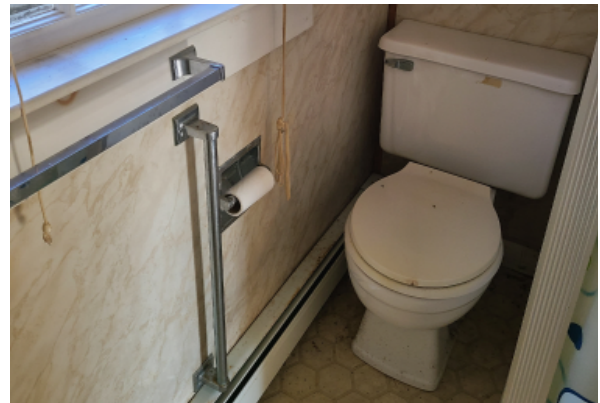
Toilet fixture with signs of damage due to normal wear and tear. There are nonconforming guardrails in this location as well.

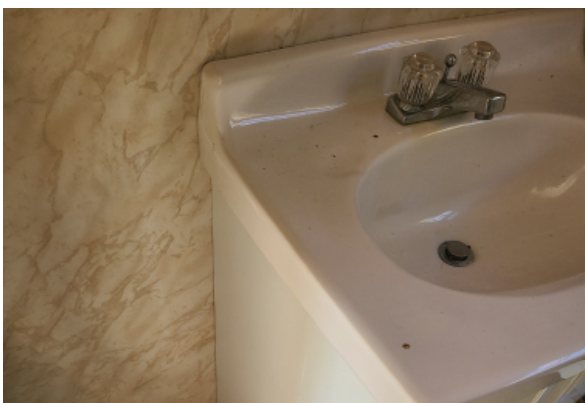
Bathroom fixture with non-compliant hardware.

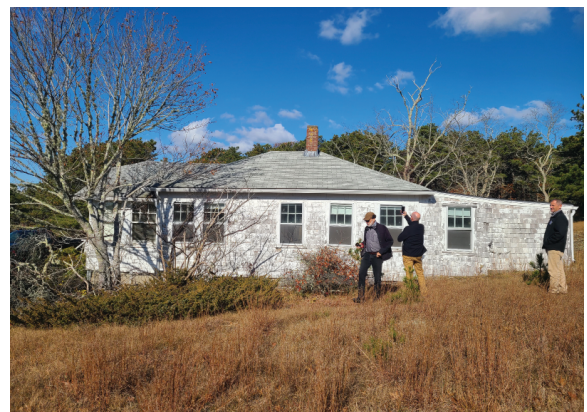
Southern face of cottage, front and rear additions are apparent. This face is missing at least 50% of its paint.

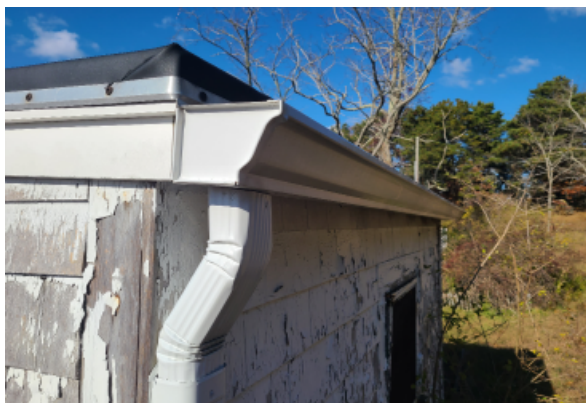
View of typical gutter and downspout condition at this cottage. The connection of the gutter to the roof eave is non-compliant, and the rust apparent in the fastening screws indicates a need for roof replacement.

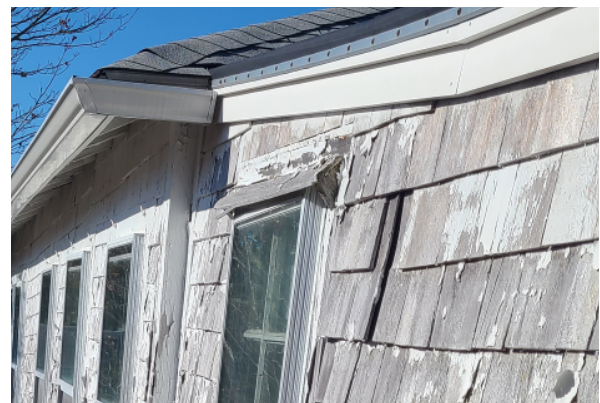
View of the original asphalt roof construction connecting to the rear addition membrane roof rake. The ridge of the original roof can be seen to show signs of degradation.

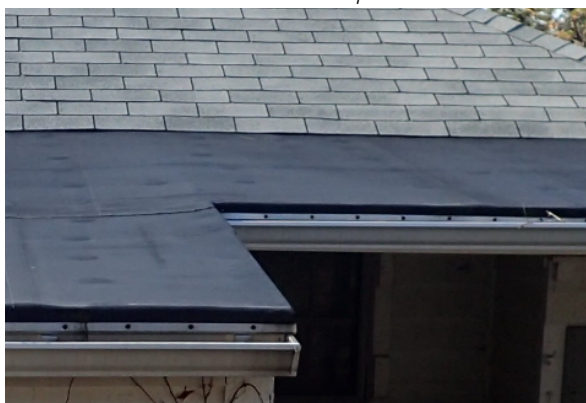
View of membrane roof of the rear addition, this roof has a significantly lower pitch than the original roof, and is showing signs of deflection in the structure.

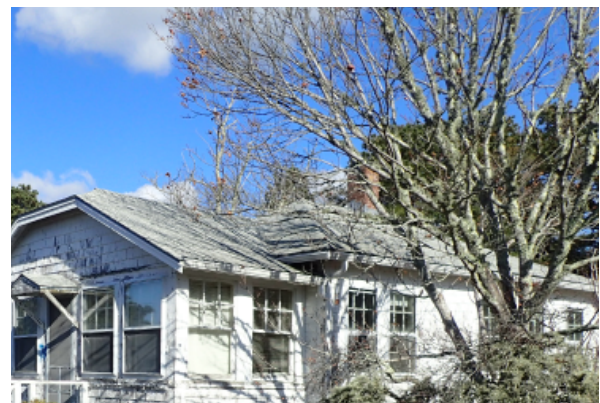
Cottage roof condition with front addition roof rake meeting the original building siding below the original roof eave. This roof construction is non-compliant and must be made to be so.

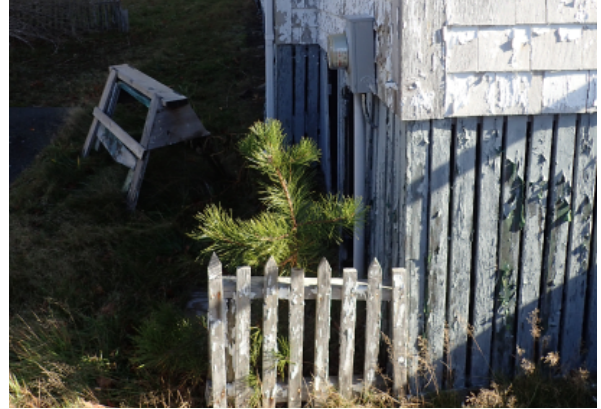
View of the foundation enclosure at the front of the building where the grade is the lowest. The boards of the enclosure are rotting and two layers of paint can be seen peeling.

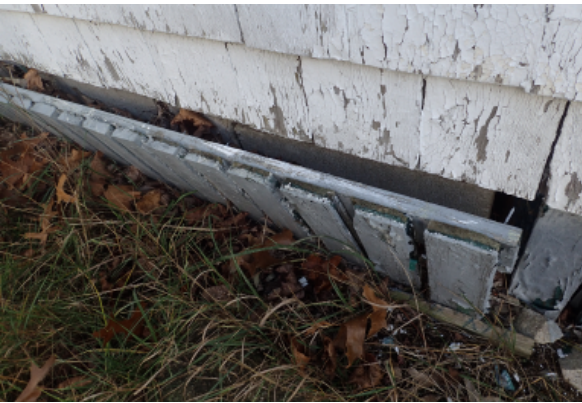
Wooden foundation enclosure rotting and detached from the building. Signs of past reinforcement efforts with a horizontal 1x3 can be seen at the very base.

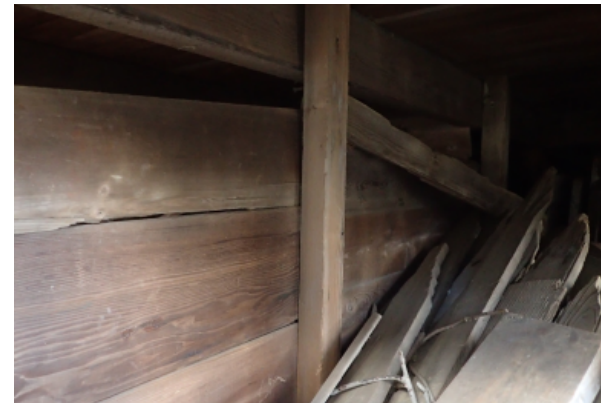
View into foundation crawl space. Insufficient floor supports can be seen, and a wood board partition dividing the space into storage and inaccessible.

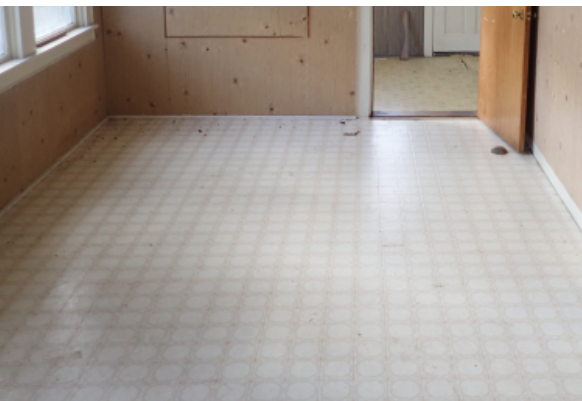
Wall to wall sheet flooring with word spots and some crumbling at the edges.
