North
Truro
Air
Force
Station

WALSH WAY PROPERTY ASSESSMENT REPORT

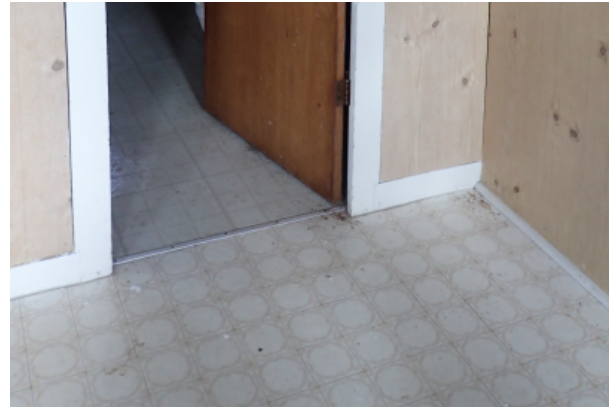
Sheet flooring with signs of degradation throughout and crumbling at the edges.

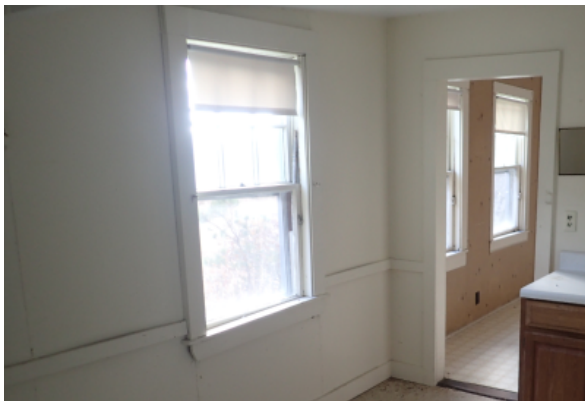
Painted plaster wall with trim about openings and at the base, as well as trim board at about 3' above finish floor. Paint shows signs of mold and mildew growth.

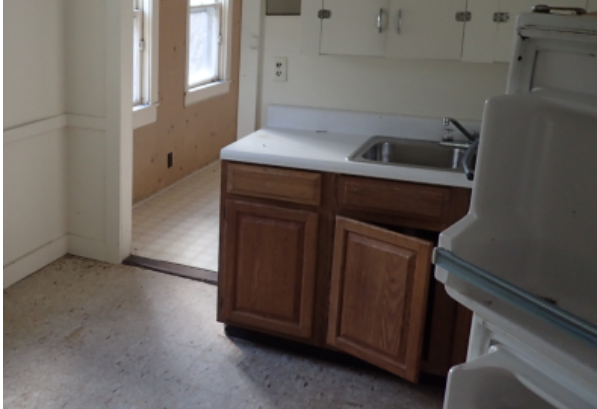
Refrigerator and in counter double sink are present. The refrigerator has signs of mold, and must be replaced.

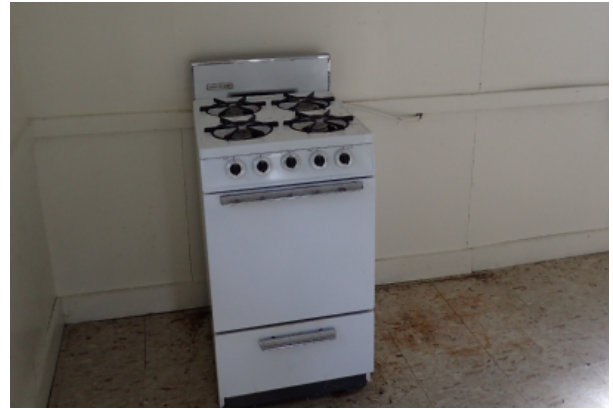
Stove/oven fixture with exposed connection into the wall. Fixture is outdated and needs replacing.

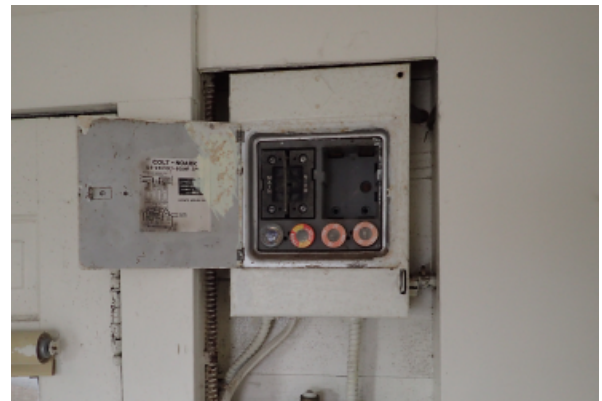
Conduit box with original fuses is non compliant and must be removed and replaced with up-to-date fixture and wiring.

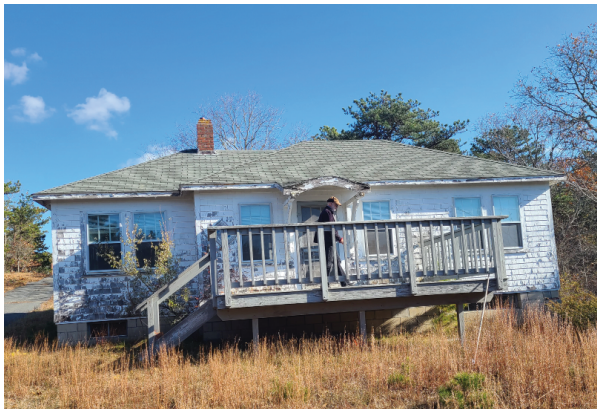
Front view of cottage, CMU foundation has two window penetrations just above grade. The paint is peeling throughout.

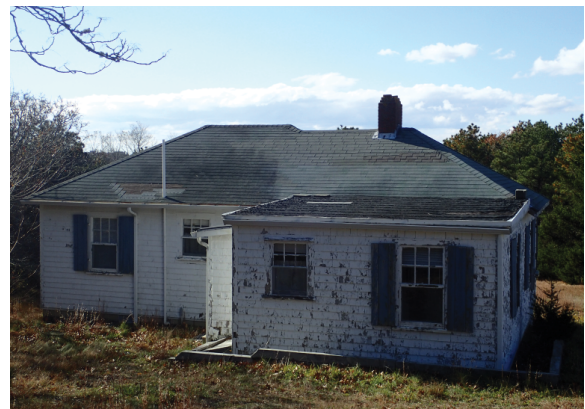
The cottage has gutters at every eave, but some downspouts are missing, and all aluminum is failing.

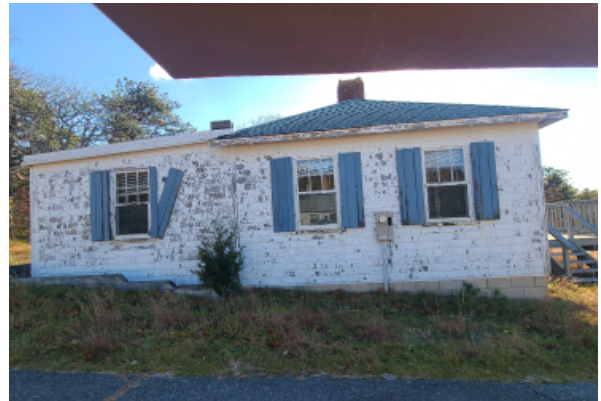
North elevation, bedroom addition to the left has with damaged window and peeling paint.

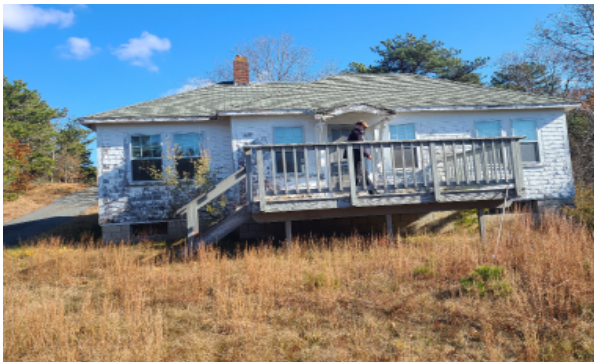
Shingled eyebrow canopy over front entry is rotted and failing. The fascia board is damaged and rotting at the entire perimeter of the roof. The wood deck is not worth saving.

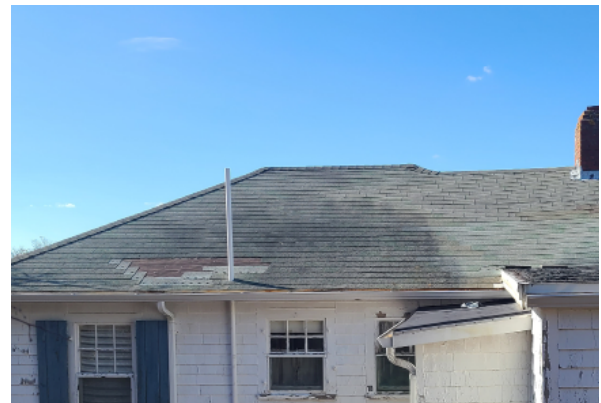
Patched asphalt shingle roof past it's useful life.

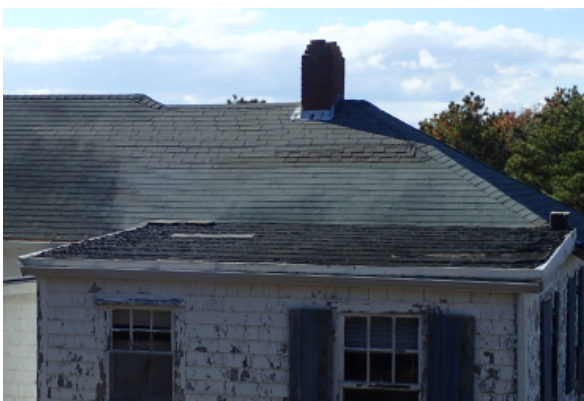
Poorly constructed addition with degraded asphalt shingled low pitched shed roof.

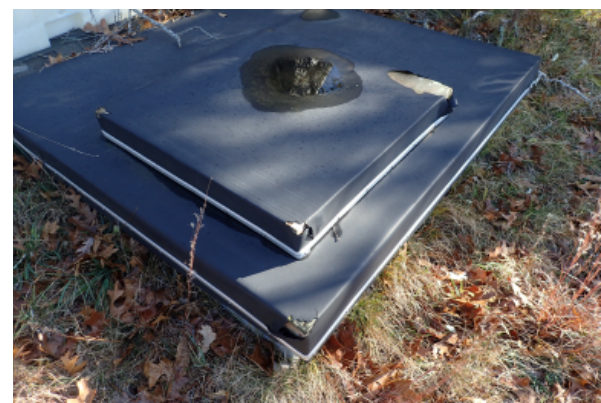
Membrane roof assembly nearby building similar to other membrane roof constructions on the property. Failure at the corners and edges indicates age and needs replacing.

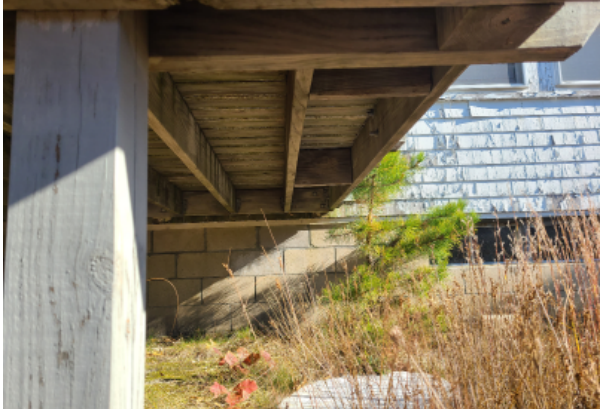
Deck addition framing supported by the CMU foundation at one side and piers at the other.

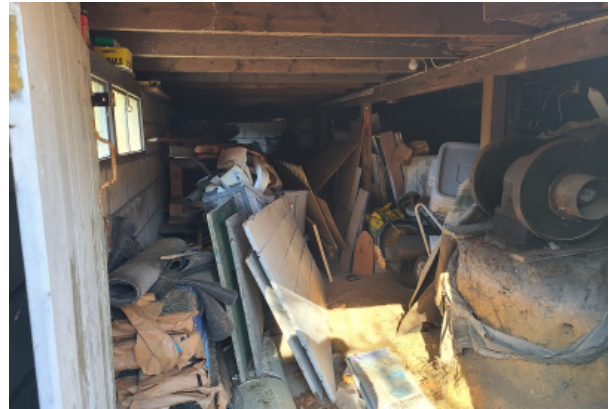
View inside crawl space/basement.

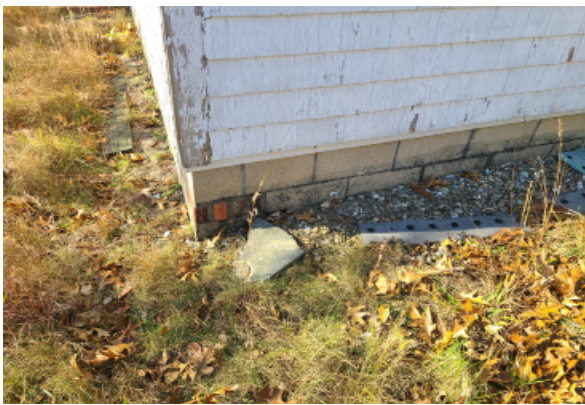
CMU foundation wall at grade, with brick patching seen in the corner.

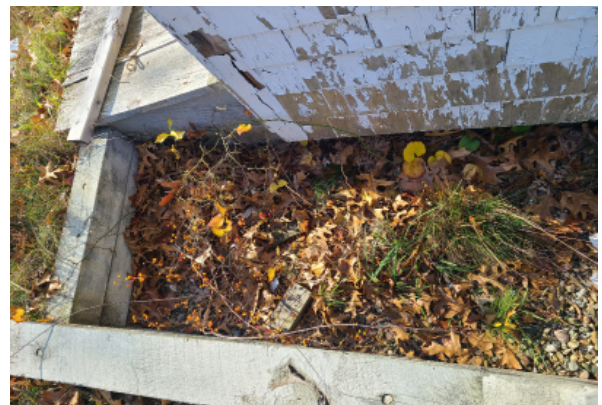
Insufficient wood retaining wall set back from building face.

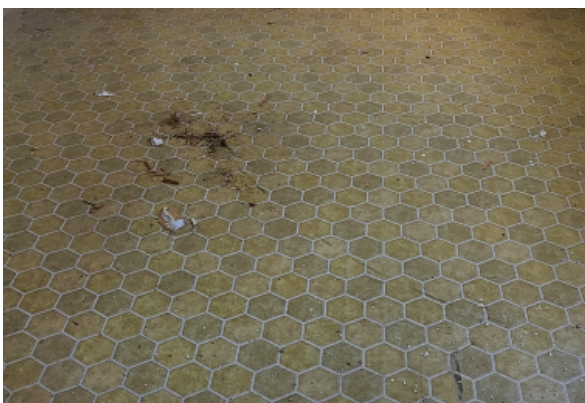
Worn and damaged sheet flooring.

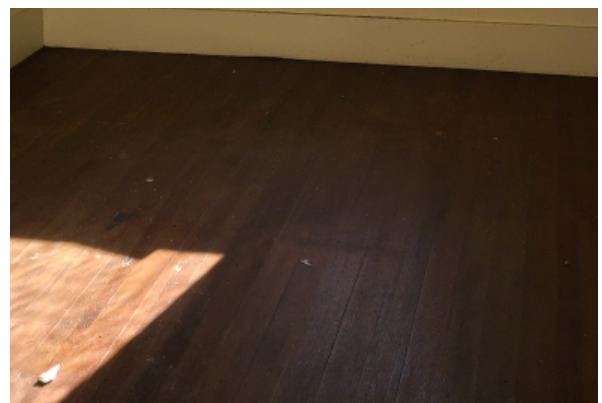
Hardwood flooring needs restoring, and has a slight pitch indicating foundation settlement.

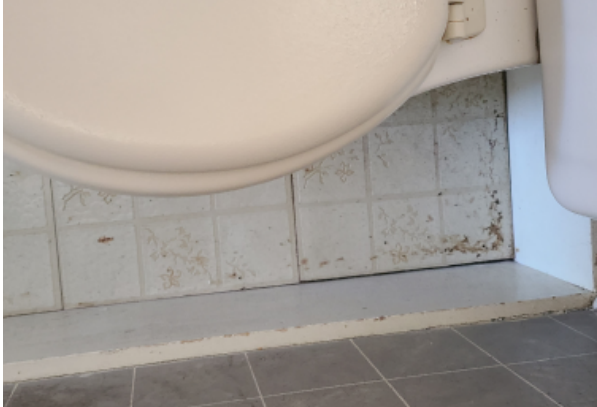
Sheet tile flooring in full bathroom. Tiles have become unsecured in areas and failing.

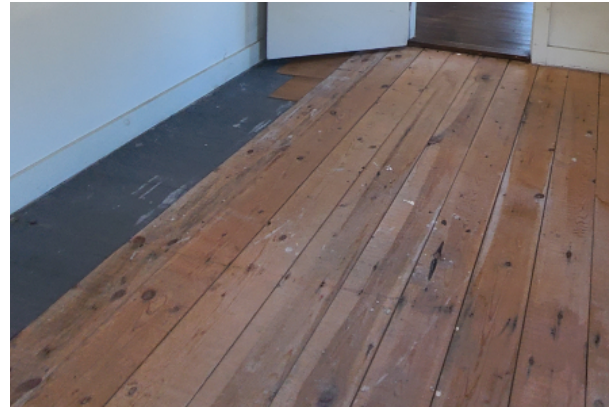
Buckled wood flooring in one of the bedrooms due to water damage.

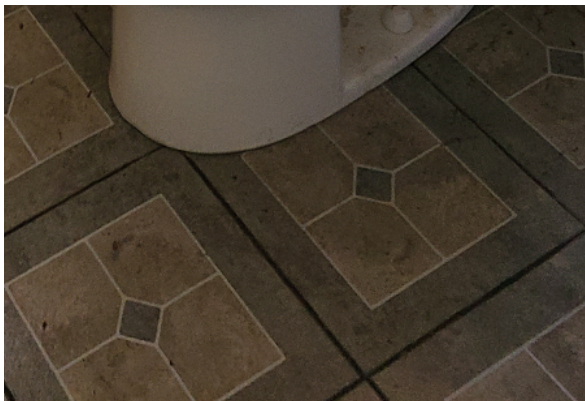
Sheet tile flooring in half bathroom, is crumbling at the edges and seems.

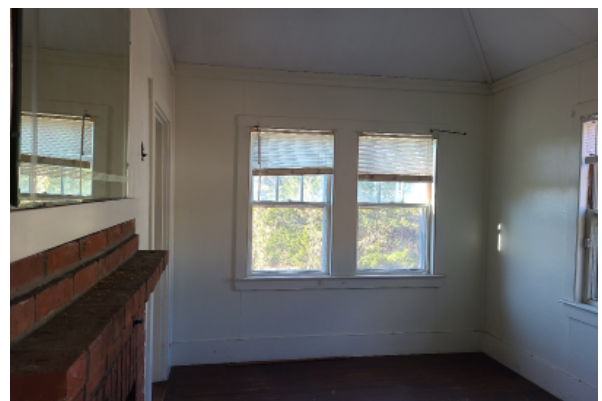
Painted plaster wall with base board trim and crown molding. Trim around window frame is beginning to separate from the wall, and needs replacing. Window hardware at the top is damaged and must be removed.

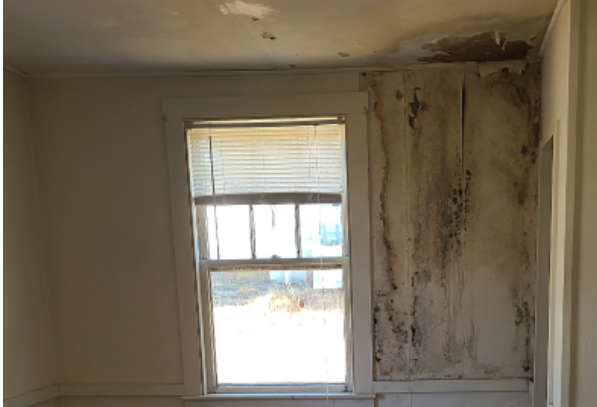
Interior wall with severe water infiltration and resultant mold.

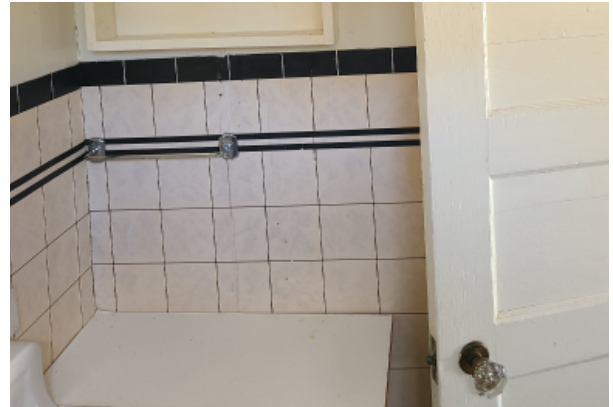
Tile wall finish in half bathroom, terminating in a tile bull nose and has painted plaster above.

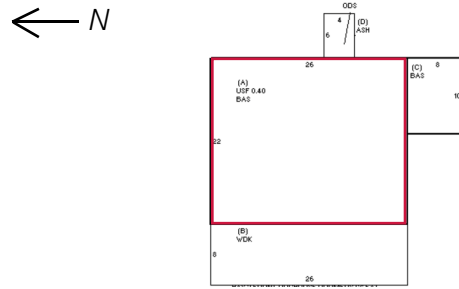
Original building structural core outlined in red

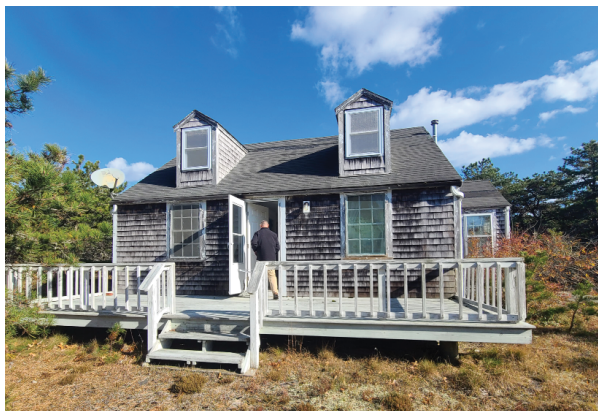
View of front of building and porch addition.

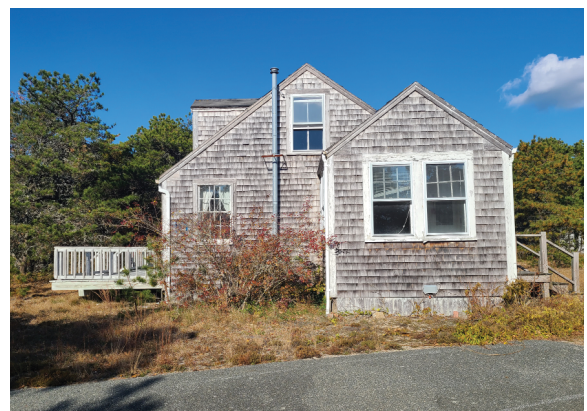
Unpainted cedar shingle siding in fair to poor conditions dependent upon wall orientation.

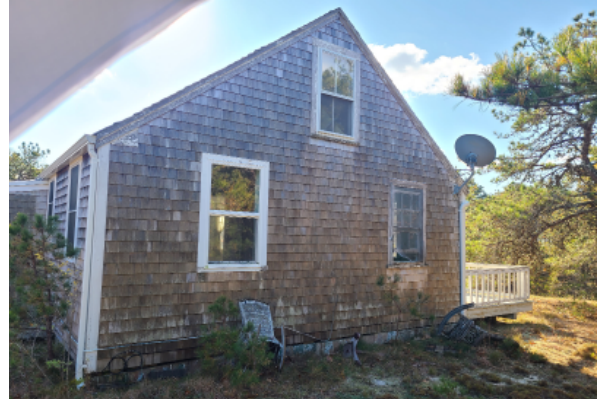
North elevation shows staining indicating water damage at each window sill.

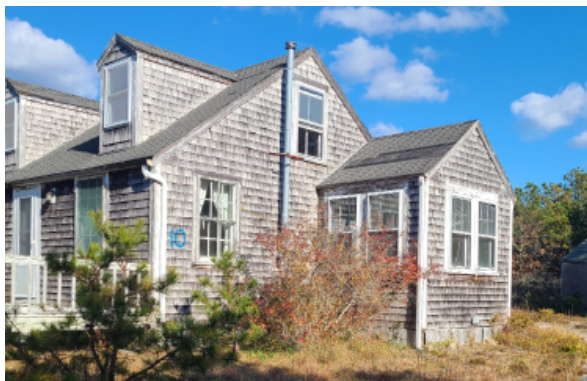
Asphalt roof above kitchen addition shows insufficient roofing coverage.

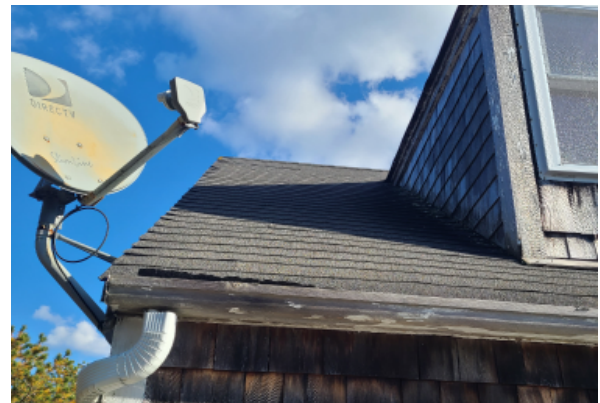
Rotted Integral wood rain gutter and downspout are rusting and failing.

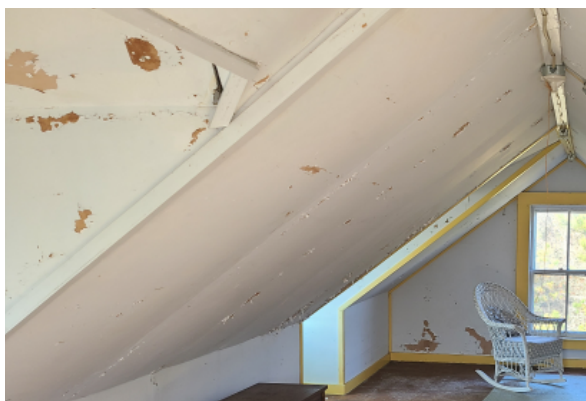
Roof from the interior of the second level. Water damage can be seen, as well as ripples indicating further damage and settling.

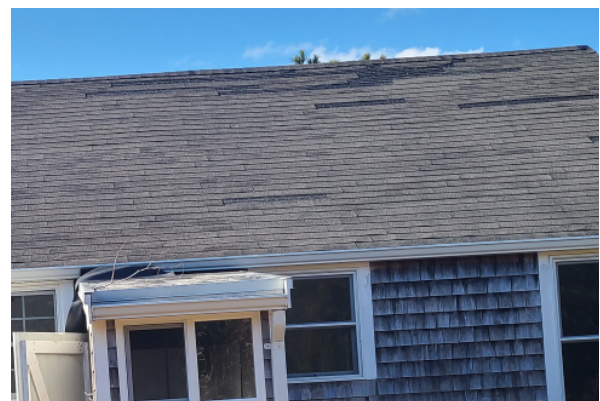
Asphalt roof generally is failing, and the shower stall addition has failed at the connection to the main structure.

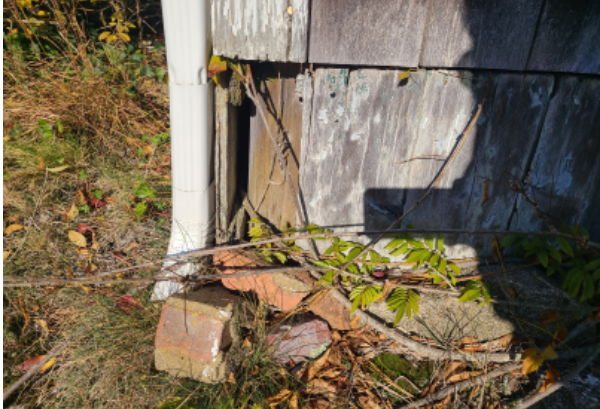
View of foundation pier, wood siding, wood foundation skirt, and brick supports. Foundation is insufficient for this building, and was not intended to support two levels.

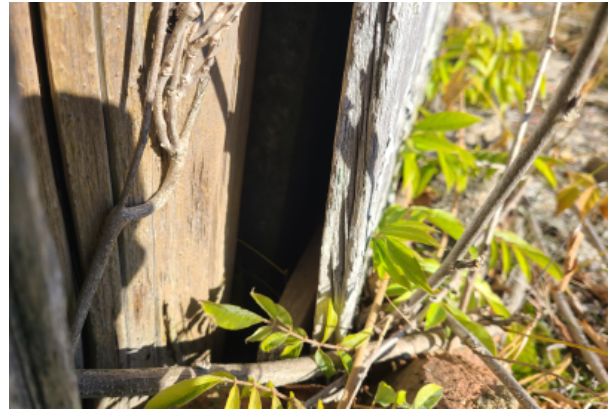
View of foundation pier exposed at one corner.

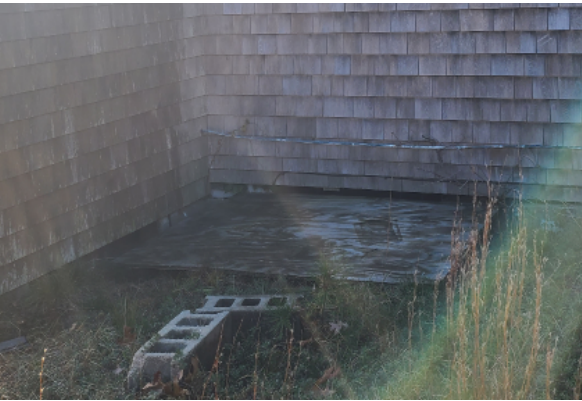
Rotting wooden access hatch to foundation crawl space, and remnants of CMU retaining wall.

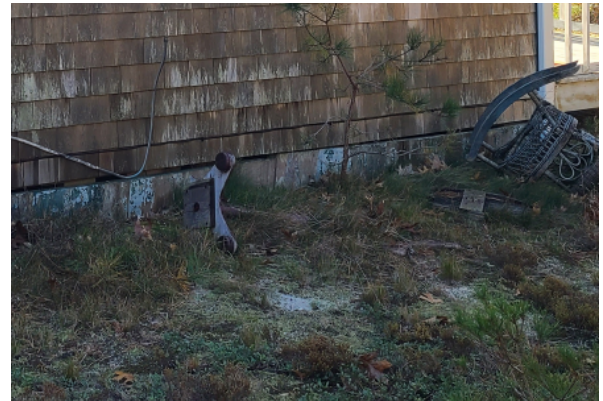
Rotting wooden foundation enclosure at grade.

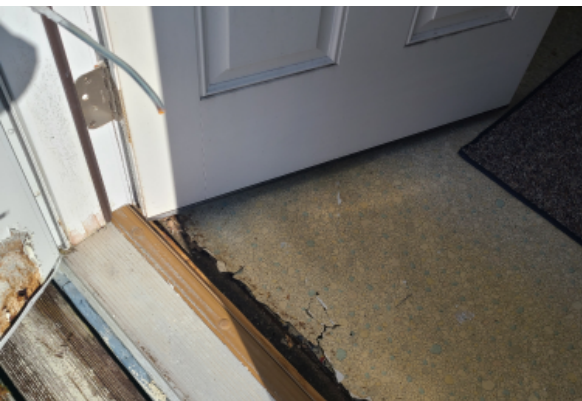
Sheet flooring at building threshold is damaged down into the floor sheathing and crumbling.

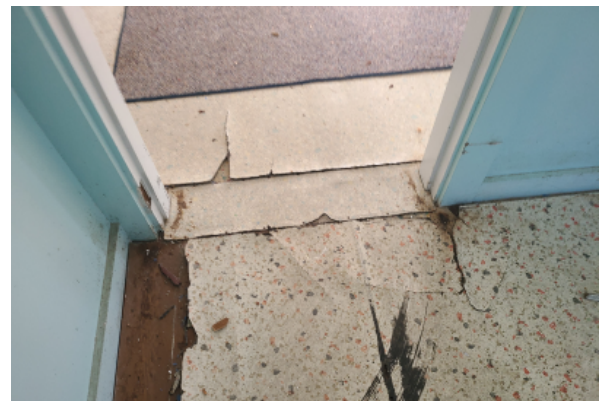
Piece made sheet flooring crumbling at the edges. Multiple layers of flooring can be observed in the area at the top of this photo. The area at the bottom has large areas where the flooring has crumbled to reveal the floor sheathing.

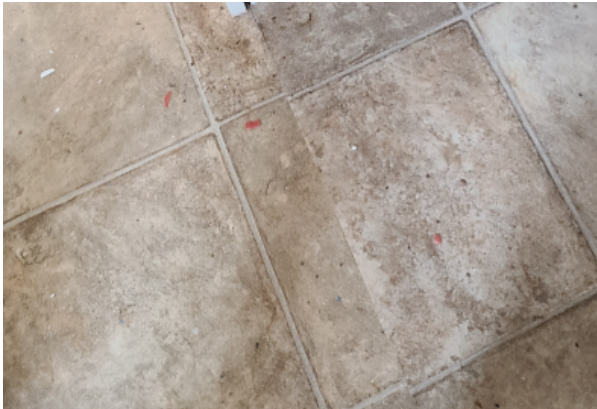
Tile flooring with failing grout joints and cracked tiles.

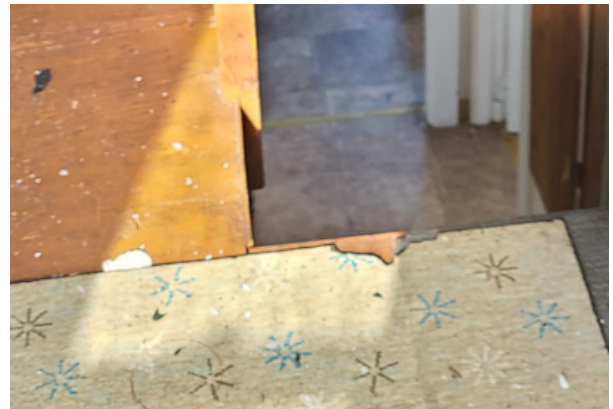
Sheet flooring and board flooring at second level, crumbling and failing from age.

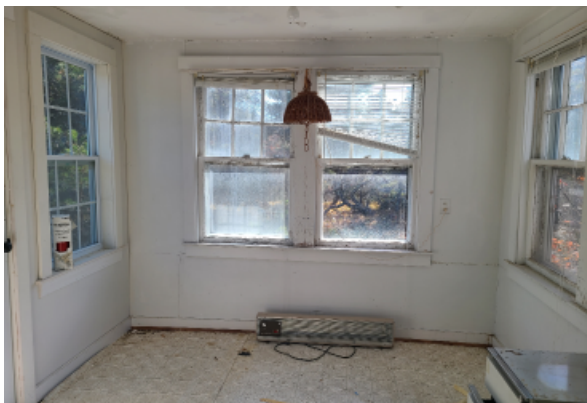
Kitchen addition, paint is chipping and peeling throughout and water damage can be seen at the windows.

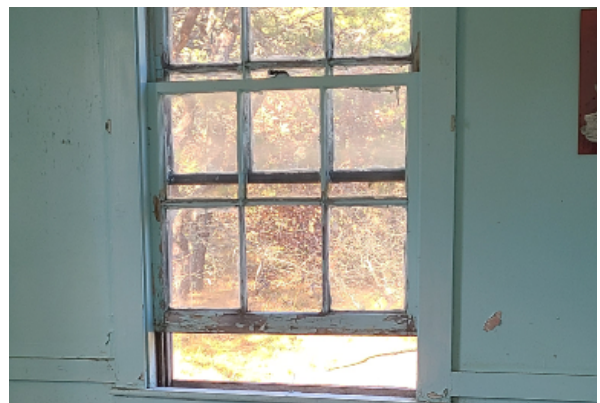
This window stuck open, exposing the interior to the elements.

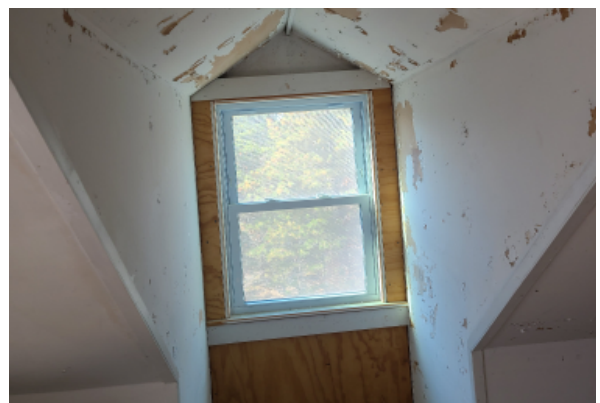
Dormer condition at the second floor. Chipping paint and insufficient framing about window.

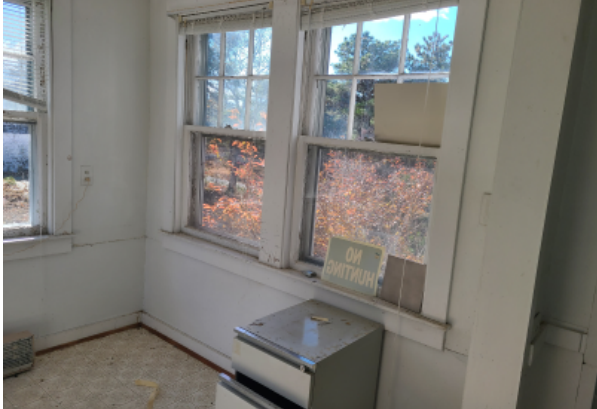
Kitchen addition windows, single paned and damaged bug netting.

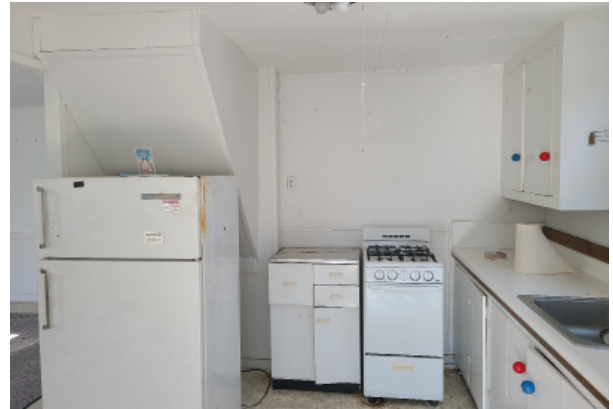
Kitchen with refrigerator, stove/oven, and in counter sink. Both the stove/oven and refrigerator are outdated and need replacing.

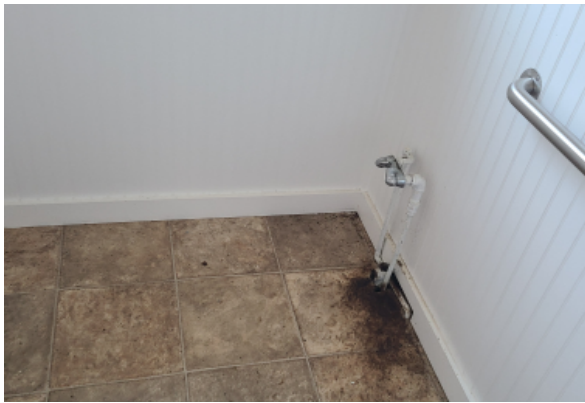
Missing bathtub fixture.

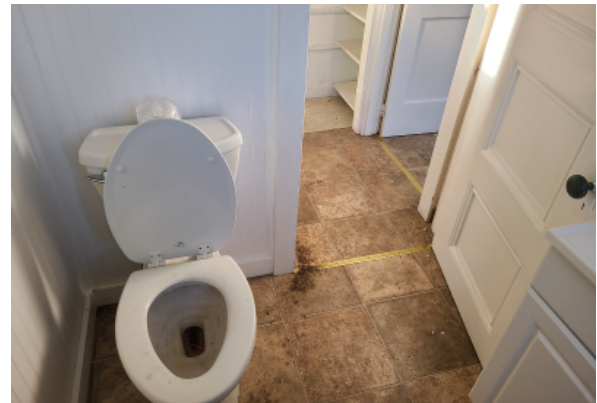
Toilet fixture and sink, the layout of this bathroom is non-compliant with accessibility codes.

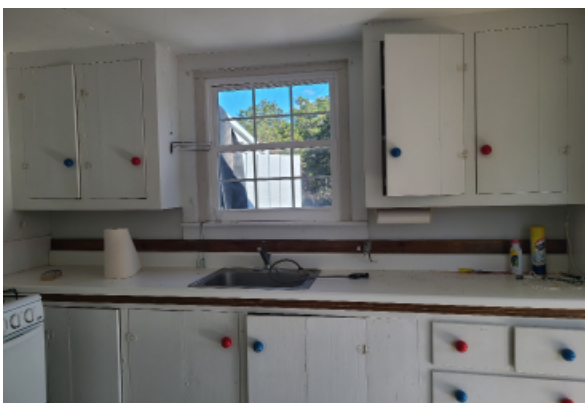
In counter sink, with missing and non compliant hardware. Cabinet hardware is also non compliant.

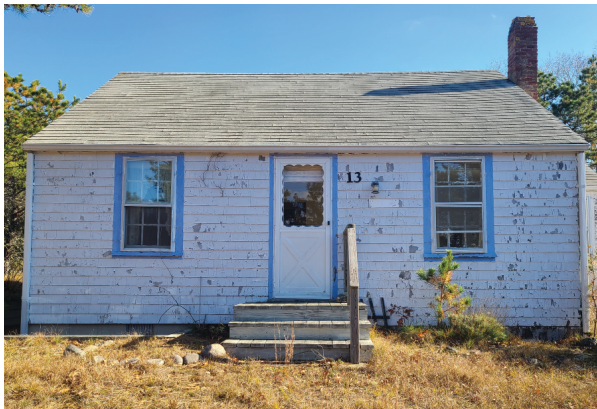
Front elevation of the building, concrete steps with insufficient railing, and original windows that need replacing.

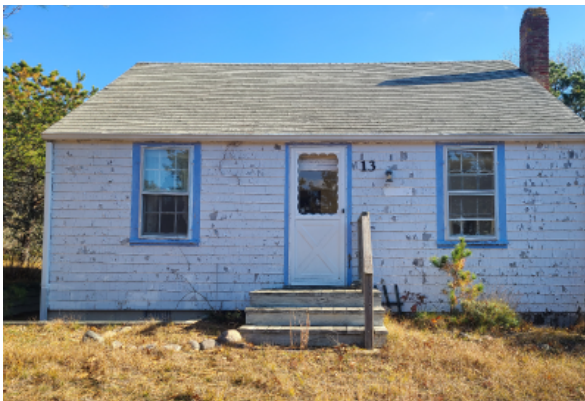
Asphalt shingle roof showing nonconformities and failure of adhesion in places.

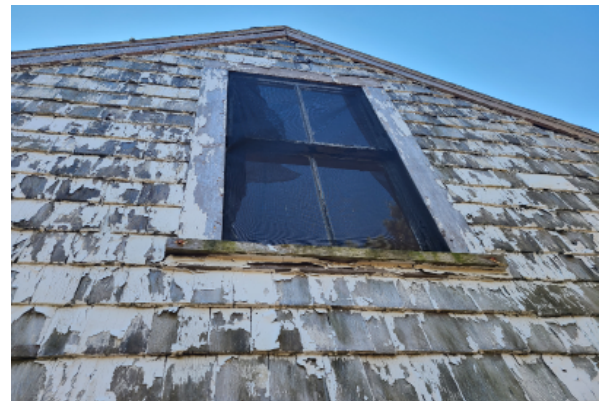
North side peeling paint and rotted window sill. Window lacks storm.

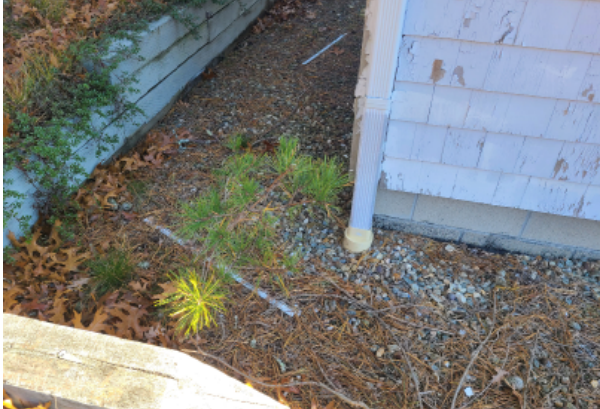
Wood retaining wall set back from building foundation.

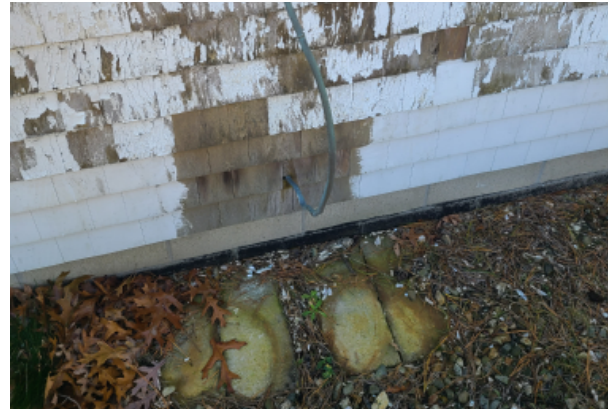
CMU perimeter foundation with grade build up, and insufficient water mitigation.

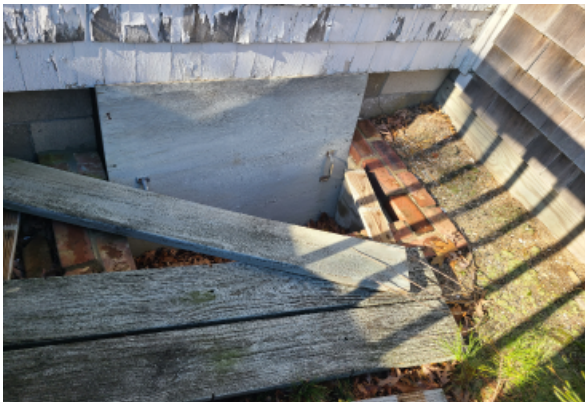
Access panel to crawl space

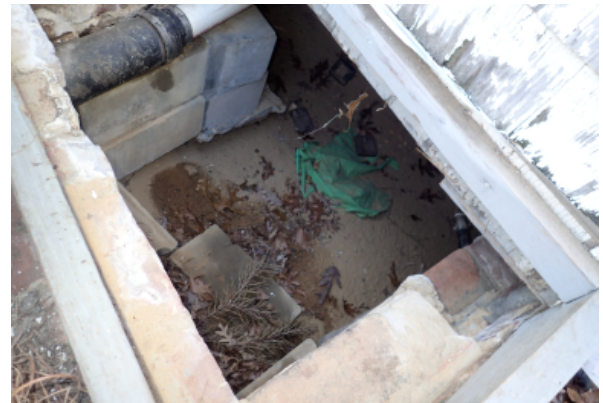
Access to foundation crawl space, the foundation of CMU and wood members can be seen.

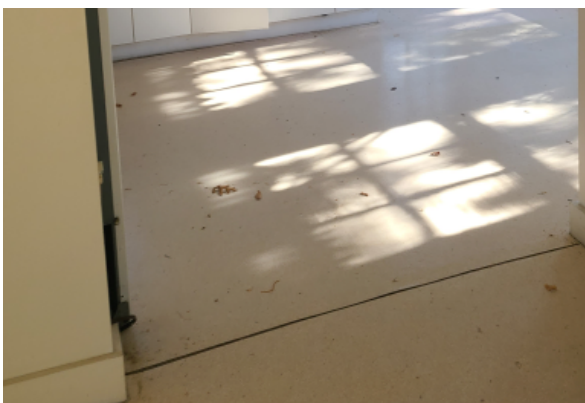
Uneven flooring transition between two rooms.

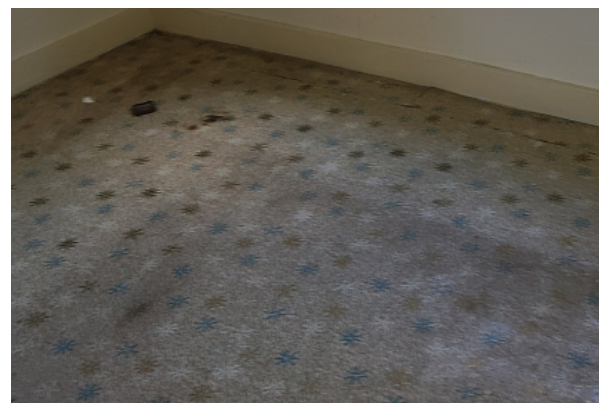
Sheet flooring in bedroom, evidence of water damage, and is crumbling at the edges due to age.

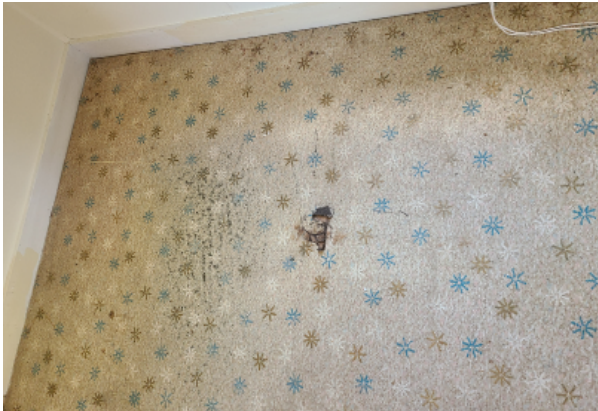
Sheet flooring, worn down to the floor sheathing in areas and crumbling at the edges.

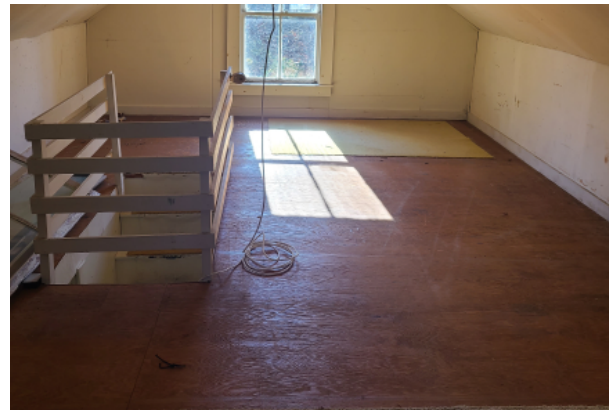
Second level flooring is exposed wood boards.

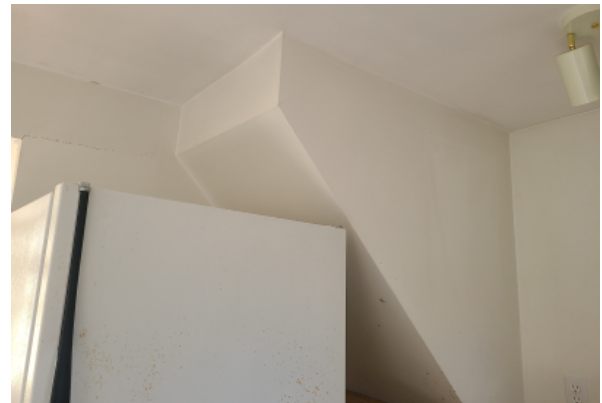
Sloped ceiling condition below stairs, enclosed with plaster and painted to match.

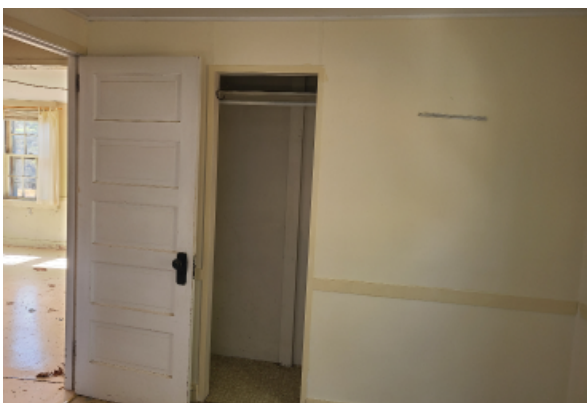
Painted plaster wall with trim around doorway, base of wall, and chair rail height. Paint is yellowing and chipping.

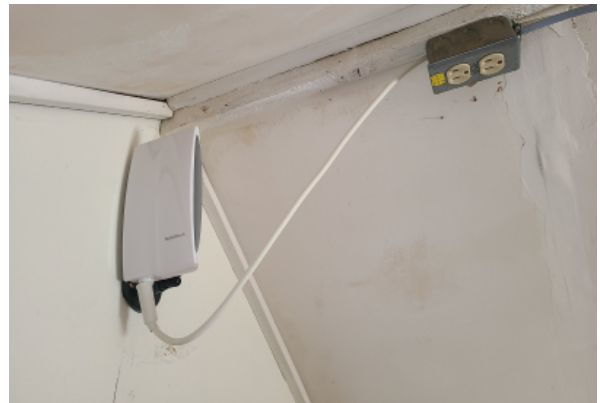
Internet router that is in good condition at roof pitch.

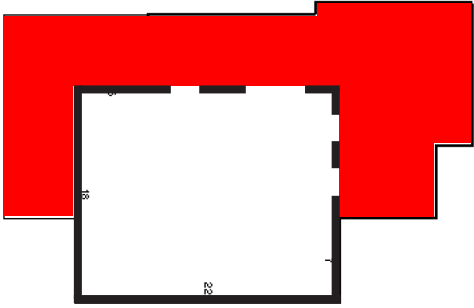
Demolition of add-on structures

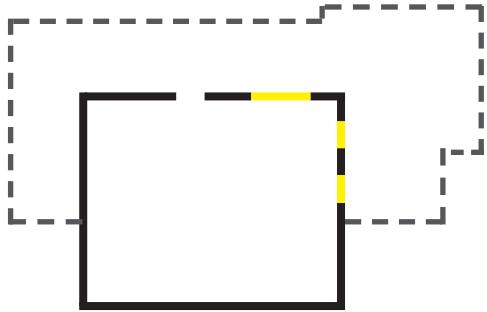
Reinforcements and repairs on existing structure

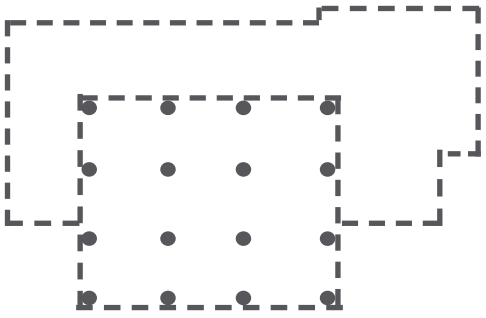
Structure lifted and moved to temporary site to expose foundation

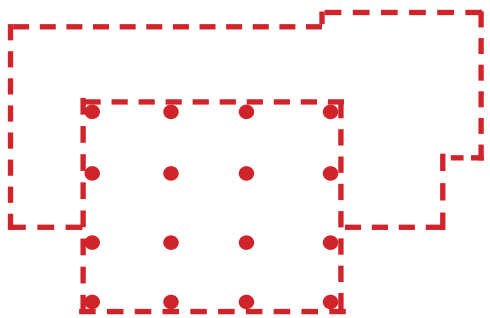
Foundation demolition

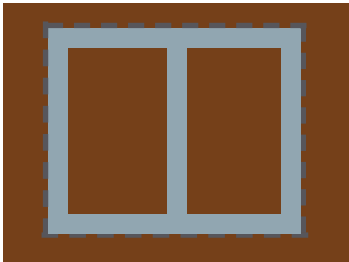
New foundation excavated, poured, and infilled

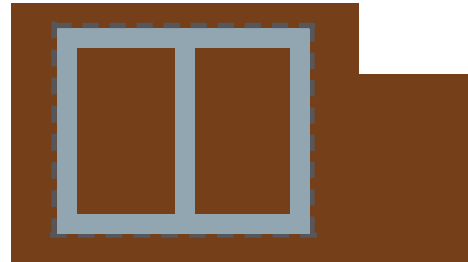
Site excavation for new septic system and utility improvements and installation

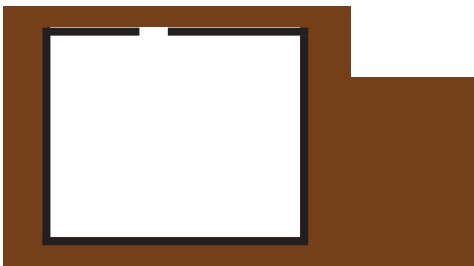
Building structure placed on new foundation

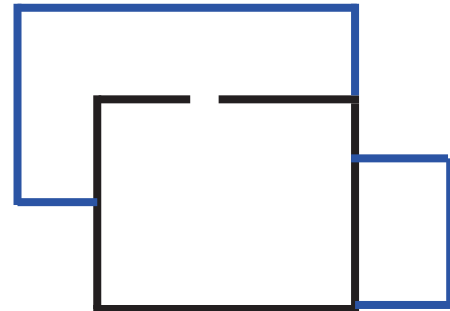
Exterior rehabilitation:

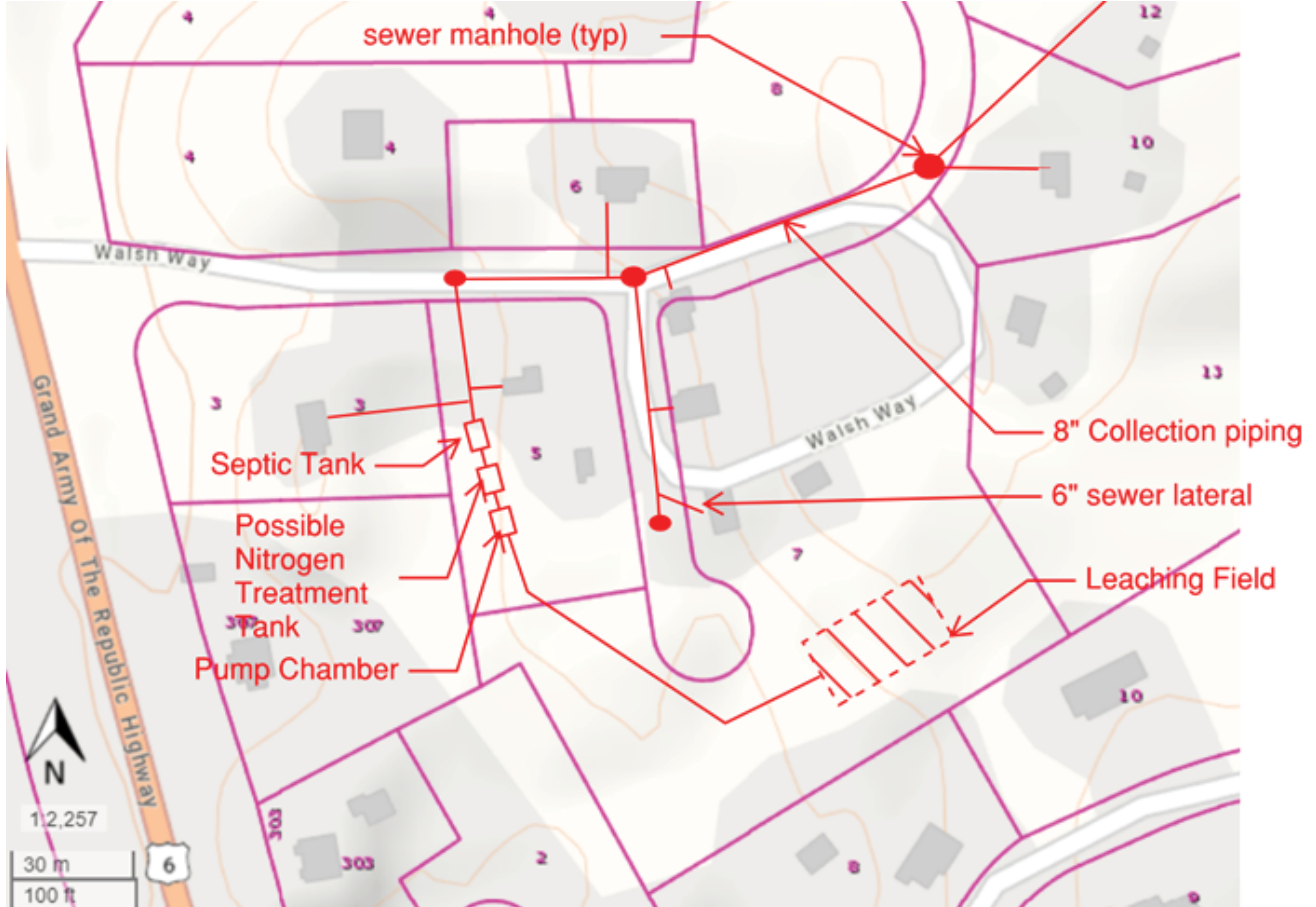
SEPTIC / COLLECTION SITE LAYOUT
