MICHELE CUDILO, P.E.
Consulting Structural Engineer

February 12, 2021

**RE: Residence at BUILDING 3
WALSH WAY, TRURO, MA**

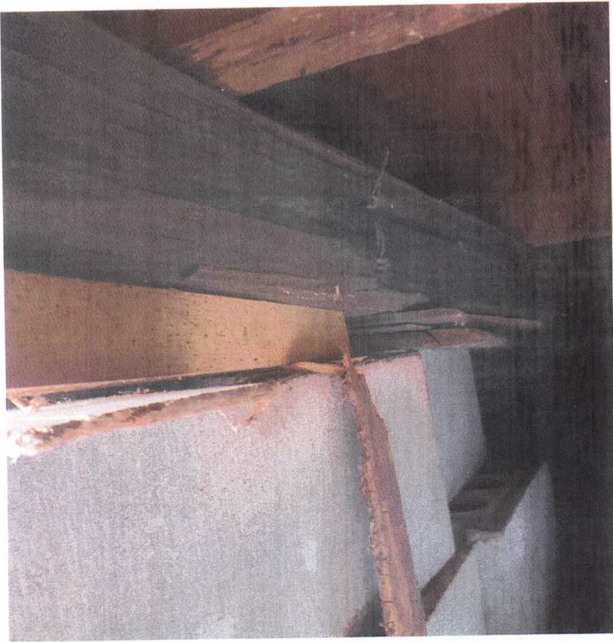
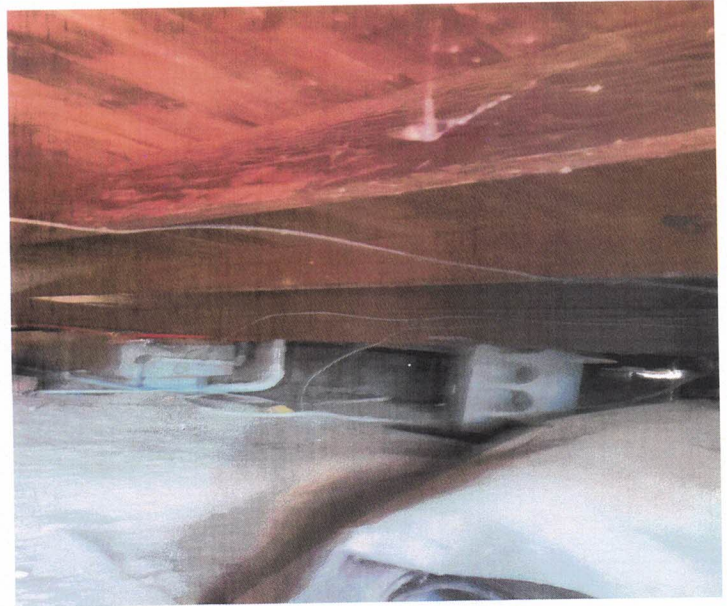
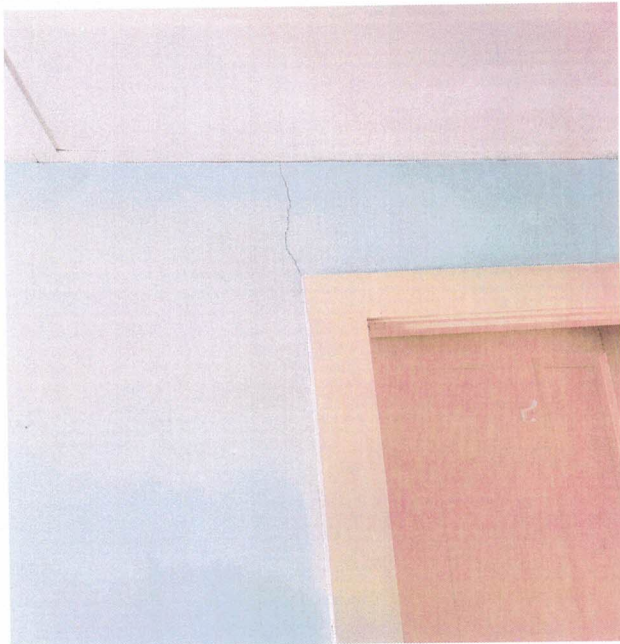
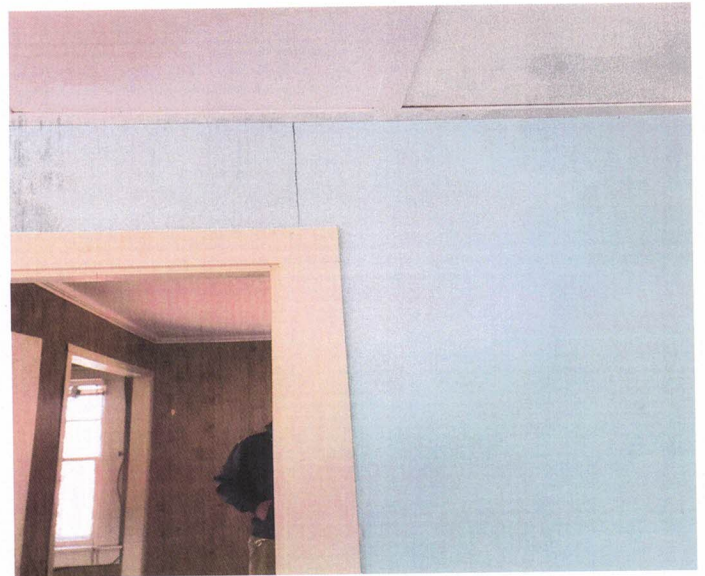
1. The building is a hip roof 1-story residence with a gable-roofed add-on for two sections: the main core, 26'x20', is a Sears house, dated 1900 on assessors database, constructed with a site built entrance bump-outs at each side. Finished ceiling height is 7'-6".

2. Existing first floor beams, 4x6, on timber posts and dry-laid concrete block foundation piers, approximately 1' above grade: 2x6 joists on 6x4 sill has rot and deterioration. The piers are set on the exposed soil, with no vapor barrier. There is a thin timber surround at grade. There is evidence of animal digging below this surround to get inside the footprint.

3. Left hand side (LHS) entrance stoop has rotted construction and requires replacement.
4. Right hand side (RHS) entrance porch, approximately 9' x 17'3", inside: Floor dips to exterior wall at the Sears exterior wall. Exposed rafters, 2x4@2' on center with tongue and groove sheathing is a cathedral with 7'6" to 11'9" height. Ridge rot is evident.

5. Interior: floor dips toward center wall. Wall height approximately 7'10", with structural crack at top of wall due to settlement.
6. Suspended ceiling with 1x3 hangers to 2x6 rafters and 2-2x8 hips. Evidence of water leaks in roof appears, seen from the access hatch.

The structure requires a new foundation due to the substandard and deteriorated nature of the existing support. This is recommended to be a poured concrete crawl space foundation, with frost wall depth of footing below grade of 4'. This effort requires lifting the structure and excavation below the footprint. The RHS entrance porch and LHS entrance stoop require reconstruction.

The superstructure core, the Sears portion, may be considered for reuse, however, the presence of cracks in the architectural finish indicates gaps in the framing that need to be re-fastened. Roof leaks need to be sealed and damaged wood requires replacement. All architectural finish requires replacement due to mold remediation.

Alternatively, demolition and reconstruction is suggested.

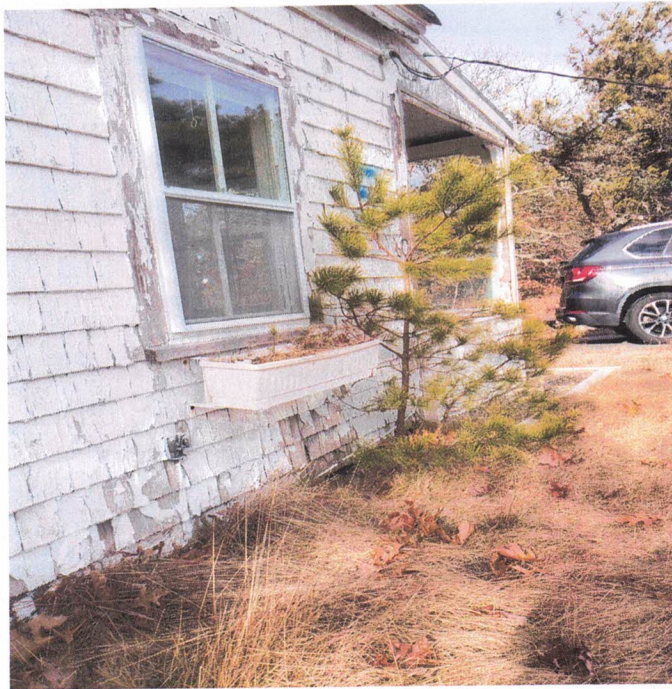
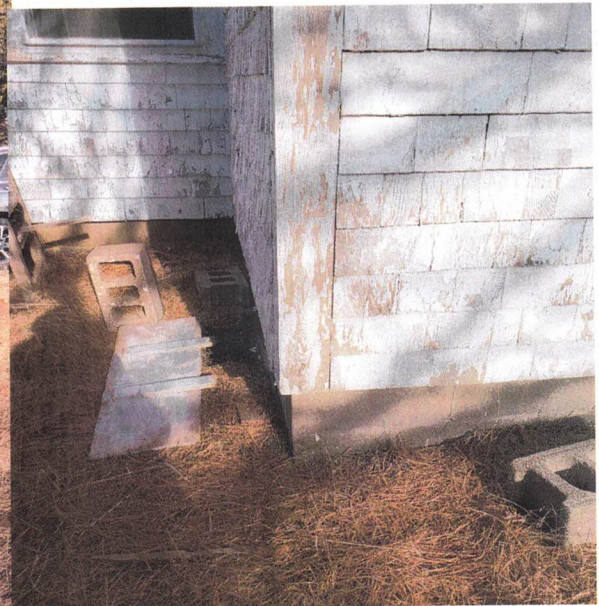
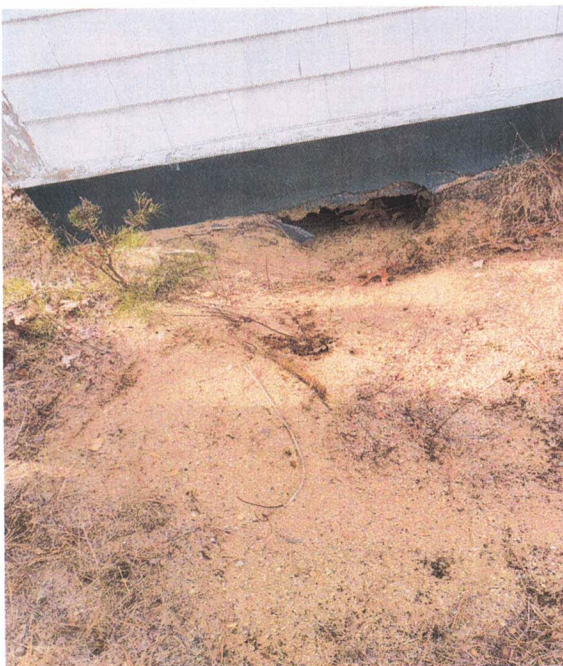
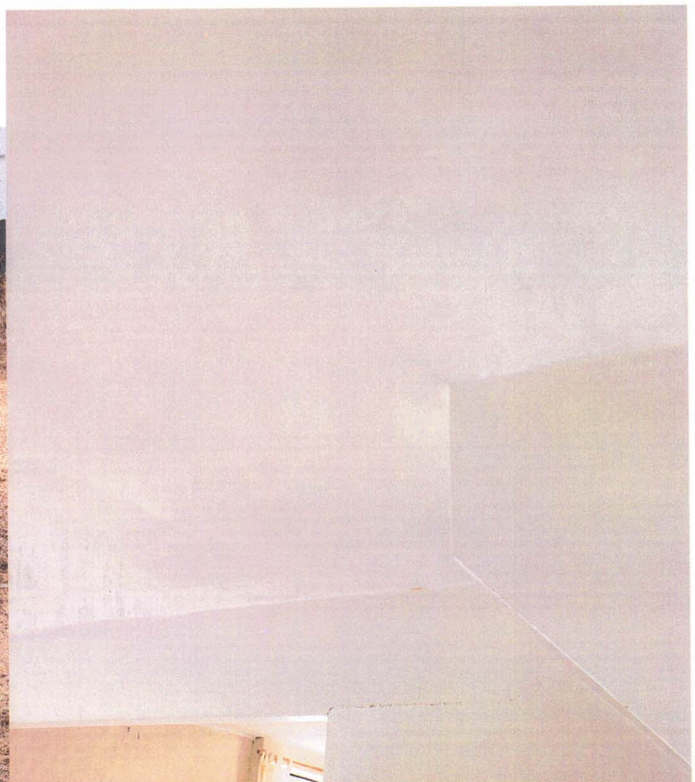
1. The building is a gable roof 1-story gable-roofed residence with add-ons for two sections: the main core, 18'x20', is a Sears house, dated 1900 on assessors database, constructed with a site built covered entrance screen porch bump-out, and rear bath bump-out on concrete block foundation. There is a low ceiling height from 6'-11" to 5'-8" height in the bath. The living space has 8' ceilings, with 7'-6" height in the Bedroom.

2. Existing first floor beams, 4x6, on timber posts and dry-laid concrete block foundation piers, approximately 1' above grade: 2x6 joists on 6x4 sill has rot and deterioration. The piers are set on the exposed soil, with no vapor barrier. There is a thin timber surround at grade. There is evidence of animal digging below this surround to get inside the footprint.

3. The entrance screen porch has rotted construction and requires replacement.
4. Interior: floor dips throughout, indicative of insufficient foundation support. There is a chimney that may be abandoned.

5. Flat ceiling with 2x6 ceiling joists and rafters. Evidence of water leaks in roof, observed from the access hatch.

The structure requires a new foundation due to the substandard and deteriorated nature of the existing support. This is recommended to be a poured concrete crawl space foundation, with frost wall depth of footing below grade of 4'. This effort requires lifting the structure and excavation below the footprint. The entrance Screen Porch requires reconstruction. The rear bump-out is recommended to have compliant ceiling height minimums.

The superstructure core, the Sears portion, may be considered for reuse; however, the presence of cracks in the architectural finish indicates gaps in the framing that need to be re-fastened. Roof leaks need to be sealed and damaged wood requires replacement. All architectural finish requires replacement due to mold remediation.

Alternatively, demolition and reconstruction is suggested.

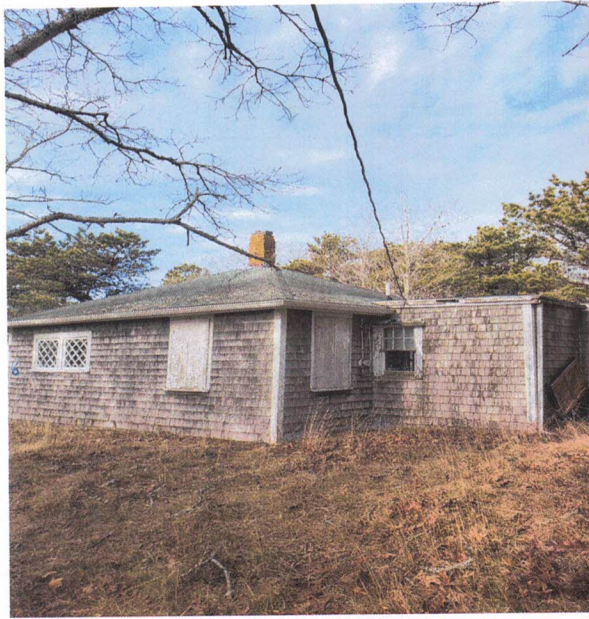
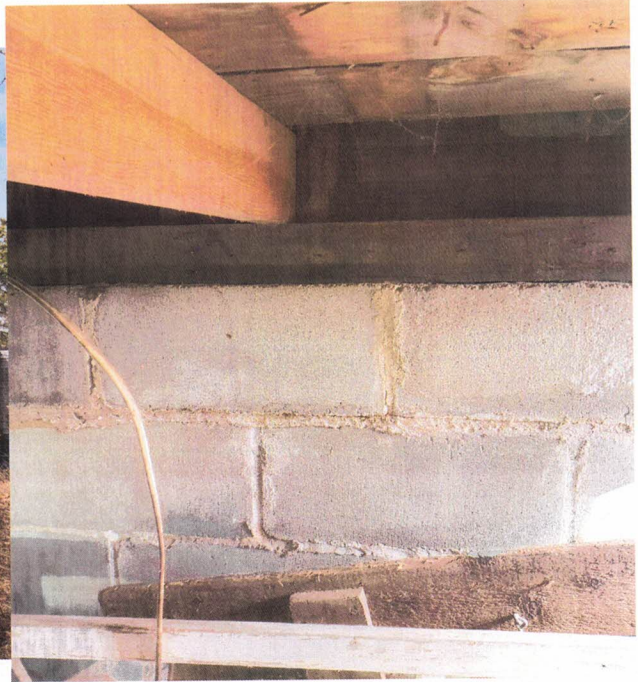
1. The building is a 1-story gable-roofed residence with covered porch add-on: the main core, 22'x18' is a Sears house, dated 1940 on assessors database. The house and bump-out are supported on CMU walls and piers. There is a rear partial basement access.
2. Interior: floor dips throughout, indicative of insufficient foundation support. There are interior fireplace leaks. Mold is evident.
3. The grade slopes from a rear and left side hill; the rear has a hollow CMU retaining wall adjacent to the foundation, which has failed in locations. The structure is supported on CMU piers on grade, observed through access at rear. The 4x6 sill is dry at this location, where there is a partial basement at the access.

First floor 2x6 @ 2' on center x 10.5' long, framing over dry-laid CMU. There are loose shims between beams and piers.

4. There is no attic scuttle, however ceiling cracks are observed.

The structure requires a new foundation due to the substandard and deteriorated nature of the existing support. This is recommended to be a poured concrete crawl space foundation, with frost wall depth of footing below grade of 4'. This effort requires lifting the structure and excavation below the footprint.

The superstructure core, the Sears portion, may be considered for reuse; however, the presence of cracks in the architectural finish indicates gaps in the framing that need to be re-fastened. Roof leaks need to be sealed and damaged wood requires replacement. All architectural finish requires replacement due to mold remediation.

Alternatively, demolition and reconstruction is suggested.

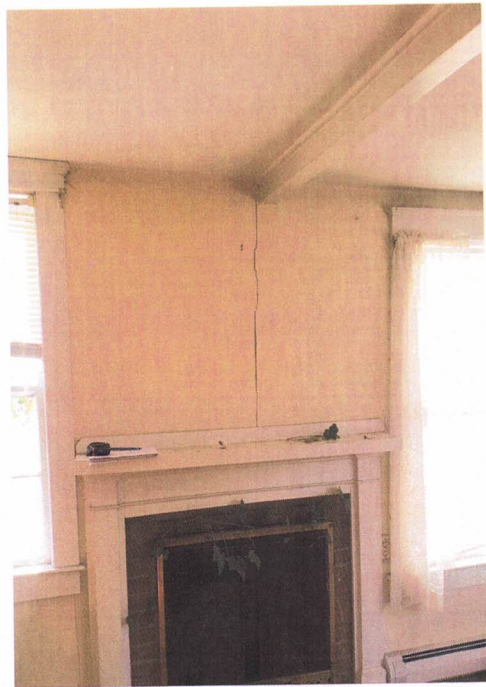
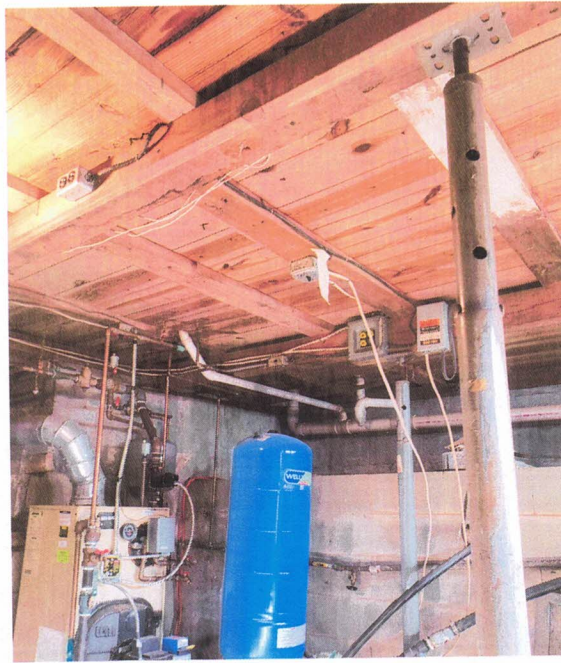
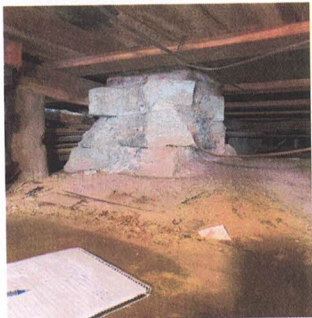
2. Interior: floor dips throughout, indicative of insufficient foundation support. There is a structural crack in the right side at the fireplace, with ivy growing through cracks in the exterior wall. Mold is evident. There is a parquet flooring material.

3. The basement is partial C.M.U. frost wall, with a partial basement at the access entrance. 2x4 and 2x6 flat first floor framing, with tongue and groove sheathing is substandard. Intersection crawl and full not well constructed, with 6x4 flat and temporary telescopic column support.

4. An exterior chimney at the left side may be abandoned.

The structure requires a new foundation due to the substandard and deteriorated nature of the existing support. This is recommended to be a poured concrete crawl space foundation, with frost wall depth of footing below grade of 4'. This effort requires lifting the structure and excavation below the footprint.

The superstructure core, the Sears portion, may be considered for reuse; however, the presence of cracks in the architectural finish indicates gaps in the framing that need to be re-fastened. Roof leaks need to be sealed and damaged wood requires replacement. All architectural finish requires replacement due to mold remediation.

Alternatively, demolition and reconstruction is suggested.

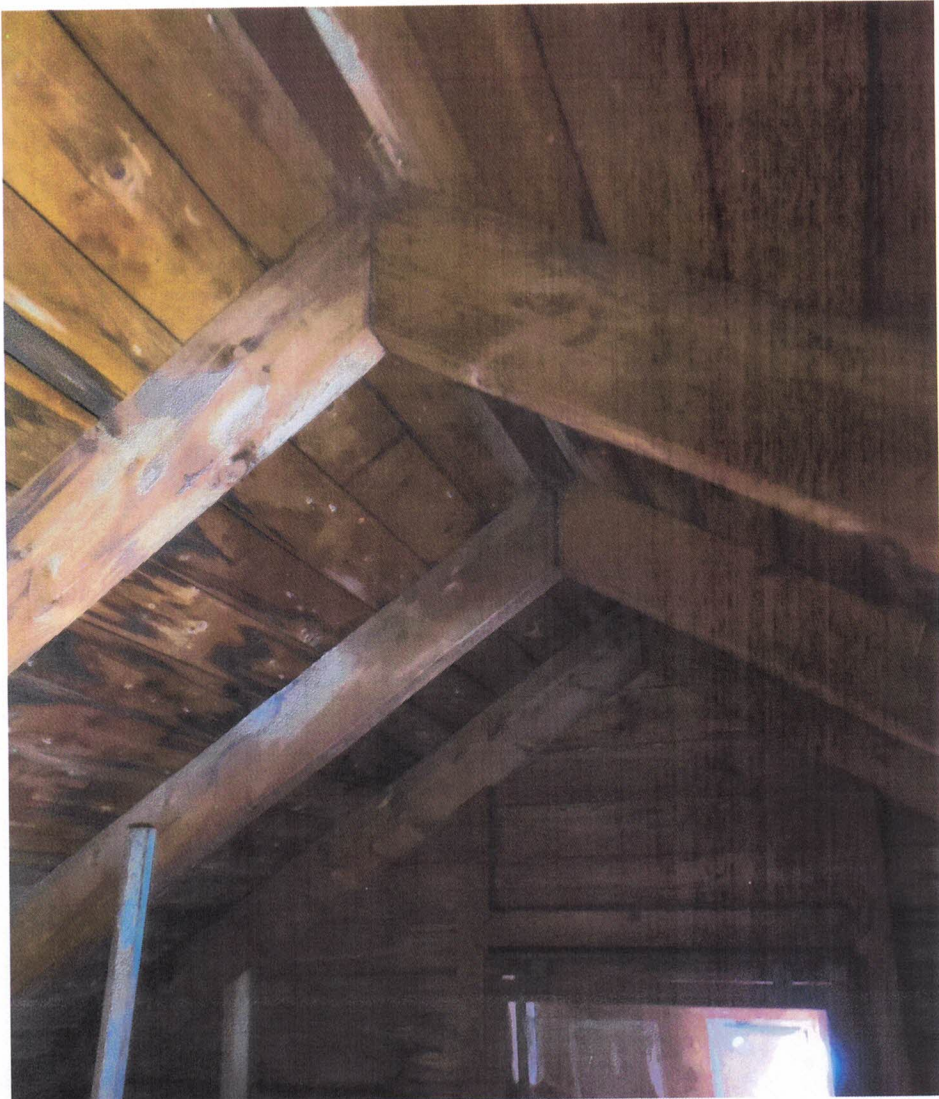
2. Interior: floor dips throughout toward the center bearing wall, indicative of insufficient foundation support. There are structural cracks in the center wall. There is a hump at the interior chimney. Mold is evident.

4. There is a large front deck, with rot, and portico brackets. There is a left side sun porch.
5. Flat ceiling with 2x4 @ 2' on center ceiling joists to center bearing. Collar ties at 2' on center. Possible asbestos present; was informed that asbestos was left in abandoned detached Garage at rear, which is now taped off, "Danger".

The structure requires a new foundation due to the substandard and deteriorated nature of the existing support. This is recommended to be a poured concrete crawl space foundation, with frost wall depth of footing below grade of 4'. This effort requires lifting the structure and excavation below the footprint.

The superstructure core, the Sears portion, may be considered for reuse; however, the presence of cracks in the architectural finish indicates gaps in the framing that need to be re-fastened. Roof leaks need to be sealed and damaged wood requires replacement. All architectural finish requires replacement due to mold remediation.

Alternatively, demolition and reconstruction is suggested.

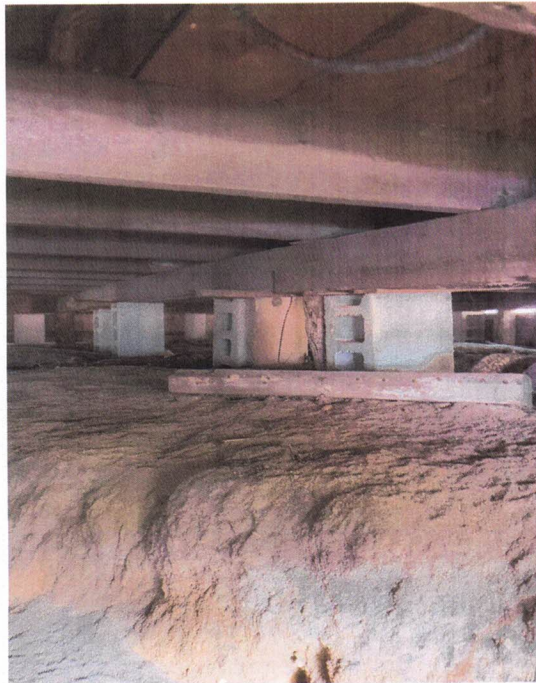
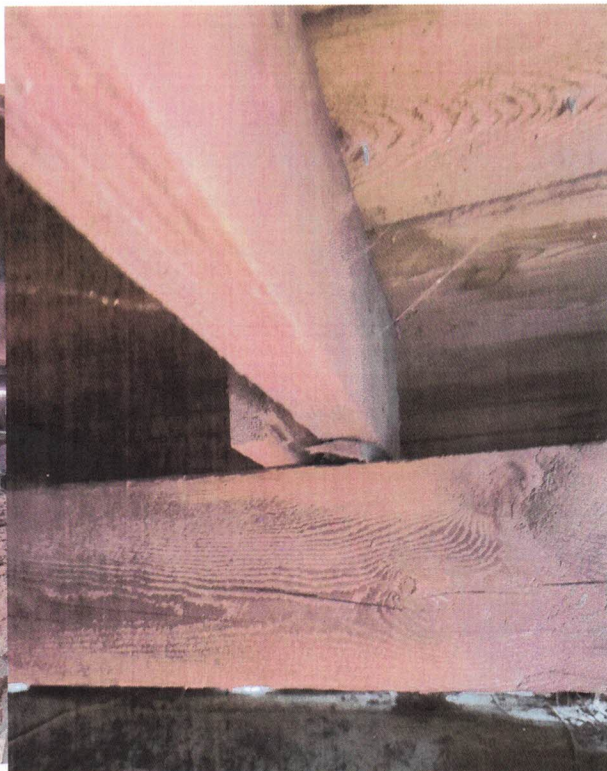
1. The building is a 1-story gable-roofed residence with 2nd floor loft, similar to Building #13: the main core, 22'x25' is a Sears house, dated 1940 on assessors database. The house and bump-out are supported on piers. There is a front deck in generally good condition, and rear entry deck and enclosed shower.
2. Interior: floor dips throughout toward the center bearing wall, indicative of insufficient foundation support. There are structural cracks in the center wall. Mold is evident. There are exposed floor sheathing areas with rot and mold present.
3. The grade slopes away from the front right side. The structure is supported on two-course CMU piers on grade, with access at rear.

First floor 2x6 @ 2' on center framing over 4x6 beams @ 8.5' on center; with 2 rows at 10' on center, is light framing. Each wood pier is constructed with 2 CMU upright supplemental piers. There are loose shims between beams and piers.

The structure requires a new foundation due to the substandard and deteriorated nature of the existing support. This is recommended to be a poured concrete crawl space foundation, with frost wall depth of footing below grade of 4'. This effort requires lifting the structure and excavation below the footprint.

The superstructure core, the Sears portion, may be considered for reuse; however, the presence of cracks in the architectural finish indicates gaps in the framing that need to be re-fastened. Roof leaks need to be sealed and damaged wood requires replacement. All architectural finish requires replacement due to mold remediation.

Alternatively, demolition and reconstruction is suggested.

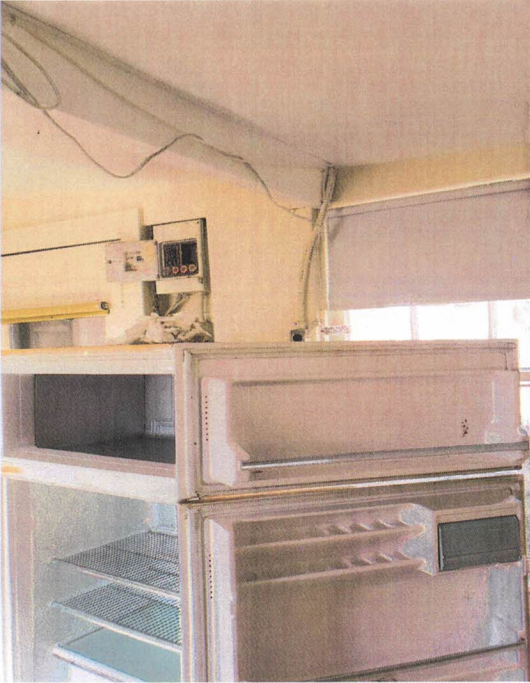
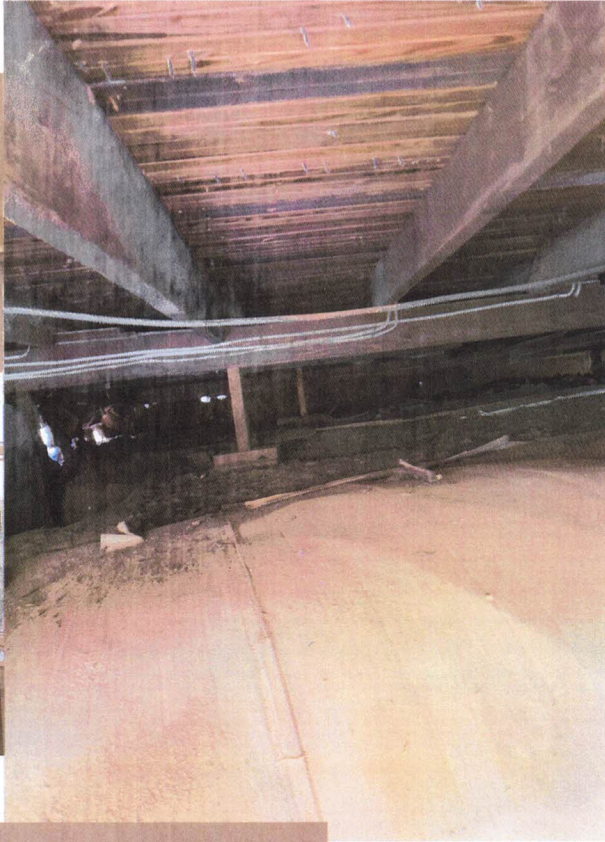
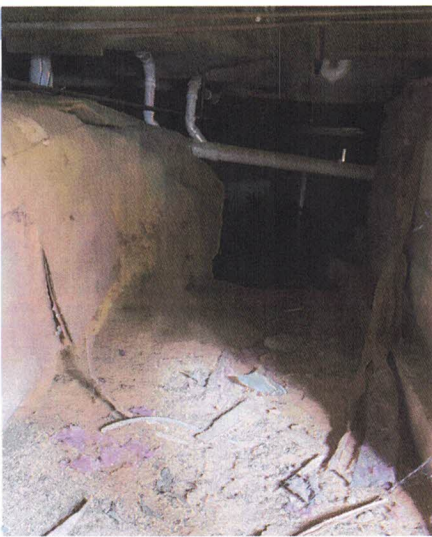
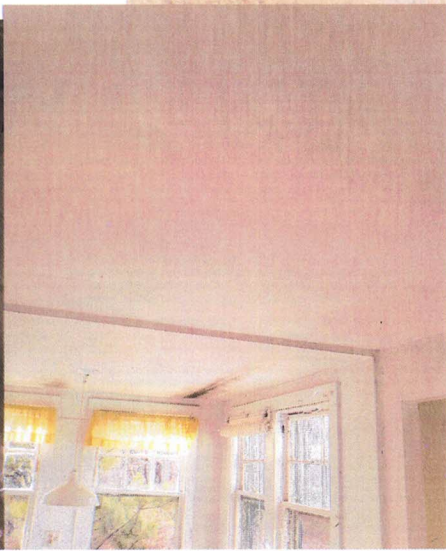
1. The building is a 1-story gable-roofed residence with loft: the main core, 24'x26' is a Sears house, dated 1940 on assessors database.
2. Interior: floor dips throughout toward the center bearing wall, indicative of insufficient foundation support. There are structural cracks in the center wall. Mold is evident. There are exposed floor sheathing areas with rot and mold present.
3. The grade slopes away from the front. Front stoop has 2x6 decking. The structure is supported on CMU crawl space walls with entrance below rear Kitchen bump-out. LHS CMU on 16" concrete footing. RHS piers with timber retaining wall adjacent to foundation. Noted bottom siding replaced, repairs made.

First floor is 2x6 and 2x8 @ 2' on center framing. There are loose shims between beams and piers.

4. There is a loft with 7'3" to 3' ceiling height at kneewalls. There is 7'3" first floor ceiling height, with 6'4" below beam at rear kitchen. There are structural cracks over center bearing wall. Ceiling cracks also, indicate that not meant for 2nd floor occupancy.

The structure requires a new foundation due to the substandard and deteriorated nature of the existing support. This is recommended to be a poured concrete crawl space foundation, with frost wall depth of footing below grade of 4'. This effort requires lifting the structure and excavation below the footprint.

The superstructure core, the Sears portion, may be considered for reuse; however, the presence of cracks in the architectural finish indicates gaps in the framing that need to be re-fastened. Roof leaks need to be sealed and damaged wood requires replacement. All architectural finish requires replacement due to mold remediation.

Alternatively, demolition and reconstruction is suggested.
