# **Mill Pond Salt Marsh Restoration Alternatives Assessment Technical Memorandum**

**Town of Truro**  
Truro, MA

June 2022

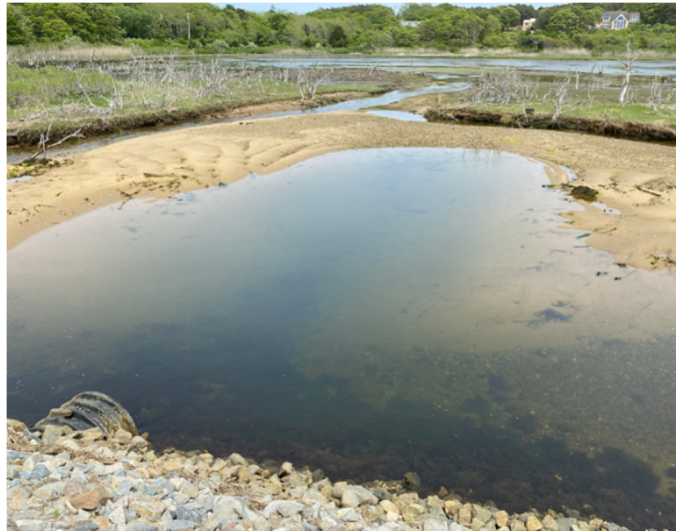
The upstream end of the CPP projects from the earthen causeway supporting MPR, which is partially covered by stone armor protection over and adjacent to the culvert. Indications of a tidal restriction near the culvert's end include a scour hole with an intertidal island formed by shoaled

Figure 3 — Upstream Culvert Outlet, Scour hole and Shoaled Sediment (facing east)

sediment, a significant tidal lag and muting, poor drainage during inland precipitation events, and bank erosion adjacent to the culvert.

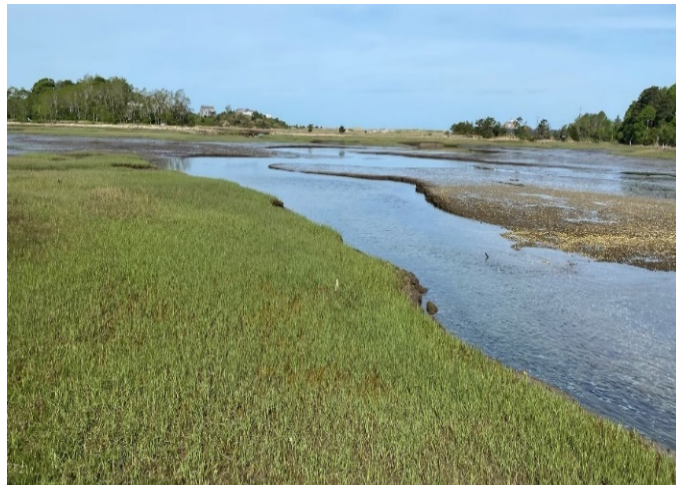
Figure 4 — Downstream Tidal Channel and Abutting Salt Marsh (facing west)

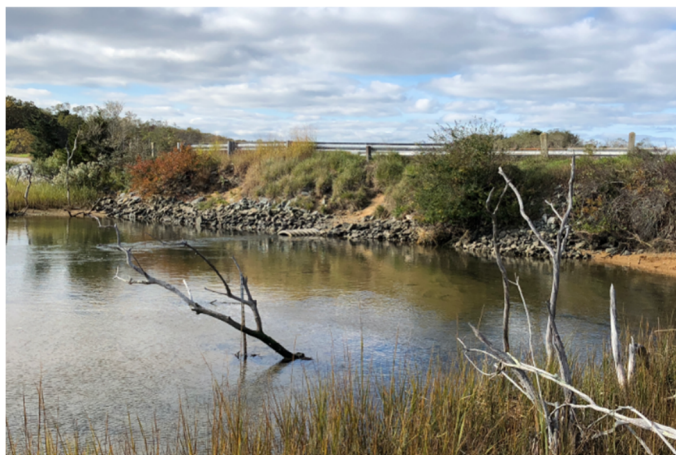
Figure 5 — Upstream Culvert Outlet and Stone Armor Slope Protection (facing south)

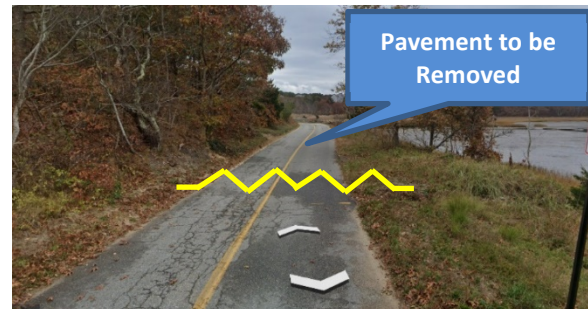
Figure 10 — Limit of Pavement Removal South of Mill Pond Road / Depot Road Intersection (facing south)

Both breach alternatives involve abandonment of Mill Pond Roadway due to the breach through the causeway, with the asphalt pavement to be removed and conceptually replaced with a gravel walking path bordered by grassed shoulders. As shown in [Figure 10](#), pavement would be removed from the northern segment of Mill Pond approximately 150 feet south of the intersection of Mill Pond Road and Depot Road and continue to a location immediately north of the culvert, as shown in [Figure 11](#). The limit of pavement removal will maintain access to a residential driveway at 40 Mill Pond Road, which is north of the limit of pavement removal shown in [Figure 10](#).

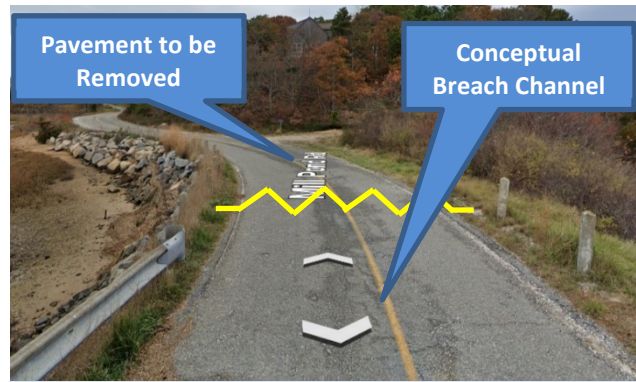
Figure 11— Approximate Limit of Pavement Removal and Channel Breach North of Mill Pond Culvert (facing north)

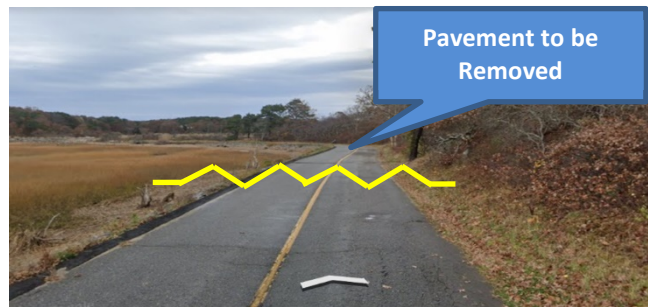
Figure 12 — Limit of Pavement Removal South of Mill Pond Road / Post Drive Intersection (facing north)

Pavement removal on Mill Pond Road's southern segment would begin approximately 150 feet east of the Post Drive/Mill Pond Road intersection and continue to the southern limit of the conceptual breach channel, as shown in Figures 12 and 13, respectively.

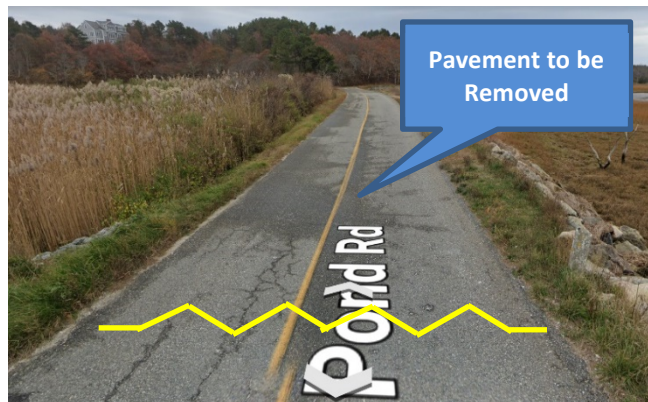
Figure 13 — Approximate Limit of Pavement Removal and Channel Breach South of Mill Pond Culvert (facing south)
