CAPE COD
COMMISSION

Village Pond Watershed Assessment

JULY 15, 2021 (REVISED OCTOBER 12, 2021)

Prepared by Cape Cod Commission Staff

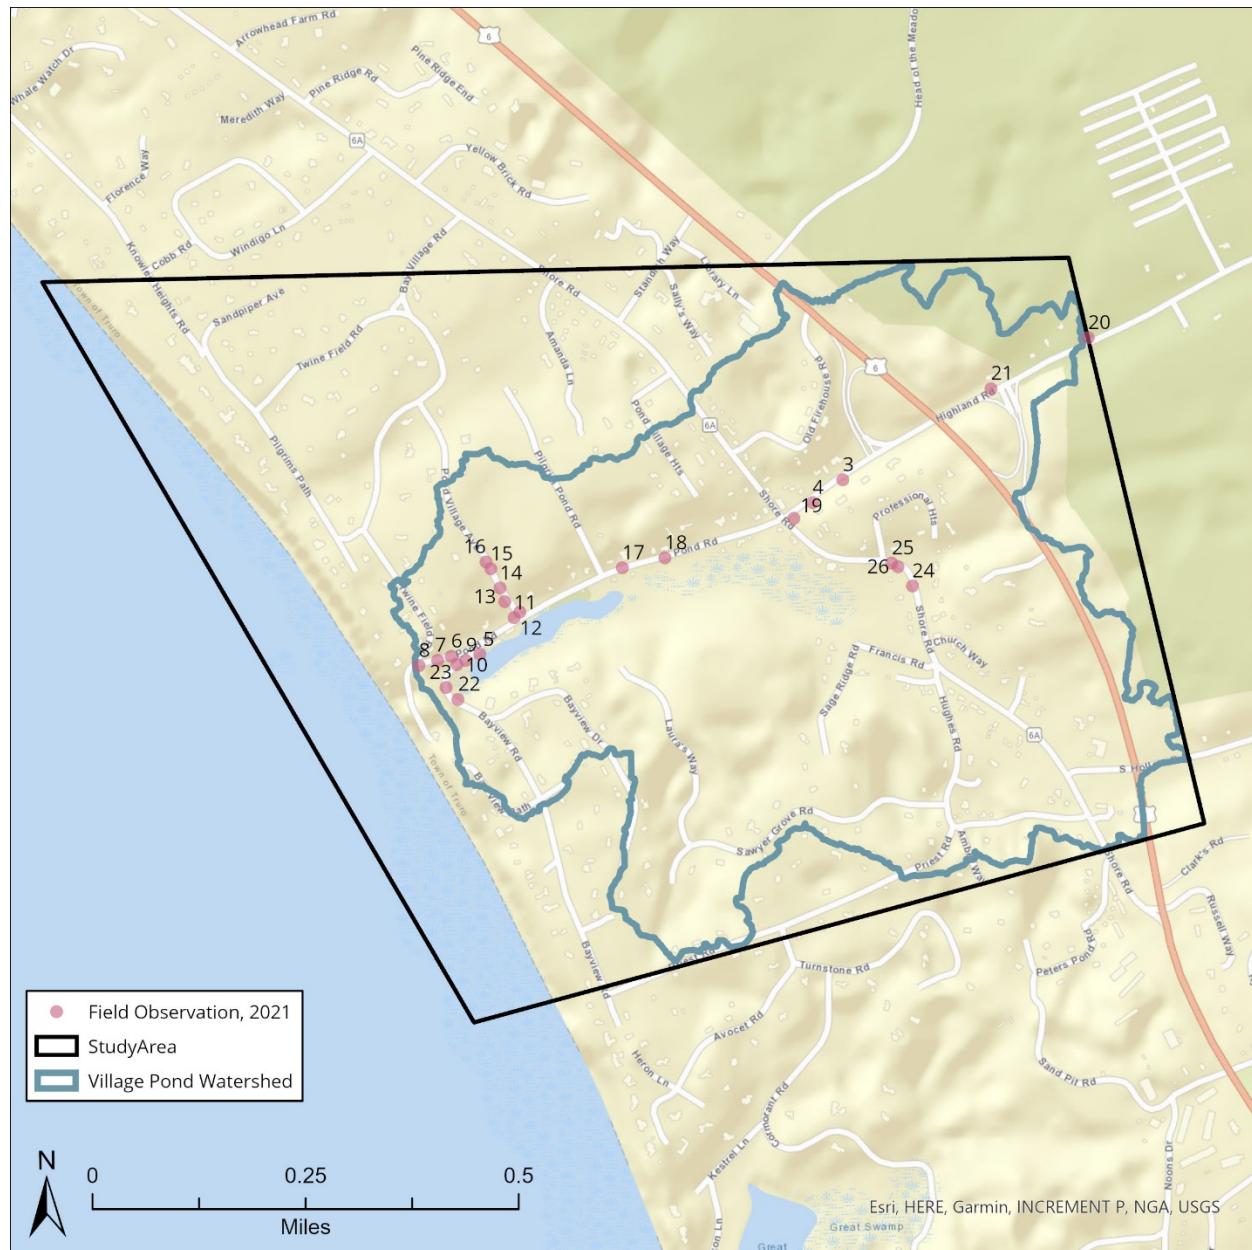
During the post rain event field visit (12/01/20) data were collected with the ESRI Collector application. Commission staff documented the presence of stormwater runoff, ponding, scouring, erosion, sedimentation, and infrastructure (presence, absence, condition, function). These locations, notes, and photographs were documented in the ESRI Collector application and uploaded to a map to provide examples of stormwater issues (Figure 1) in the Pond Village area. Descriptions of the stormwater issues can be found in Table 1.

Figure 1. Locations of field observations of stormwater issues collected post rain event, December 2020.

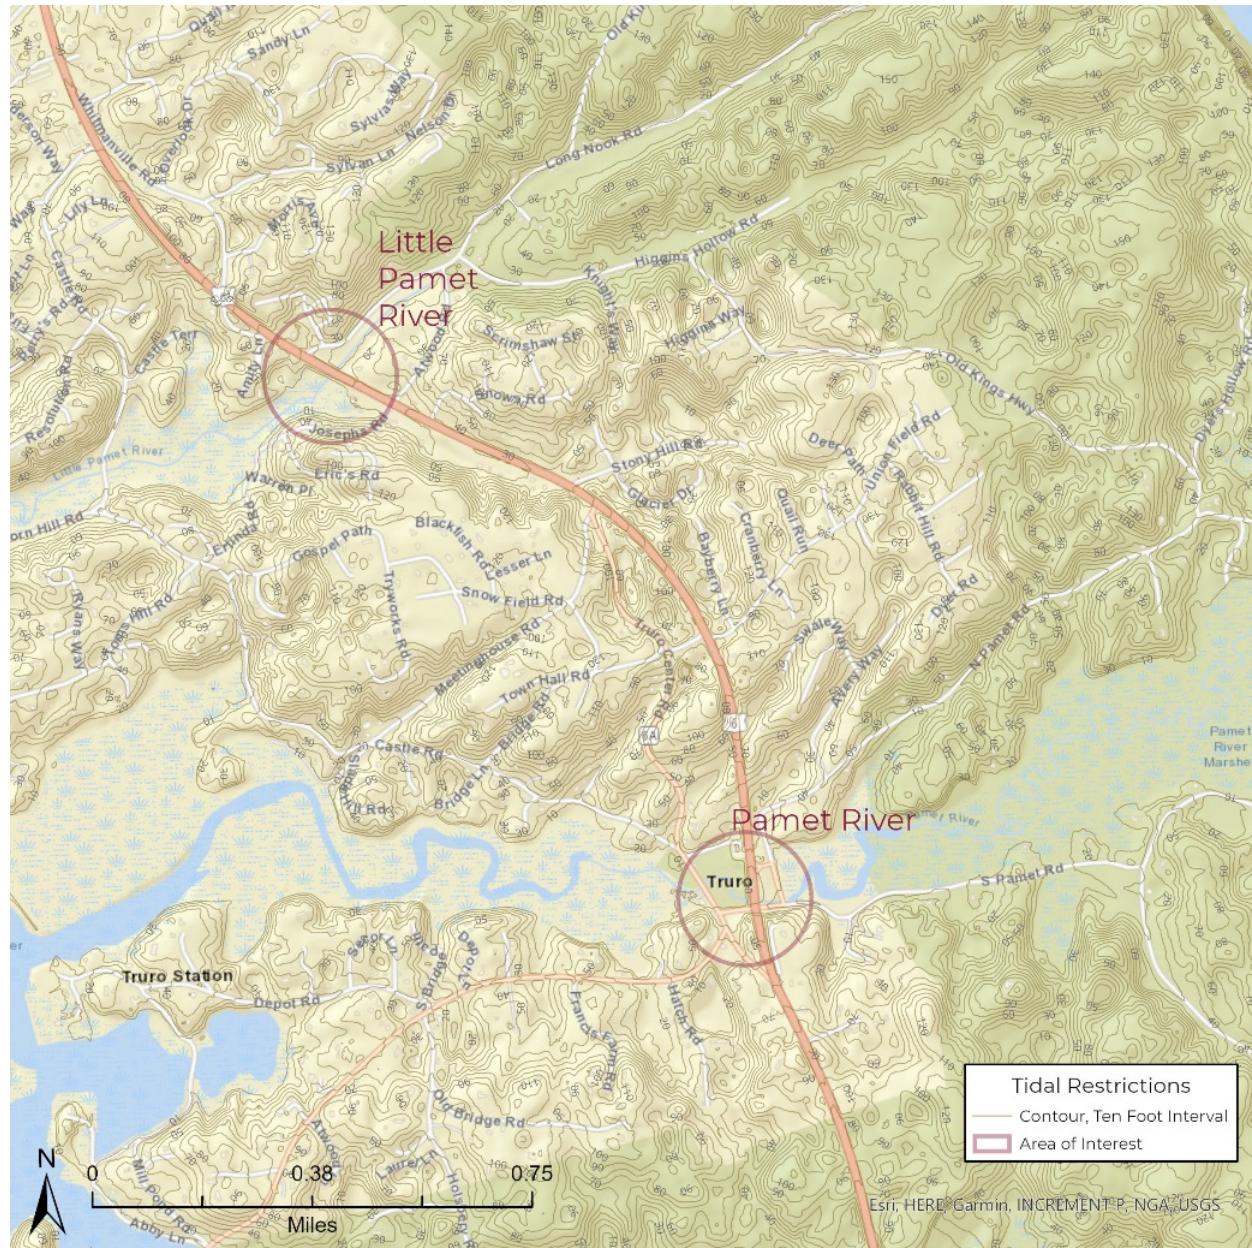
Also, during the field visits culvert assessments were conducted where the Pamet River flows under Route 6A and Route 6, and where Little Pamet River flows under Route 6 (Figure 2). The condition of the culverts as well as presence of erosion, scouring, sedimentation, and water flow were documented.

Figure 2. Culvert locations for Little Pamet River (Route 6) and Pamet River (Route 6A, Route 6, and North Pamet Road).

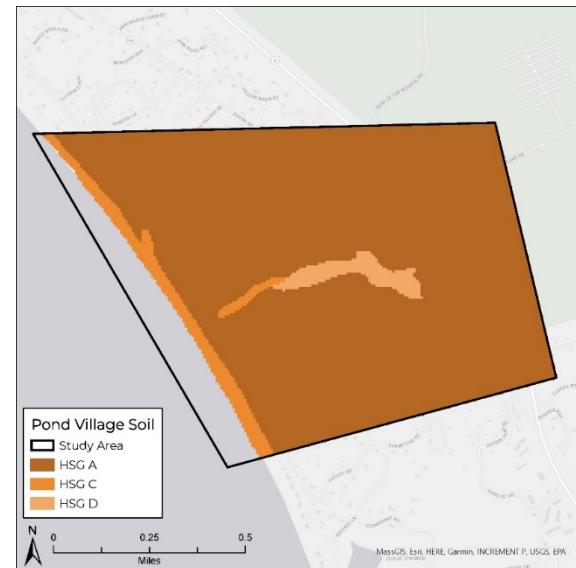
Figure 3. The soils in Pond Village are primarily in hydrologic soil group A which are characterized as having low runoff potential

Soil type refers to the makeup and characteristics of the soil, and specifically for this purpose, the hydrologic soil group (Figure 3). The soil data were obtained from USDA NRCS Soil Survey Geographic (SSURGO) Database.

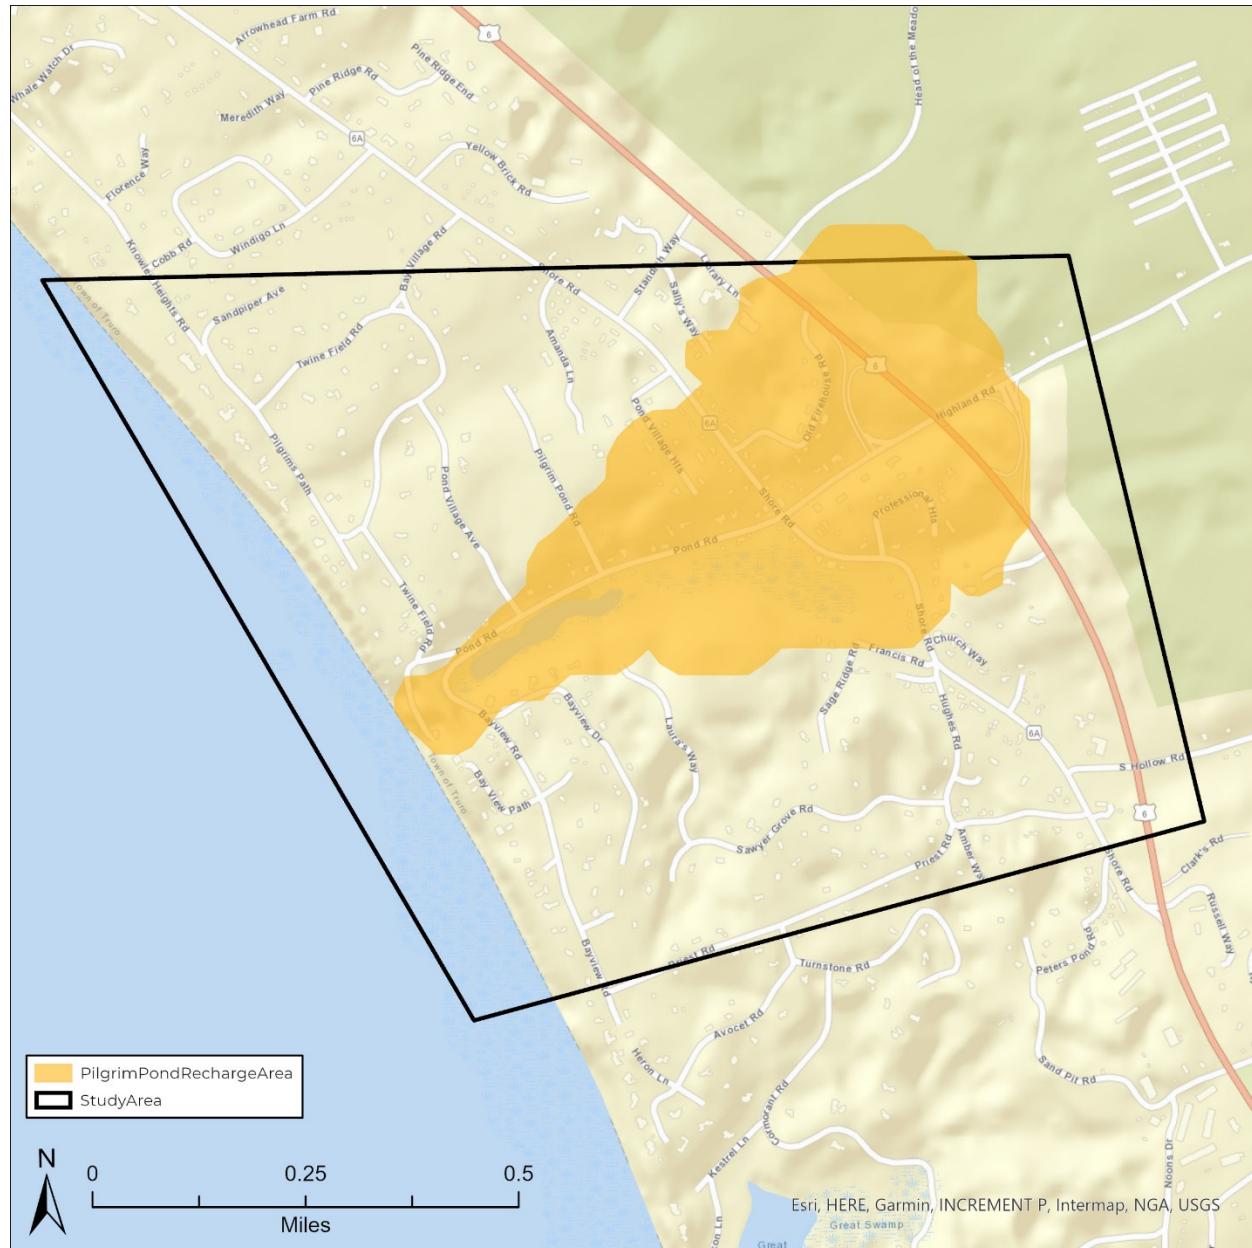
Figure 4. Recharge area for Village Pond as determined by USGS in 2004, as part of a groundwater recharge and travel time study.

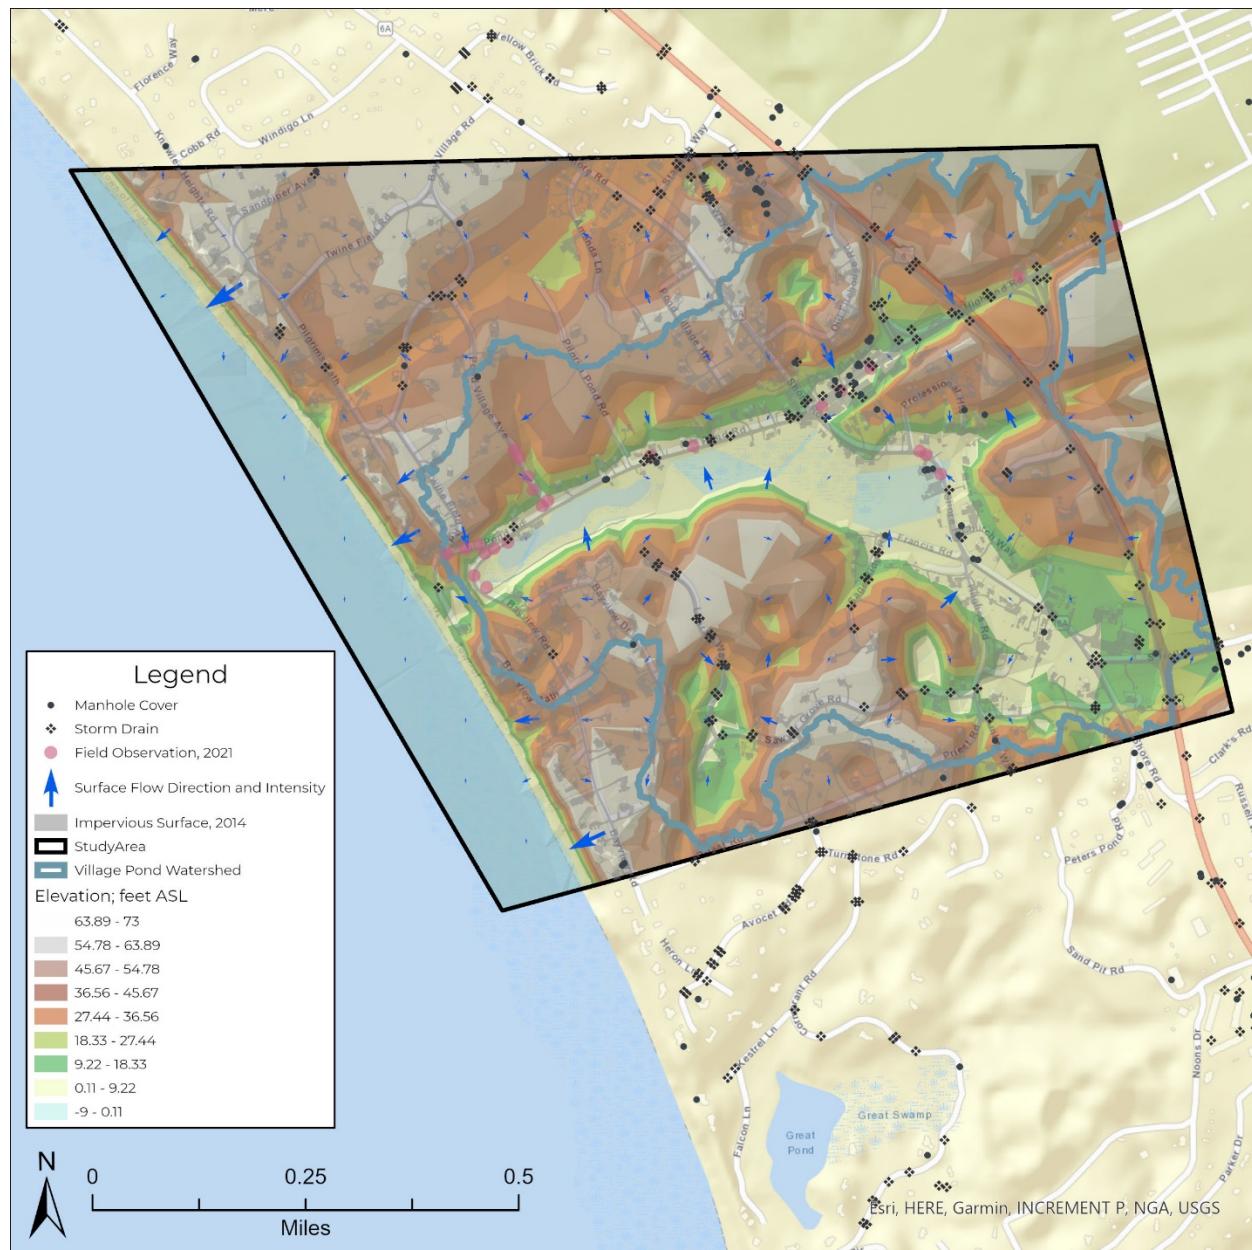
To delineate the Village Pond watershed, a vector field rendering was generated which looked at flow direction and velocity based on land cover and topography (Figure 5). The watershed delineation (indicated in the thick blue line) is larger than the recharge area (yellow area depicted in Figure 4). However, it is unlikely, given the sandy soil and hydrologic group category (HSG A), that surface runoff makes its way from the outer reaches of this delineation to Village Pond or its

associated wetland. The vector field rendering method provided flow direction of surface runoff depicted in the blue arrows noted in Figure 5. The direction of the arrow indicates the direction the surface runoff will flow, and the weight of the arrow (thickness) indicates velocity of the flow.

Figure 5. A vector field rendering of the Village Pond watershed using flow direction and velocity based on land cover and topography.

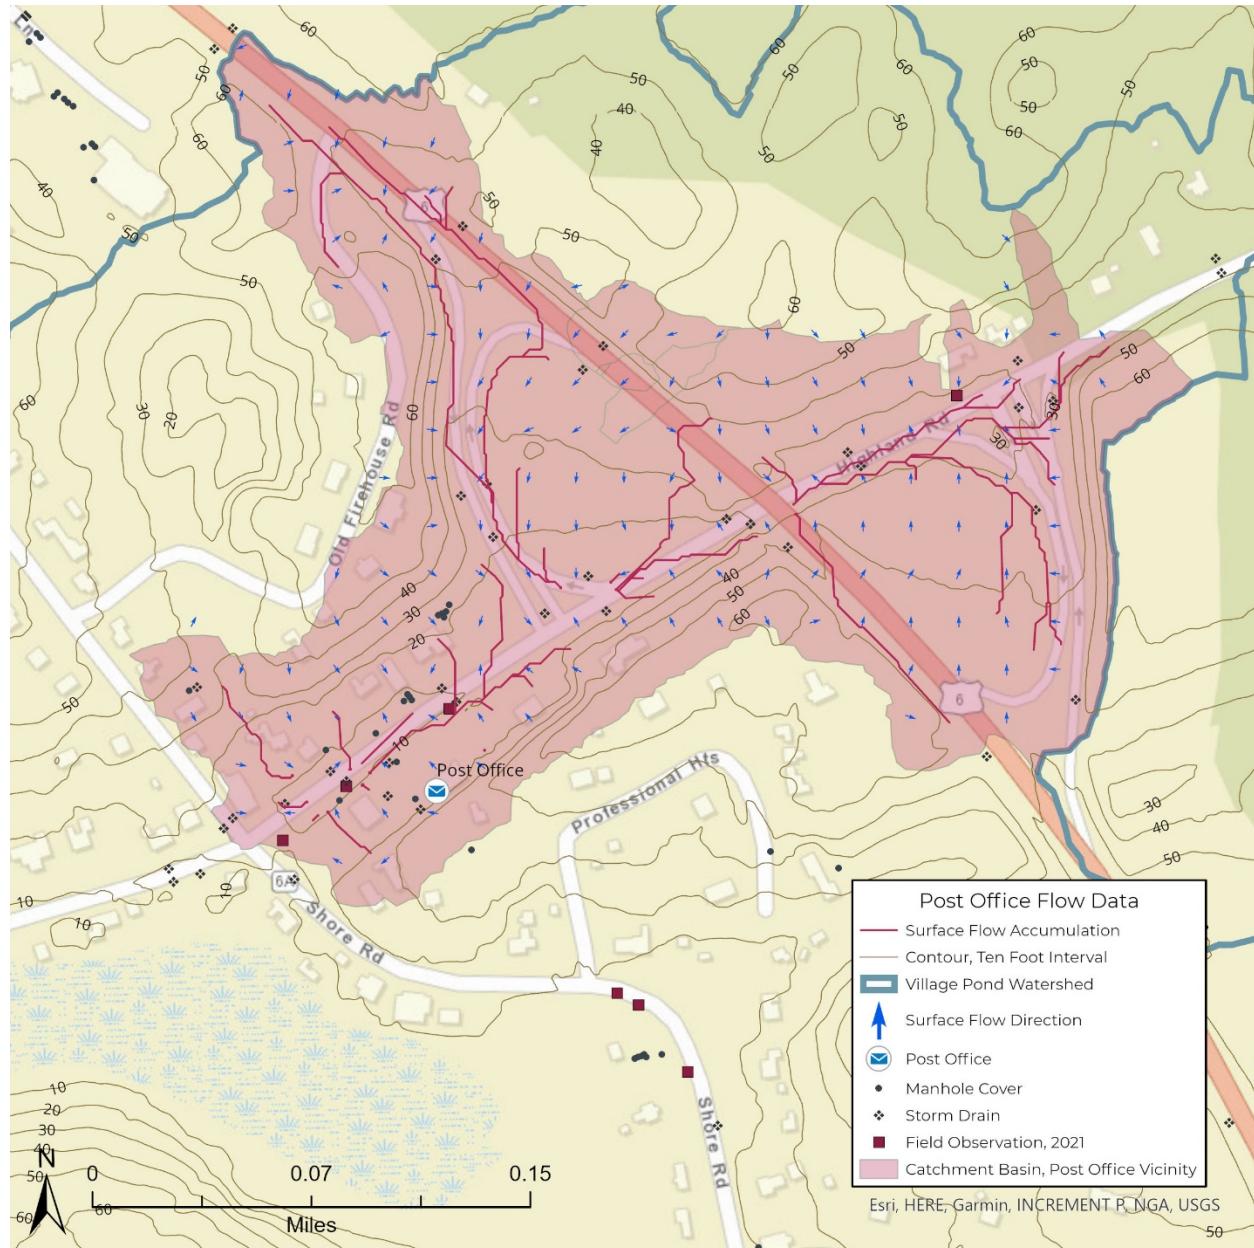
The section of Highland Road at the base of the Post Office (PO) access drive consistently floods during rain events. This area is of particular interest as the catch basin where the flood waters accumulate is connected via a pipe to an outfall located on the southeast side of Shore Road. The pipe conveys untreated stormwater from a general business district dominated by impervious surfaces to a sensitive wetland resource area adjacent to Village Pond. Stormwater runoff that ponds at the base of the PO access drive minimally includes a small section of Shore Road, Highland Road, the general business district and associated parking lots, and the Route 6 westbound exit and entrance ramps. There are other catch basins in this area on Highland Avenue and they likely capture stormwater runoff from the much larger extent of Route 6 as indicated by the pink area in Figure 6.

Figure 6. Catchment area for the storm drains located on Highland Road, near Route 6 and the US Post Office access drive.

There is likely enough space at this location to design and install an LID stormwater management system; either roadside vegetated swales along Highland Road and/or a bioinfiltration system at the southeast corner of Shore Road and Highland Road. At this location stormwater treatment systems should be designed to optimize removal of both nitrogen and phosphorus to reduce the impact of stormwater on both the drinking water supply as well as the freshwater ecosystem downstream of this area.

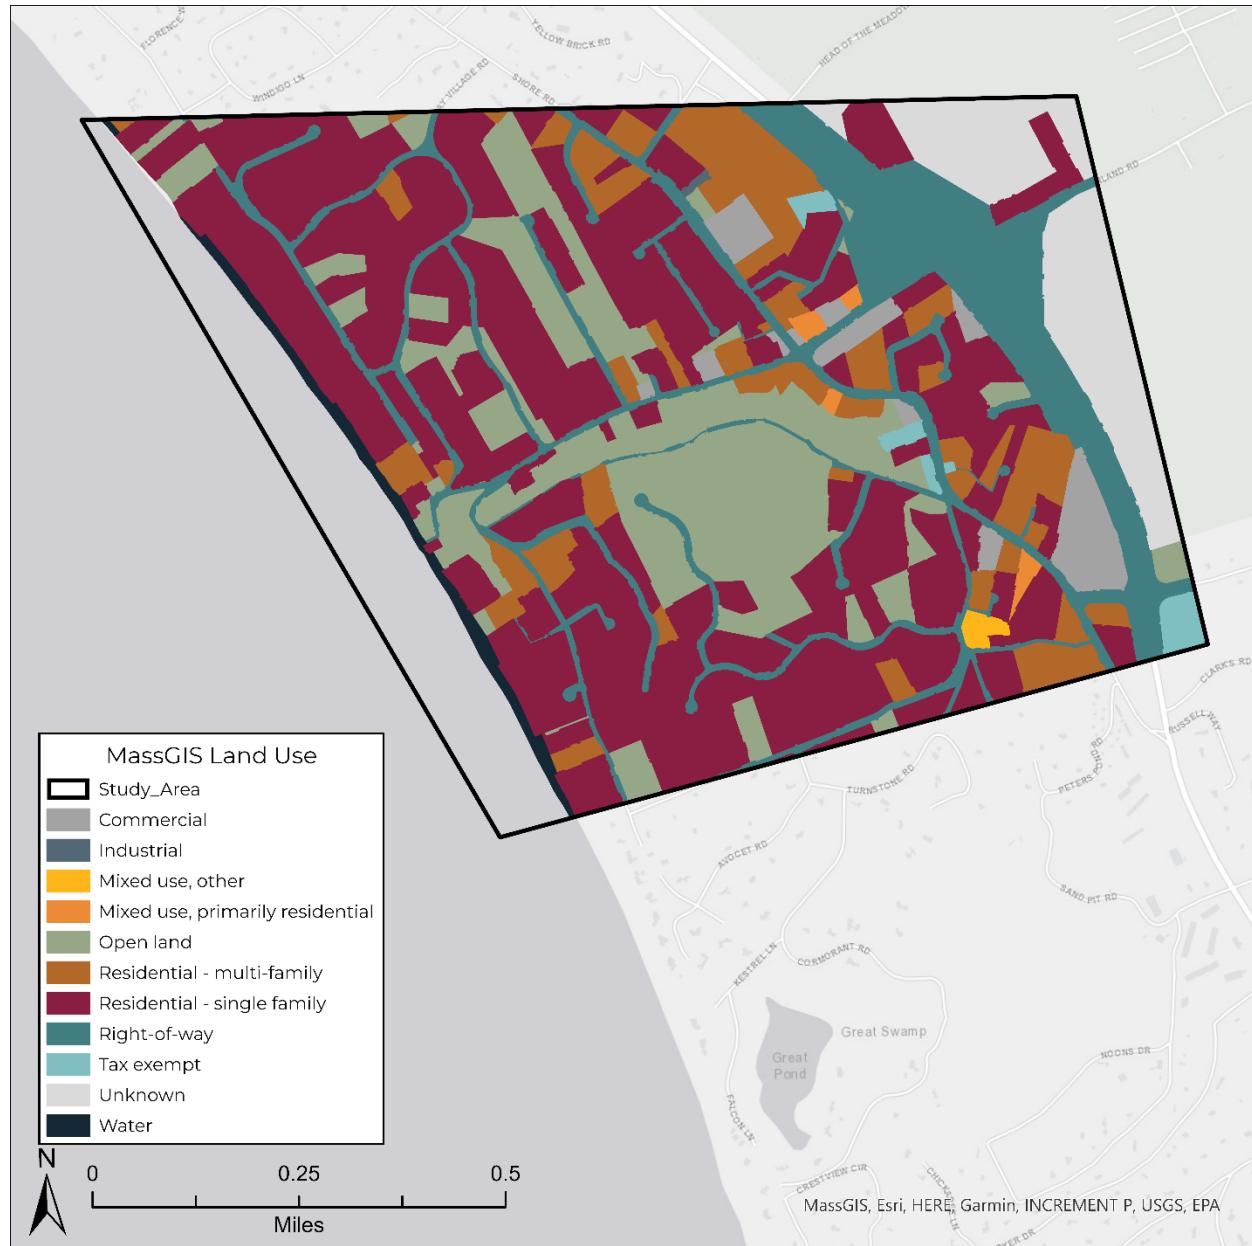
Land use describes how people use land. It represents the economic and cultural activities, (the built environment), that are practiced in a given place. Land use definitions or districts divide properties into different categories (residential, commercial, agricultural). This information was obtained from MassGIS 2016 Land Use. Classifying land use within the town is an important step in identifying areas that are more vulnerable to stormwater runoff and pollution (Figure 7).

Figure 7. MassGIS land Use classifications used to create Hydrologic Response Units for the study area in North Truro.

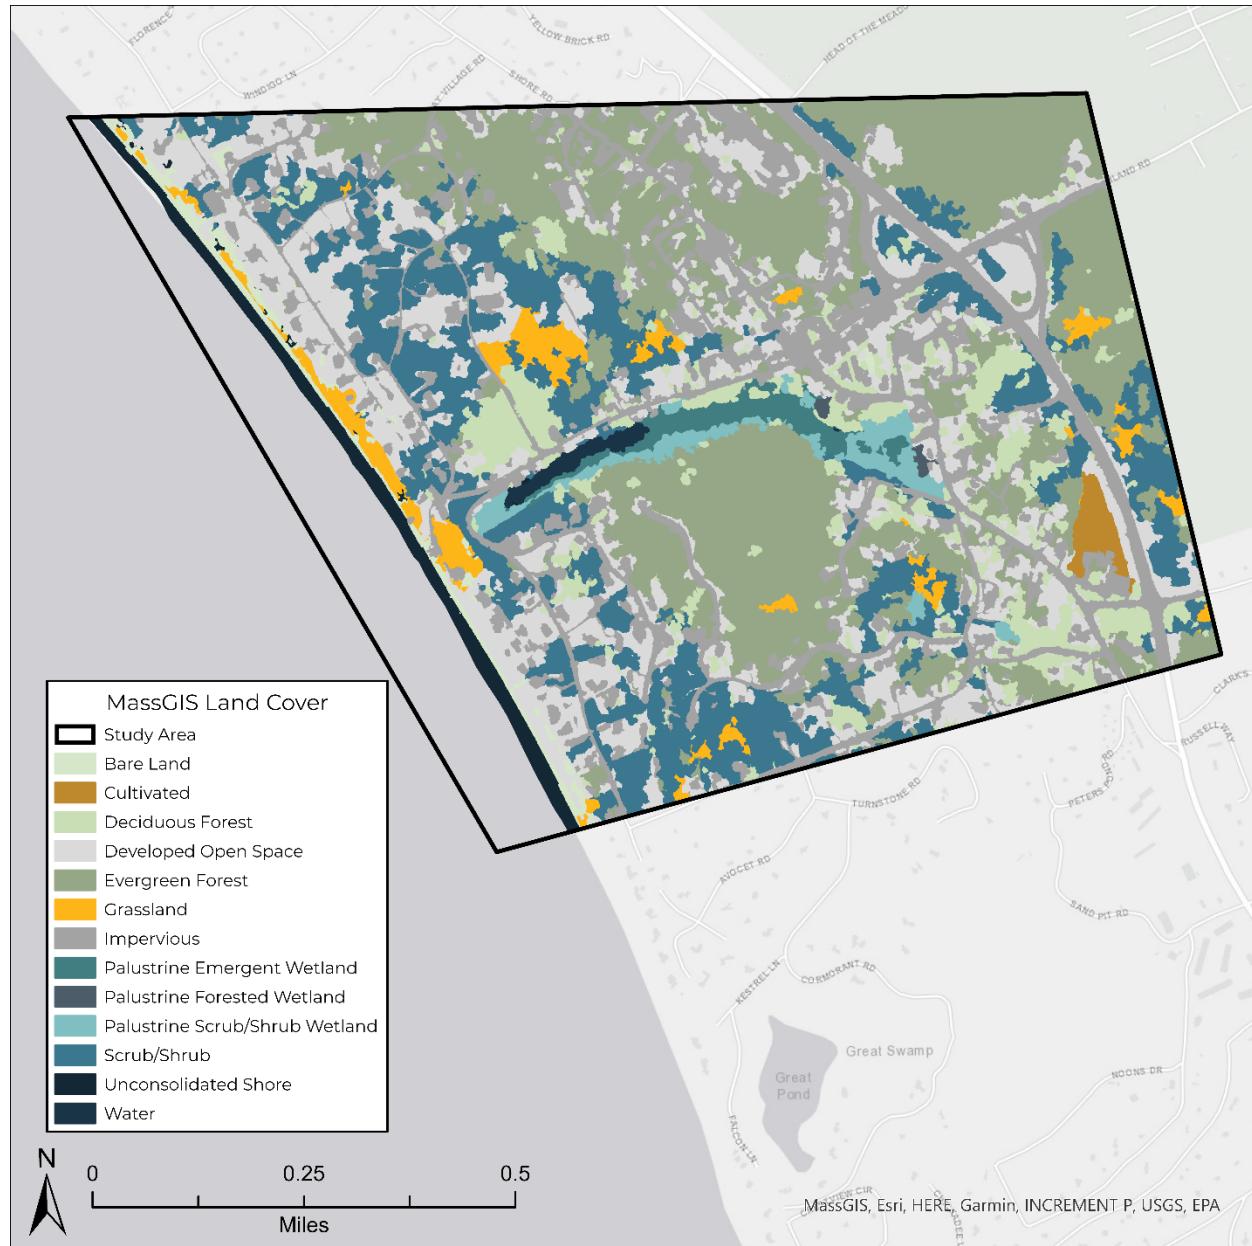
Land cover indicates the physical land type (grass, bare ground, asphalt) and was also obtained from MassGIS 2016 Land Use (Figure 8).

Figure 8. MassGIS Land Cover classifications used to create Hydrologic Response Units for the study area in North Truro.

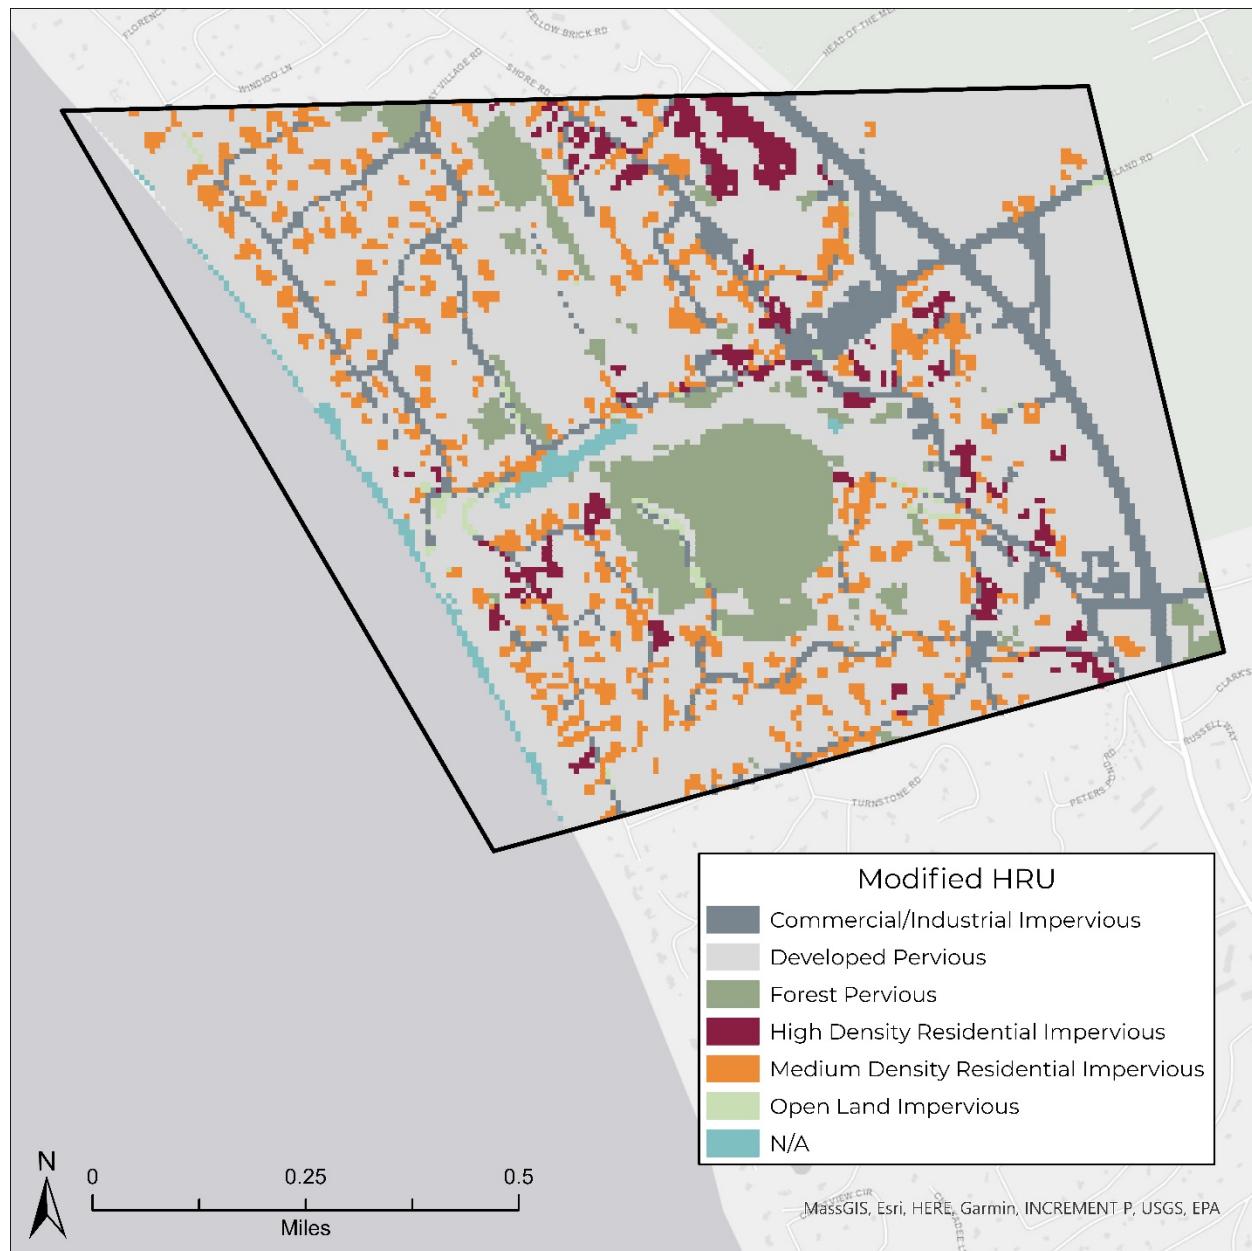
The North Truro Village Pond Watershed was used as a pilot test for this modified HRU determination process. The modified HRU classifications were obtained by combining land cover and land use categories to create a condensed list of land types. These were then combined with soil data and percent of impervious surface and are depicted in Figure 9

For example, the general and limited business districts along Highland and Shore Roads have been reclassified into a modified HRU category that accounts for the land use (business), land cover (paved), soil (HSG A), and the percentage of paved surfaces present. The reclassified categories yielded a fair amount of commercially designated land that is dominated by impervious surfaces (roads, roofs, parking areas) as can be seen in Figure 9 (dark gray color).

Figure 9. The modified HRU categories take into consideration land use, land cover, and soil type to generate classifications, as seen above, that reflect areas where the response to precipitation will be similar.

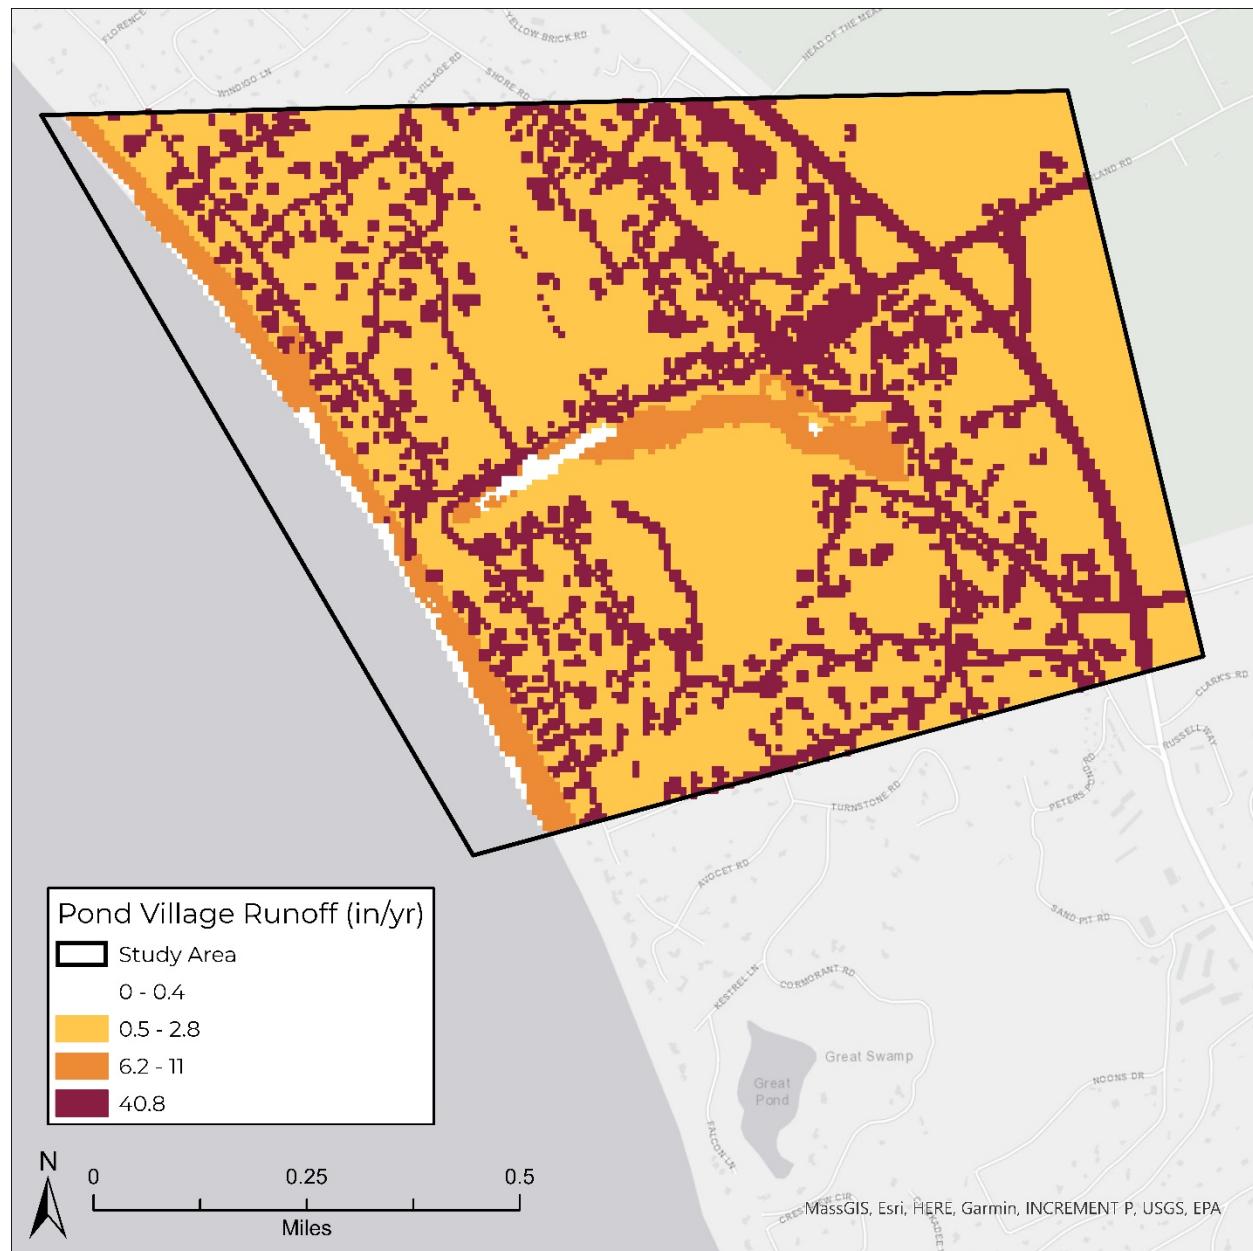
Stormwater runoff is a common and unavoidable result of rainfall and melted snow from diffuse sources such as road, roofs, and sidewalks. With increasing intensity and frequency of storms, it is imperative that stormwater management systems can handle a high quantity of low-quality runoff. Understanding the areas and surface types that produce the highest levels of runoff is necessary to improve future and current stormwater systems. The average stormwater flow runoff potential is depicted in Figure 10. It can be seen from this figure that the runoff potential is high everywhere there is pavement and development, even in the medium density residential areas.

Figure 10. Average runoff volume (inches/year) as determined by HRU unit-area in Pond Village.

As expected, these summary level analyses show that runoff volume is highest in the business districts and the high and medium density residential areas where the concentration of impervious surfaces is greatest. Total phosphorus, however, is highest in the residential areas, both high and medium density, but not in the general business districts.

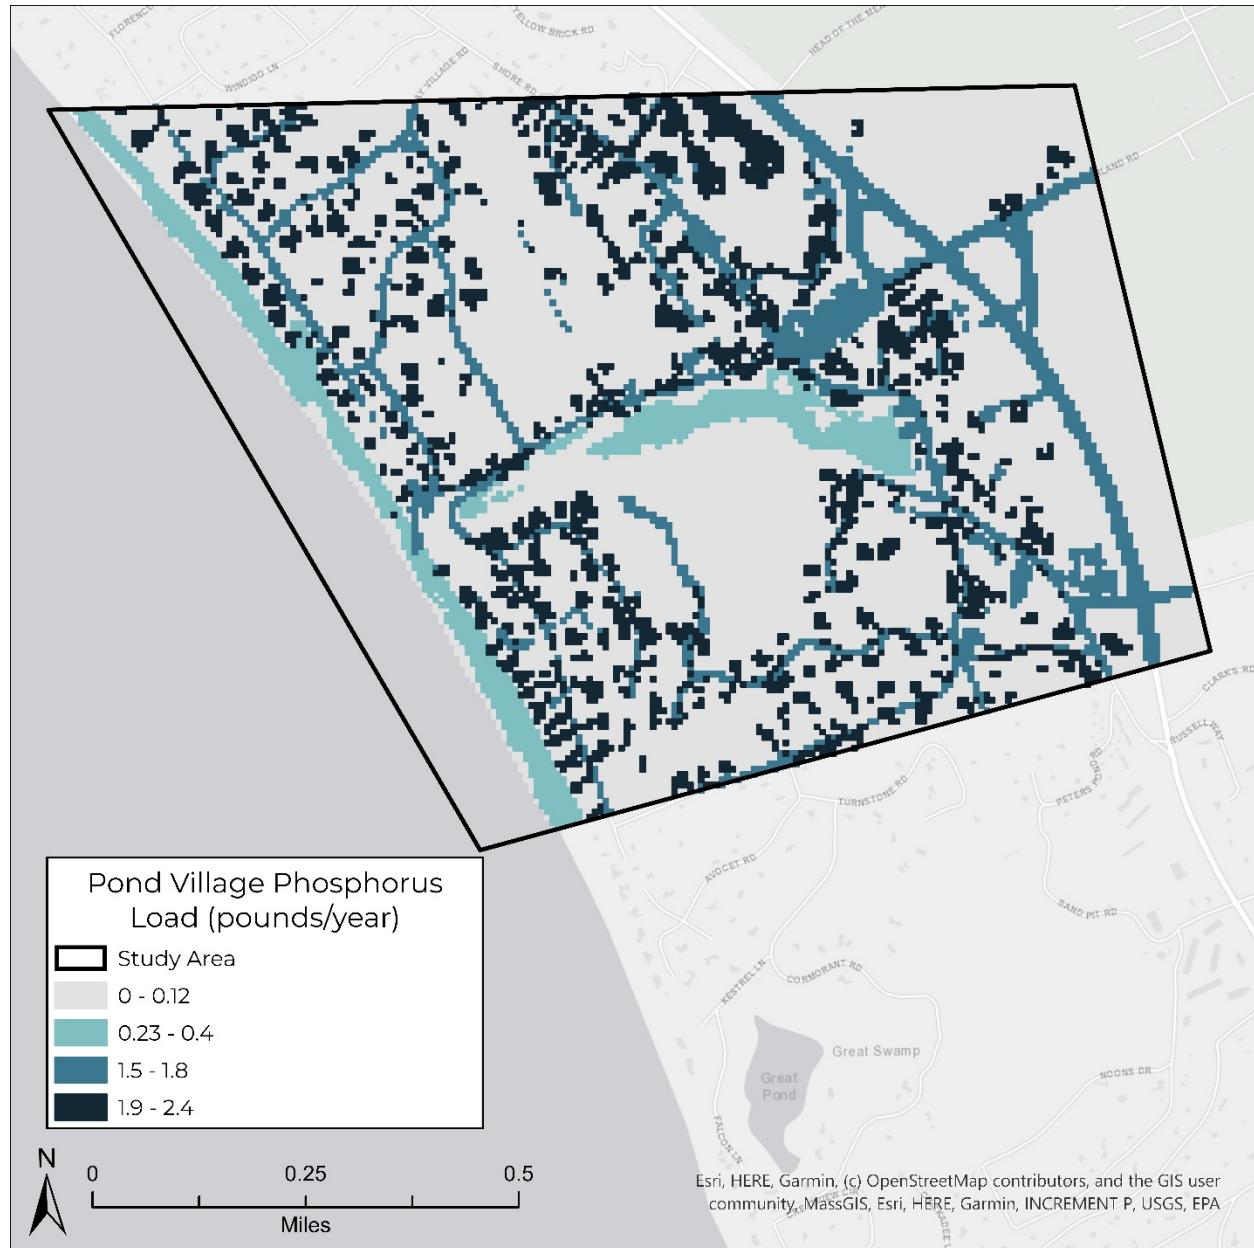
Phosphorus is a key nutrient in freshwater ponds on Cape Cod, as it is often the limiting factor in aquatic plant productivity. This means that when phosphorus is in low supply, the rate of plant and algae growth is limited. Excess phosphorus concentrations will create an imbalanced system. Protecting ponds is a high priority due to their ecosystem and recreational value. Assessing the impact of stormwater and resultant nutrient loads will benefit the ongoing work to preserve pond ecosystems and water quality. The results highlight the critical areas of nutrient loading, which, as can be expected, correlate to areas of high-density development (defined by MassGIS land use as housing on smaller than $\frac{1}{4}$ acre lots) and impervious surfaces. In Figure 11, the results indicate the critical areas of phosphorus loading.

Figure 11. Pond Village modified HRU unit-area based annual average total phosphorus load (pounds/year).

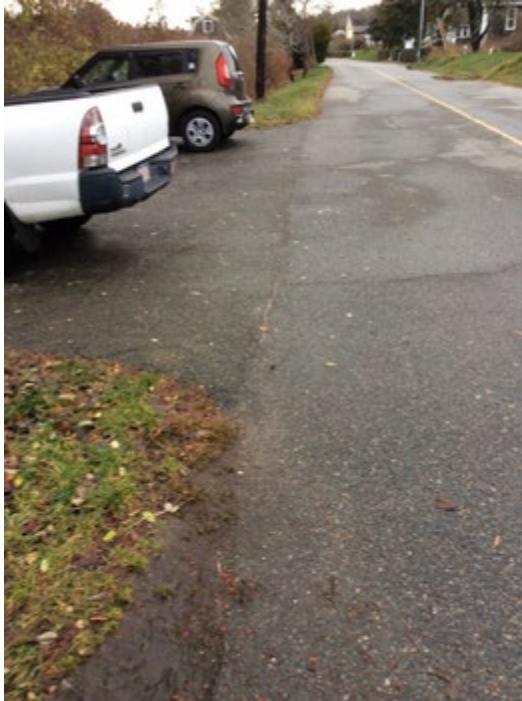
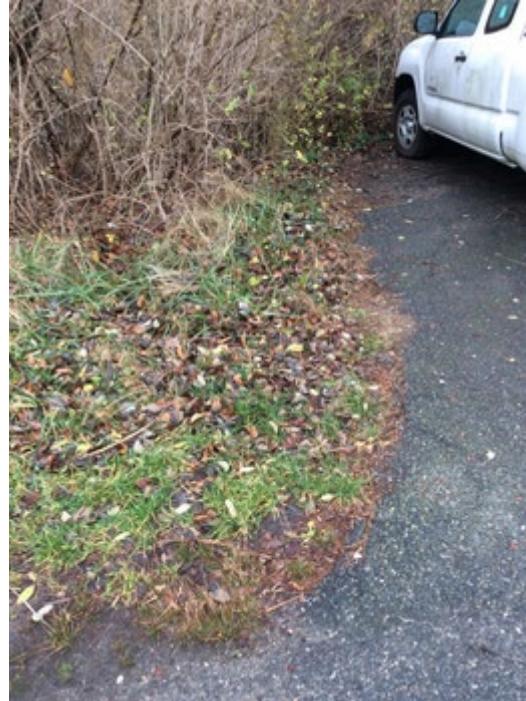
Pond Road – Across the street from 13 and 15 Pond Road there is a paved pull out of the road that slopes towards the pond and wetland. It appears to be used for residential parking. This impervious surface is a potential location for disconnecting the paved surface so that it does not serve as a conduit for stormwater runoff into the wetland/pond. This is known as impervious cover disconnection (ICD).

Photograph 1. Paved pullout area on the south side of Pond Road which serves as a conduit for stormwater to flow directly into the pond and wetland.

Photograph 2. Paved pullout area on the south side of Pond Road which serves as a conduit for stormwater to flow directly into the pond and wetland.

South side of Pond Road (Field Observation 18): There is a paved pullout area on the south side of Pond Road across the street from house numbers 13 and 15 Pond Road (Photograph 1). This paved area slopes towards the pond and serves as a conduit for stormwater runoff (Photograph 2). On each field visit cars were parked in this area; it is not clear if this is a private driveway or a ROW. This is an opportunity for impervious surface disconnection, which can be done by removing a portion of

the paved surface between the road and the pullout. Or, if space allows, design a stormwater treatment system between the bottom of the pullout area and the wetland.

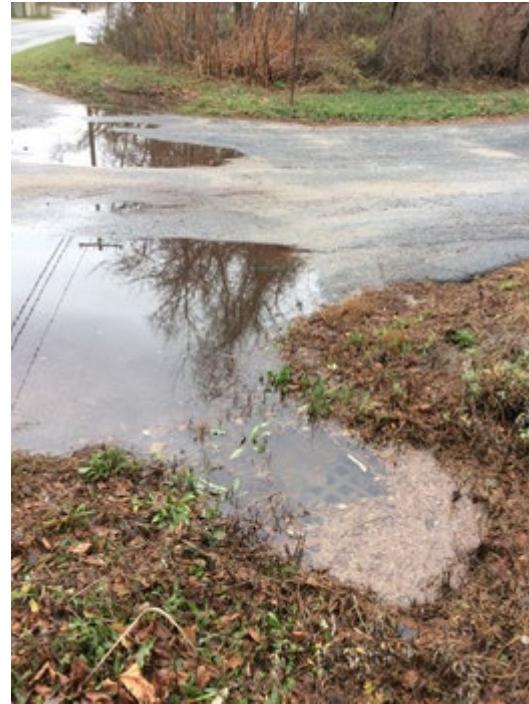
Photograph 3. Ponded stormwater and accumulated sediment at the intersection of Pond Village Avenue (on the right) and Pond Road. The ponded water nearly spans the width of Pond Village Avenue.

Intersection of Pond Village Avenue and Pond Road
(Field Observation 11-16): Pond Village Avenue has a steep slope towards Village Pond and Pond Road. At the bottom of Pond Village Avenue, where it intersects with Pond Road, there was a large volume of ponded stormwater and accumulated sediment. The ponded water nearly spans the entire width of Pond Village Avenue (Photograph 3). The location of the catch basins at this intersection are good, the ponded water sits right on top of the grates. However there appears to be more runoff than the systems can hold and process. Given the regular maintenance and cleaning that the catch basins receive (personal communication, Jarrod Cabral), it is likely that the capacity needs to be revisited and a feasibility study conducted of additional or alternative solutions for stormwater management. The shallow depth of the groundwater is likely a factor for local catch basin capacity.

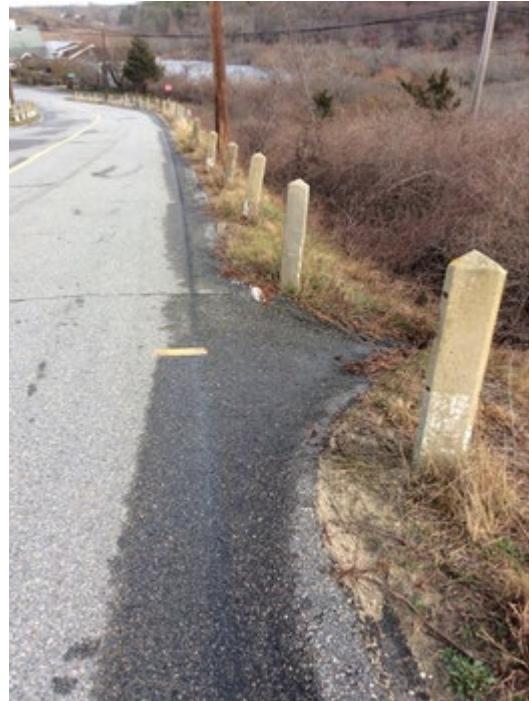
Photograph 4. The upper most paved flume on Pond Road. The vegetated area to the right likely serves to slow stormwater and promote infiltration.

Western Reach of Pond Road (Field Observation 6 and 7): There are two paved flumes located on the south side of Pond Road directing stormwater into a steeply sloped vegetated area between Pond Road and Bay View Road (Photograph 4). This natural vegetated area serves as an informal stormwater collection and treatment area. It may be worth a study to determine if the capacity and treatment of stormwater in this location can be improved with a formal LID stormwater system designed specifically to remove phosphorus and nitrogen.

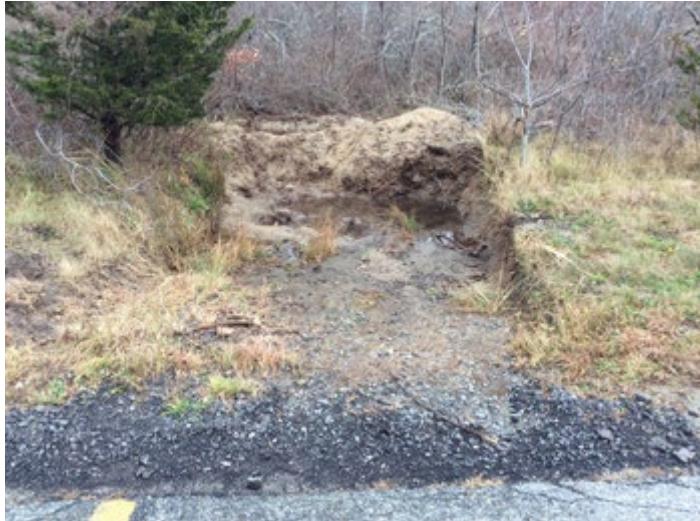
Photograph 5. Area adjacent to Bay View Road that has been plowed to facilitate stormwater to flow off the road.

Bay View Road (Field Observation 9, 10, 23): There are several areas along Bay View Road, on the eastern side adjacent to the Village Pond wetland, where the soil and vegetation appear to have been plowed away from the road (Photograph 5). This looks to serve the purpose of encouraging stormwater to run off the road into these slightly depressed sandy areas. This strategy is good for getting the water off the road but directs the untreated stormwater into the wetland resource area. This stretch of road would be a good location for a vegetated swale into which stormwater can be directed and treated prior to infiltration into the groundwater and the adjacent wetland.
