17 Town Hall Rd, Truro, MA

Figure 1

EM61 Survey Results (metallic structures)

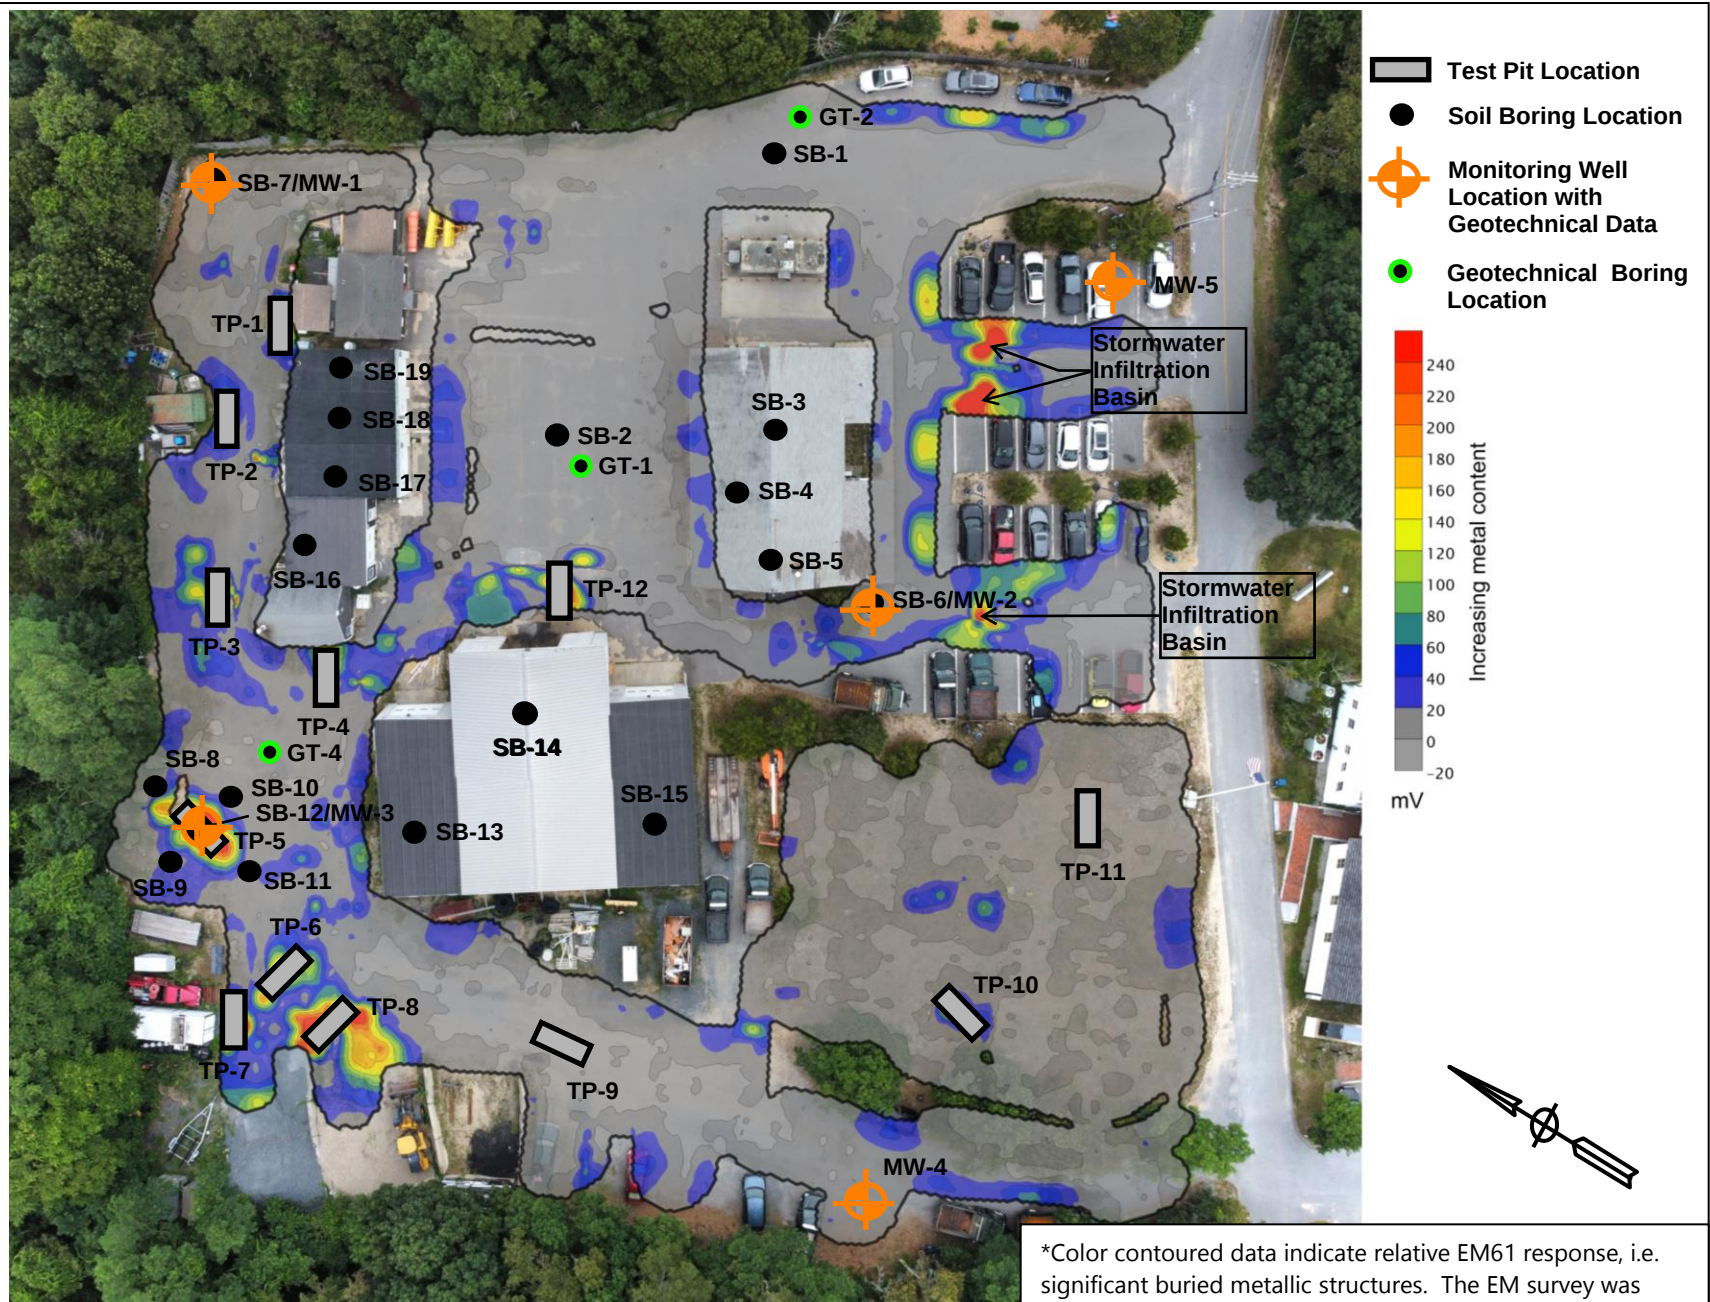
\*Color contoured data indicate relative EM61 response, i.e. significant buried metallic structures. The EM survey was conducted throughout accessible sections of the scan area, as indicated by black borderline.
