MEMORANDUM

FROM Matt Shultz, PE, Adam Finkle, PWS, and Zac Duval
Woods Hole Group
107 Waterhouse Road
Bourne, MA 02532
Direct Phone: (508) 495-6259

Little Pamet River, Truro, MA— Sediment & Vegetation Assessment and Restoration of the Little Pamet River System

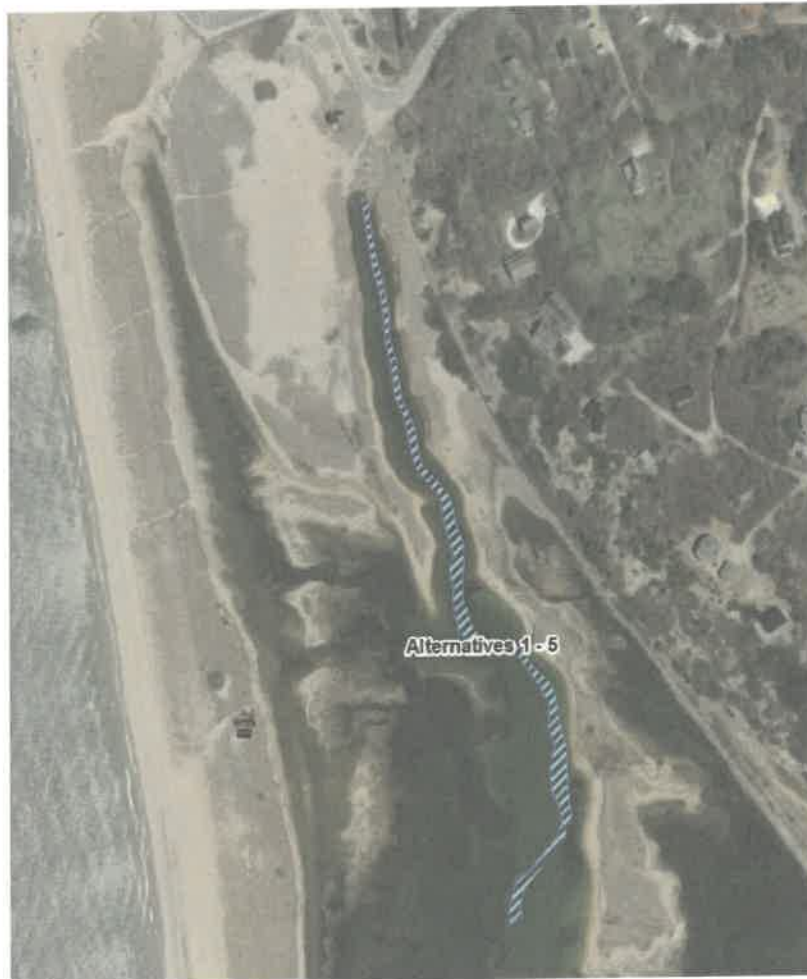
Figure 5. Portion of outlet channel to Pamet Harbor identified for improvement to better drain Little Pamet River (included with Alternatives 1 through 5).

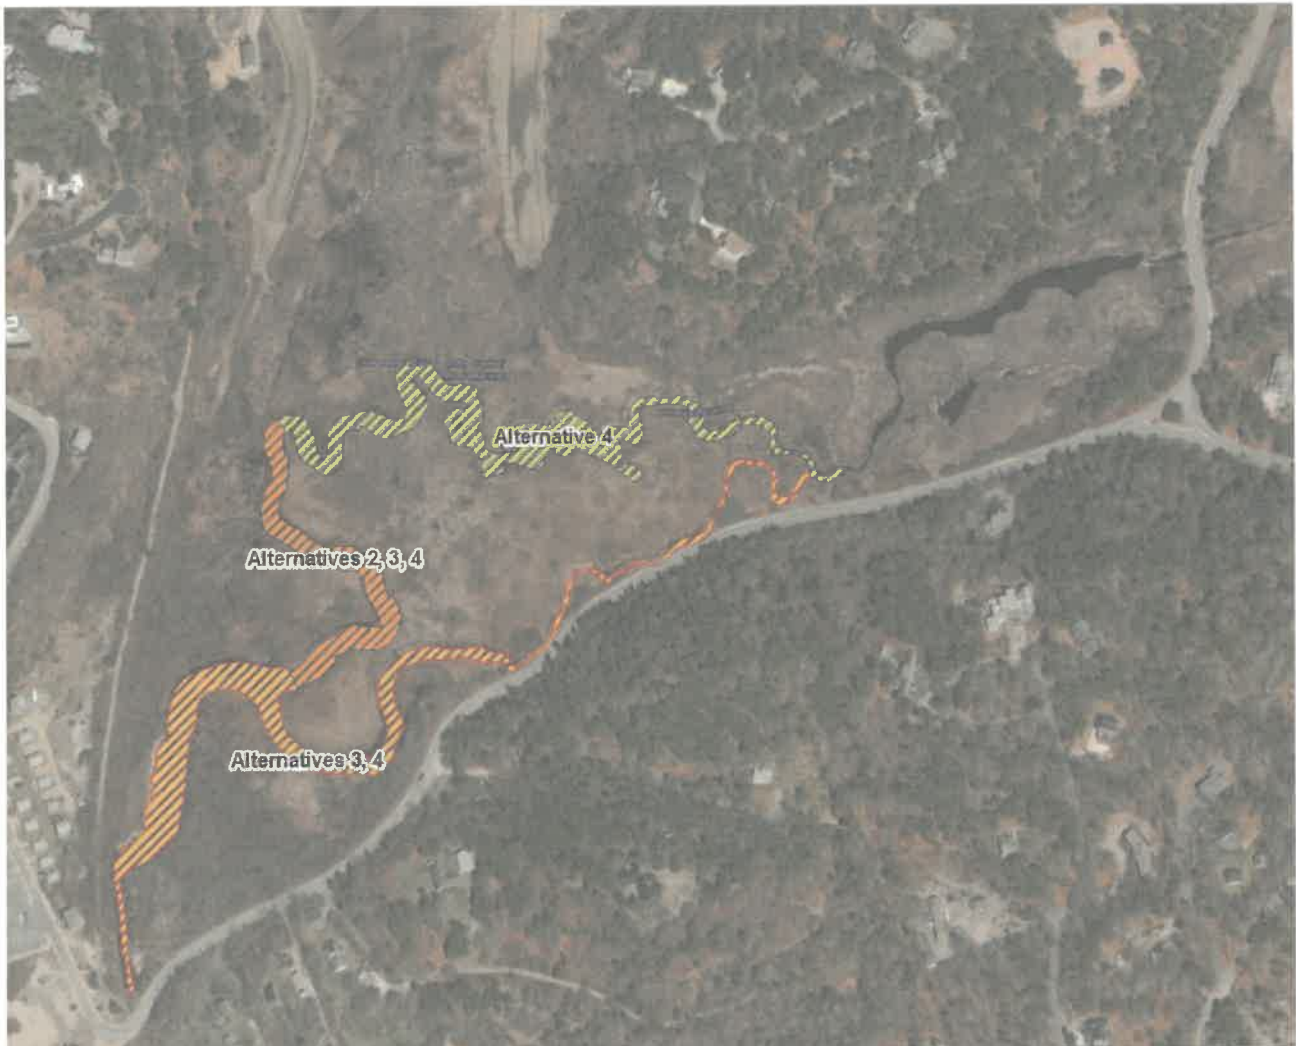
Figure 6. Different channel reaches within the lower marsh of Little Pamet River identified for improvements in the proposed restoration alternatives.

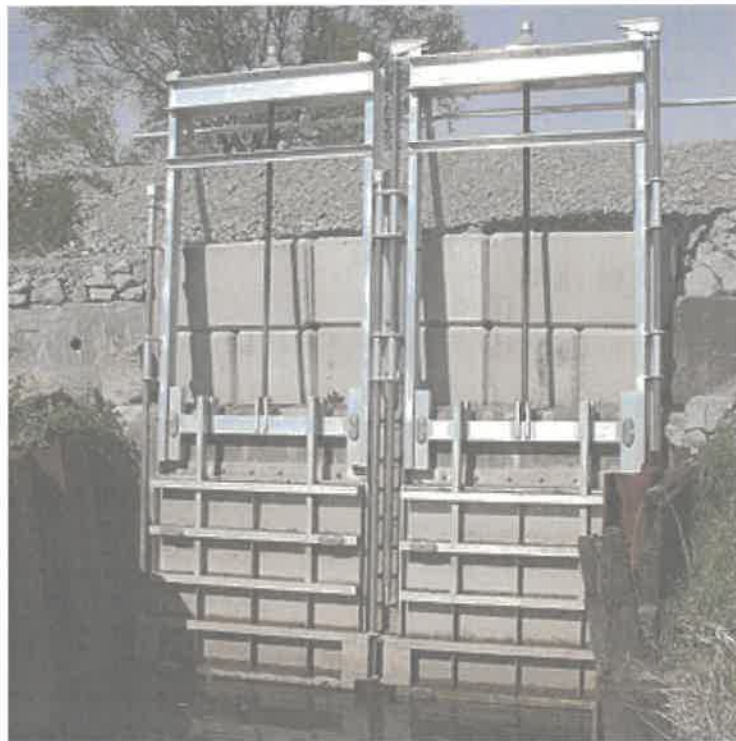
Figure 7. Golden Harvest GH-50 sluice-flap combination gate.

This alternative includes replacing the culvert structures at Corn Hill and Castle Road, and restoring tidal flow within the Little Pamet River system using an alternative tide gate control. A sluice-flap combination tide gate would regulate tidal flow under typical and coastal storm conditions to limit adverse flooding impacts while allowing the system to optimally drain (see Figure 7).

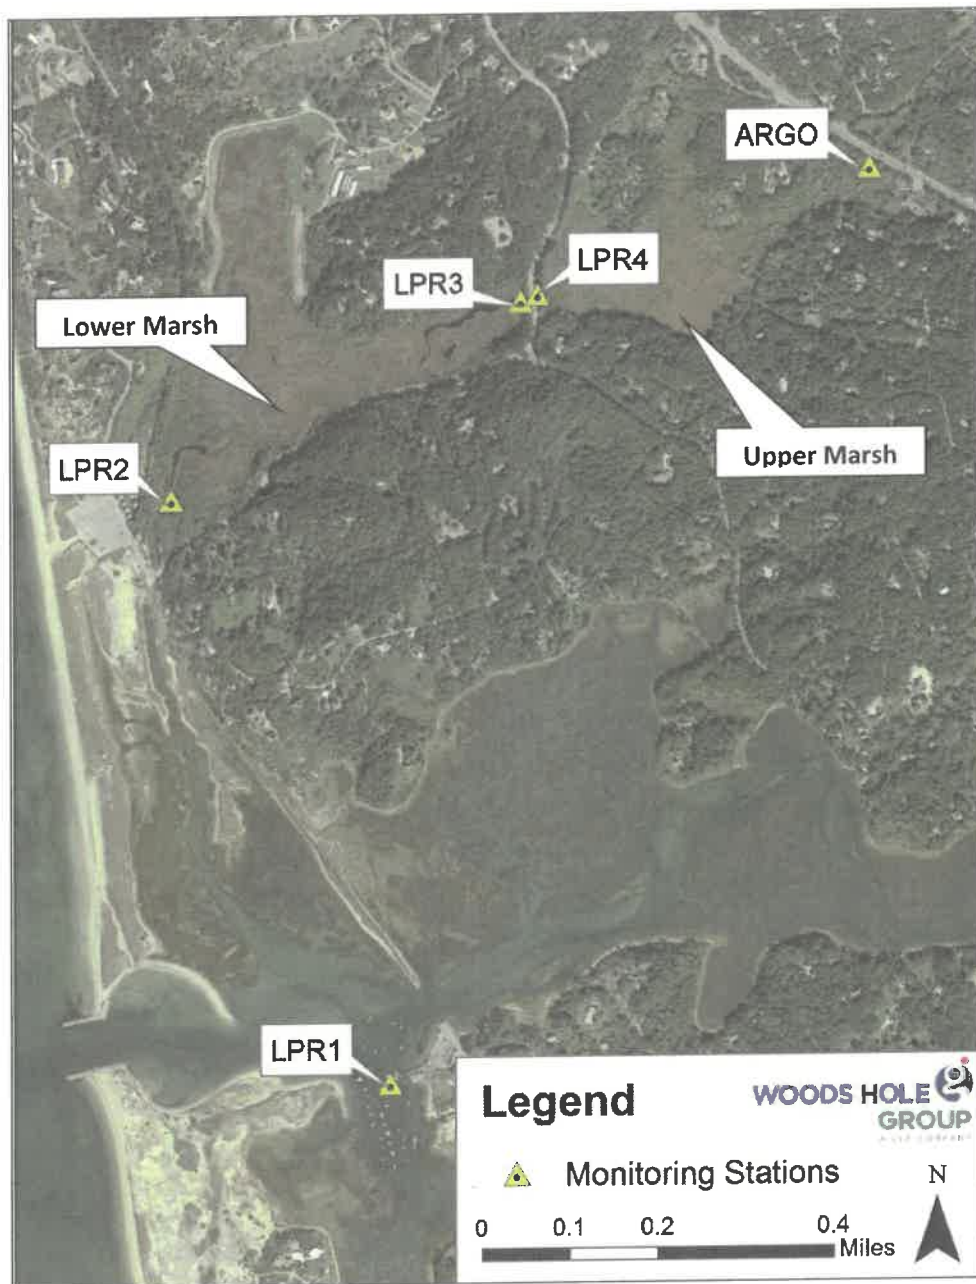
Figure 1. Locus map of the Little Pamet River estuarine system. Call out boxes indicate the different reaches of the system and approximate locations of the AquaTroll data loggers and Argonaut current meter deployed in support of this study.

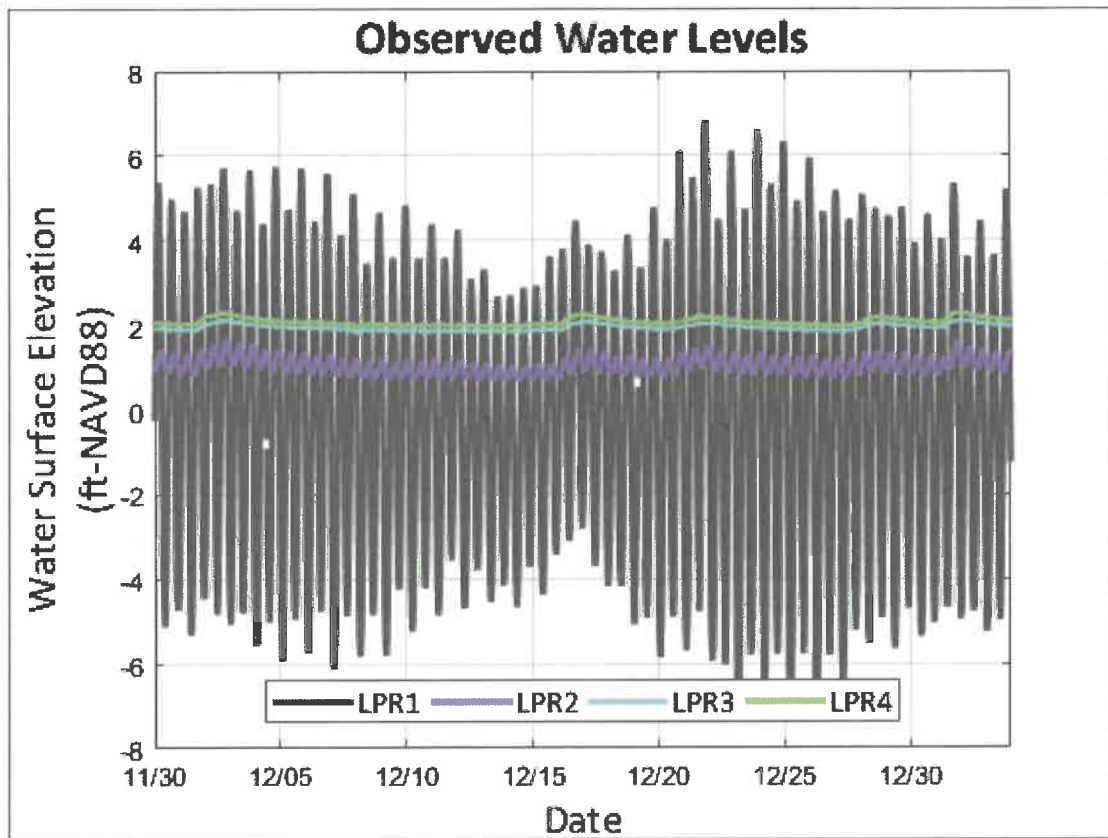
Figure 2. Observed water levels in the Little Pamet River system from November 30, 2018 through January 3, 2019.

The measured water levels in the estuarine system from the month-long deployment period (November 30, 2018 to January 3, 2019) are shown in Figure 2. The full tidal signal in Pamet Harbor at gauge LPR1 is shown as the black line, while the blue line shows measured water levels immediately upstream of the tide gate/culvert under Corn Hill Road at LPR2. Also shown in Figure 2 are water levels measured at gauge LPR3 (cyan line) and LPR4 (green line) during the deployment. At gauge LPR2, tides in Pamet Harbor appear to have a minor influence on the water levels, however there is no tidal influence at either LPR3 or LPR4. The water levels at LPR3, which is in the same lower marsh between Corn Hill and Castle Roads as LPR2, is consistently at or around 2 feet NAVD88. This indicates how aggradation of the channel between the two gauges in the lower marsh has limited flow conveyance and created a weir-like, perched effect on the upstream water levels.

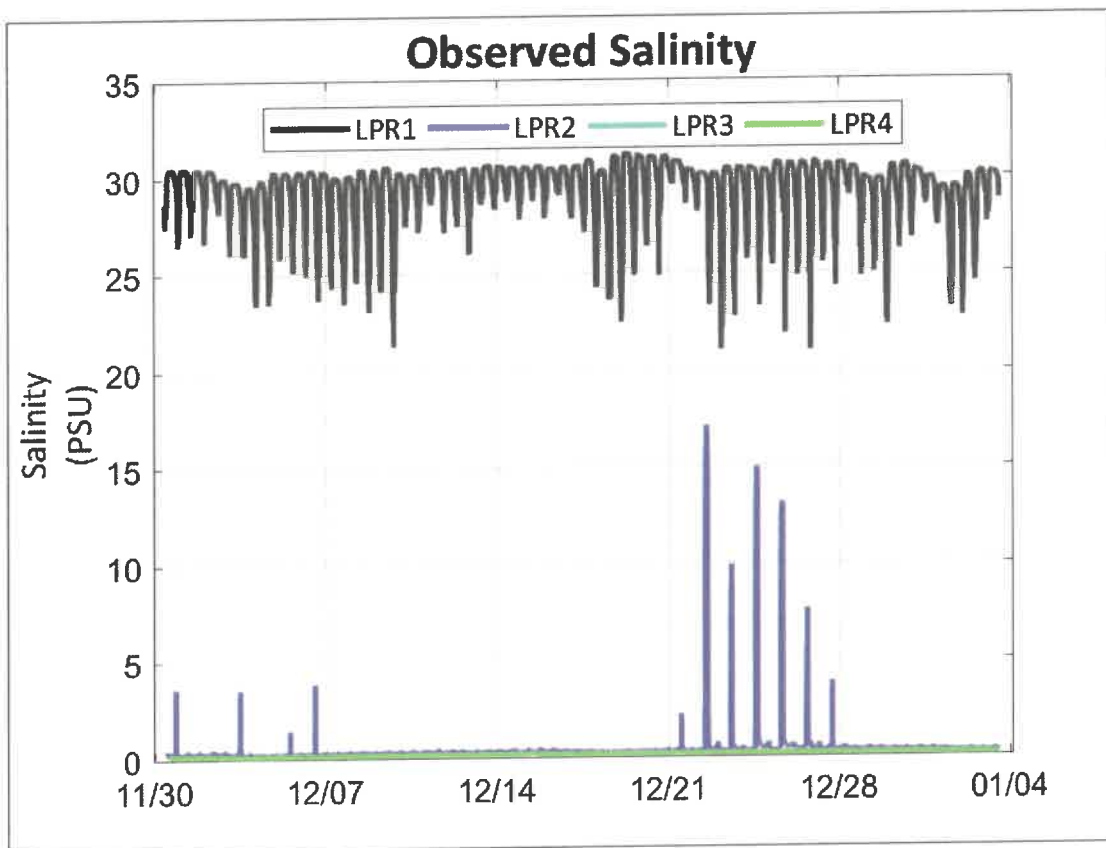
Figure 3. Observed salinities in the Little Pamet River system from November 30, 2018 through January 3, 2019.

Time series of measured salinity in the Little Pamet River are shown in Figure 3. The measured salinity in the harbor (LPR1) is shown as a black line. Also, on the figure, the two gauges in the lower marsh, LPR2 and LPR3, are shown as blue and cyan lines respectively, with the time series from the gauge upstream of Castle Road in the upper marsh reach, LPR4, shown in green. In the harbor, the salinity typically varies from 25 PSU to 30 PSU, which is consistent with seawater from Cape Cod Bay mixing with the fresher water discharging from both the Pamet River and the Little Pamet River. Immediately upstream of the Corn Hill Road culvert, which is fitted with a clapper tide gate, the waters are primarily freshwater with observed salinities being typically less than 1 PSU. There are several incidences of increased salinity, specifically between 12/21/2018 and 12/28/2018 which could be indicative of poor tide gate performance or possibly an influx of saline water around the tide gate. The peaks in salinity at the LPR2 tide gauge appear to be coincident with the higher spring tide levels at LPR1 (seen in Figure 2) when water elevations in Pamet Harbor are close to or exceed 6 feet NAVD88. At both LPR3 and LPR4 located farther upstream, freshwater having salinity values at or less than 1 PSU is present during the entire deployment.

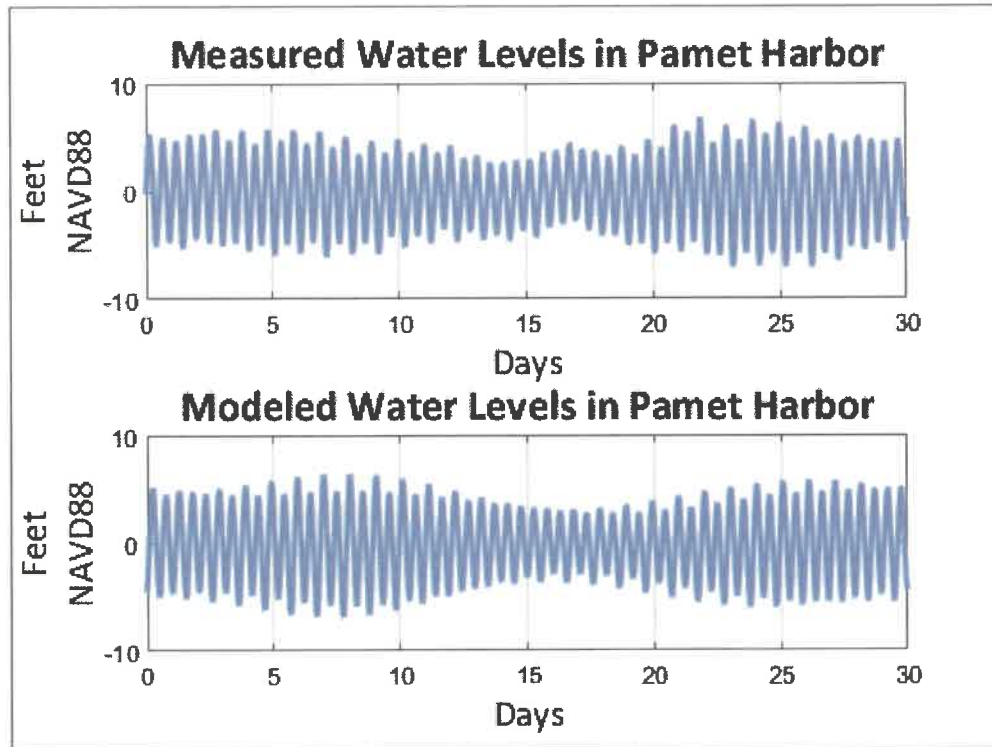
Figure 9. Tide measurements in Pamet Harbor (top) and the synthetic tide (lower panel) developed for use as the tidal boundary condition for Little Pamet River ECM model.

Observed water levels in Pamet Harbor from the LPR1 gauge were used to develop a synthetic tidal signal for use in subsequent modelling. By analyzing the full record of observations in the harbor, the tidal signal was resolved into its component tidal frequencies and amplitudes using a series of functions developed for use in MATLAB (Pawlowicz, Beardsley, & Lentz, 2002). The tidal signal consisted of 35 constituent frequencies and associated amplitudes, of which the five largest are listed in Table 1. The synthetic tide, shown in the bottom panel of Figure 9, was used in conjunction with the low return frequency surge and precipitation events to develop a greater understanding of the effects each potential drainage alternative would have on the system.

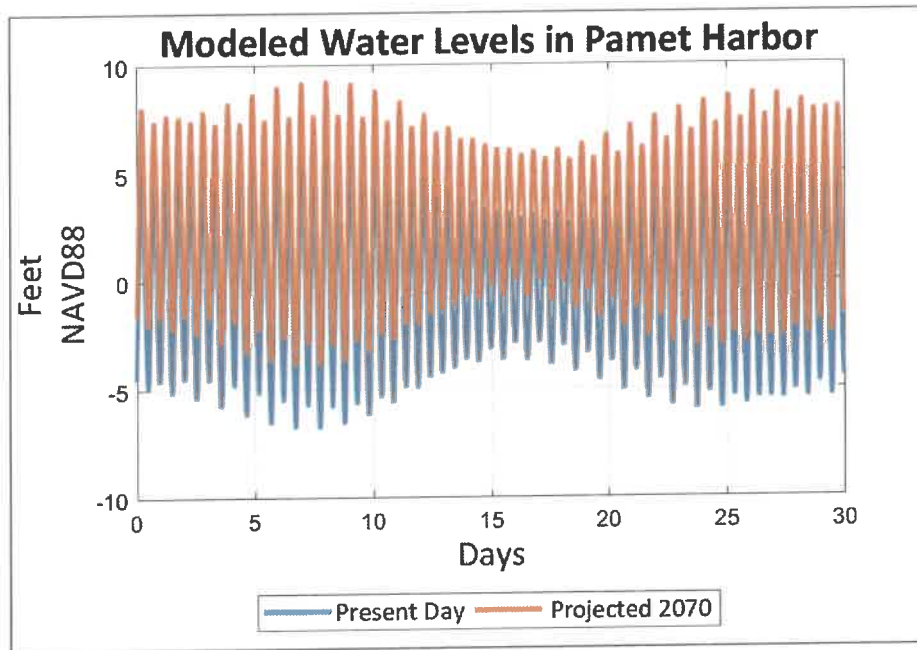
Figure 10. Tidal conditions for Pamet Harbor at present sea levels (blue) and with projected sea level rise superimposed on the tidal forcing (orange). The 2070 scenario includes a sea level rise of 2.9 feet.

In order to evaluate potential future conditions with projected increases in sea level, a tidal boundary condition was developed for a projected sea level rise (SLR) scenario. As this study is assessing the need for replacing existing culvert structures to optimize drainage, an SLR scenario were selected based on a typical culvert design life of 50 to 75 years. As such, the SLR scenario used was the intermediate-high scenario for year 2070 which gives a projected increase of 2.9 feet (Deconto & Kopp, 2017). The 14-day synthesized tide period was used as the basis for the SLR model simulations and Figure 10 shows the typical tidal conditions at present day (blue line) and projected sea levels accounting for SLR in 2070 (orange line).

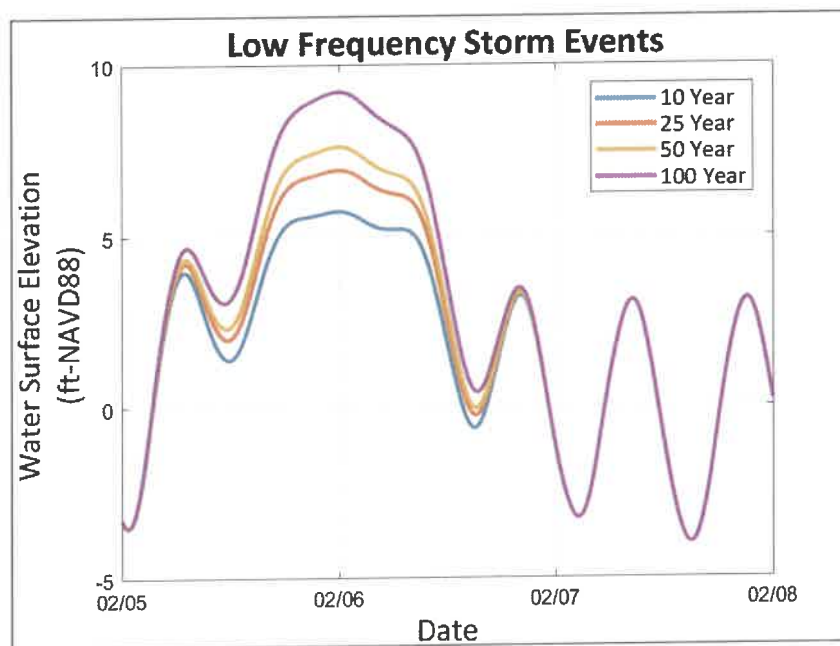
Figure 11. Synthetic storm surge hydrographs for the 10-, 25-, 50-, and 100-year storm surge events

Boundary conditions were also developed for model simulations of coastal storm surge events up to the 1%-annual-chance (100-year) level. The extreme storm surge elevations for the 10% (10-year), 2% (50-year) and 1% annual exceedance rate storms used in this study are from the preliminary Flood Insurance Study for Barnstable County (FEMA, 2018). These peak water levels were used to develop a water level for the 4% (25-year) storm event. Peak water levels for each of the low frequency storm events were then used to develop a synthetic storm surge hydrograph using methods detailed in the 2004 Federal Highway Administration Hydraulic Engineering Circular No. 25. The storm surge hydrographs developed using this procedure for each storm event occurring over 48 hours are shown in Figure 11. The 48-hour storm duration was chosen to be representative of the relatively long duration Nor'easter, or extratropical, events.

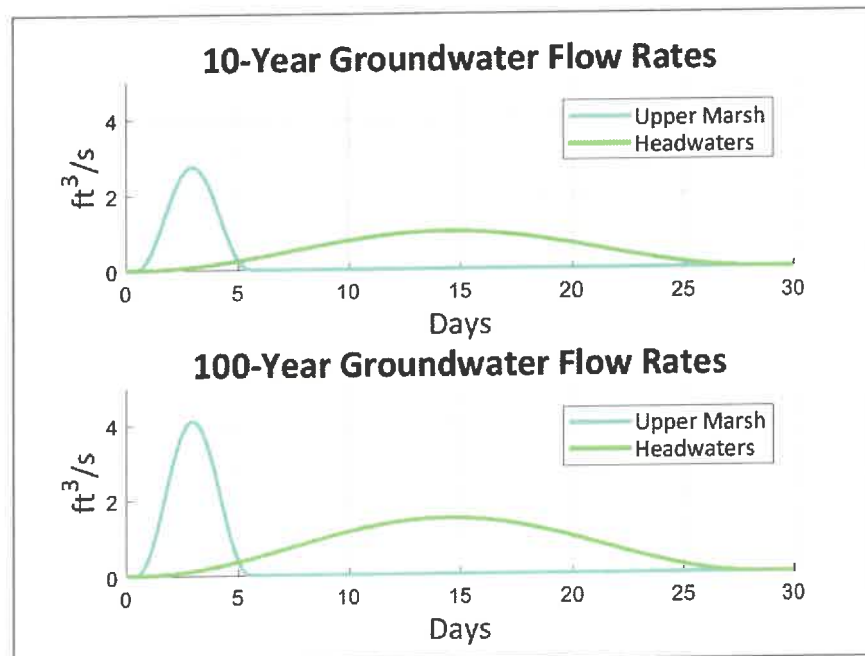
Figure 13. Groundwater flow rates developed for the 10- and 100-year rainfall events.

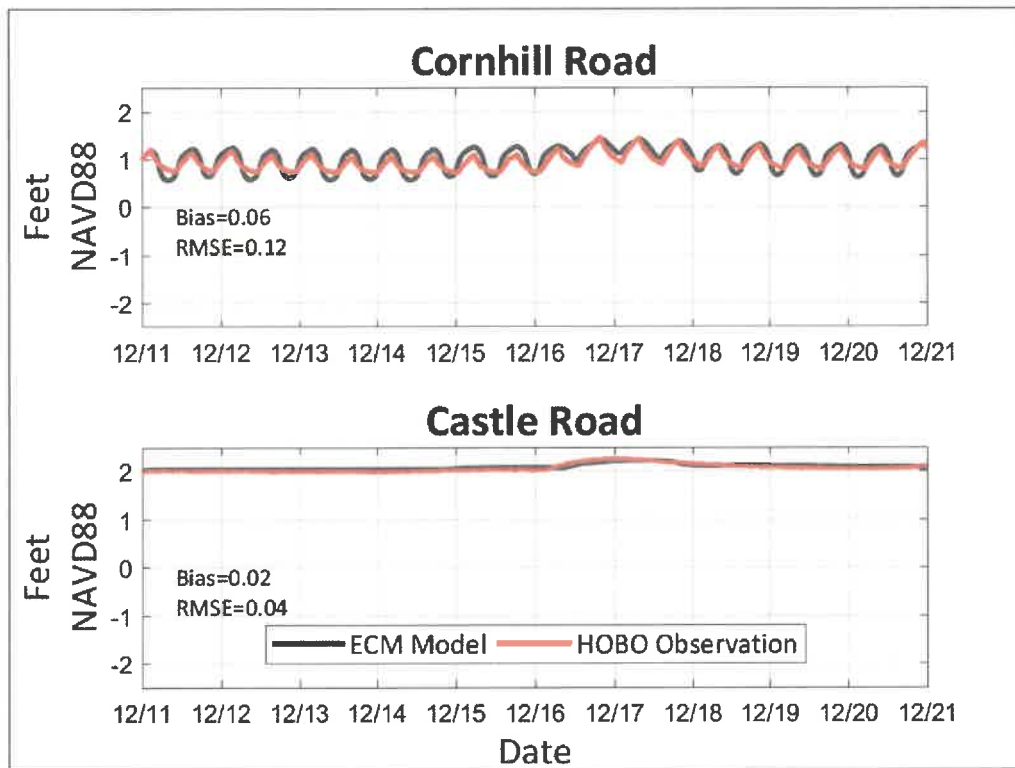
Figure 15. Comparison of the Little Pamet River ECM model results to the measured observations over the validation period between 12/11/2018 and 12/21/2018.

Figure 15 shows the model results upstream of Corn Hill Road as a black line, and compared to the measured observations, shown as a black line, for the model validation period (12/11 – 12/21) in the upper panel. Upstream of Corn Hill Road, the ECM model shows a slightly higher range in elevations with lower water levels during ebb tides, and higher peak elevations. Over all, the bias was less than 0.7 inches, with a RMSE value of 1.4 inches. In the bottom panel, the time series of model results upstream of Castle Road are shown as a black line, and are compared with the measured observations (red line) for the same ten-day validation period. At Castle Road, the ECM model had a bias of less than ¼ of an inch, and a calculated RMSE of less than 0.5 inches.

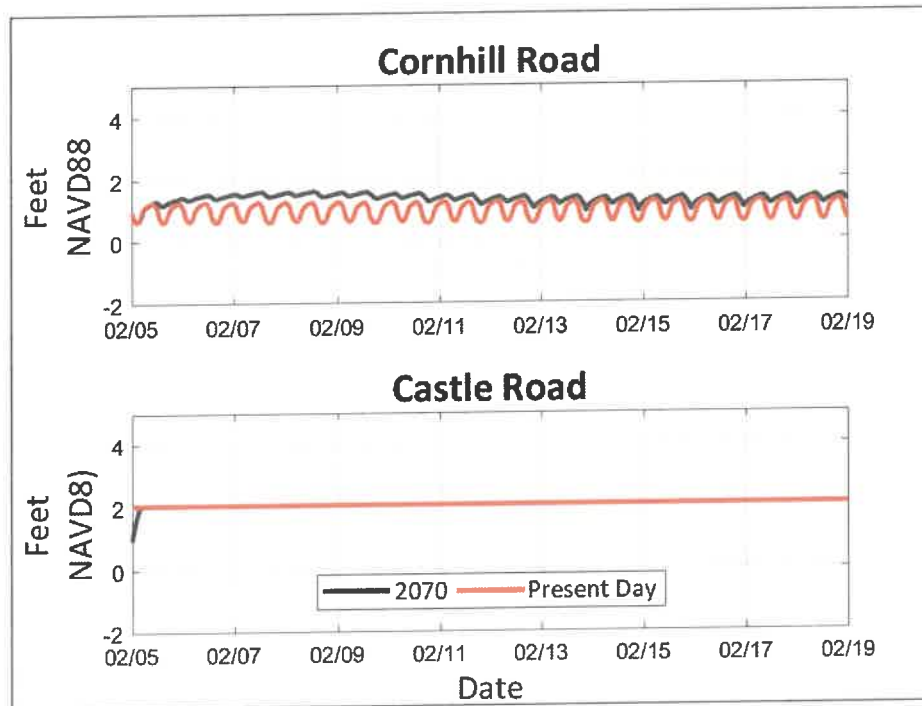
Figure 16. Time series of water levels in the Lower and upper marsh reaches of the Little Pamet River for existing conditions/typical tides with the current-day sea level (red), and with a projected sea level increase of 2.9 feet in 2070 (black).

Figure 16 shows water levels within each modelled Little Pamet River reach under typical tides with projected 2.9 feet of sea level rise in 2070. The SLR model results are shown (black line) together with current-day water levels (red line). The model simulations of the existing culverts under typical tides with SLR indicate that the efficacy of the existing tide gate/culvert combination at Corn Hill Road is reduced as the higher water levels limit the amount of time the tide gate is actuated. The combination of reduced actuation time, with the restricted flow in the Corn Hill Road culvert results in a higher mean water level in typical conditions with SLR. Peak water elevations in the lower marsh basin approach 1.6 ft-NAVD88. Additionally, the low water level in the Lower Basin increases from 0.5 ft-NAVD88 under present sea level to an elevation of 0.65 ft-NAVD88 in 2070. Conversely, under normal tidal condition at both present day and projected 2070 sea levels, the upper marsh, shown in the bottom panel, remains unaffected.

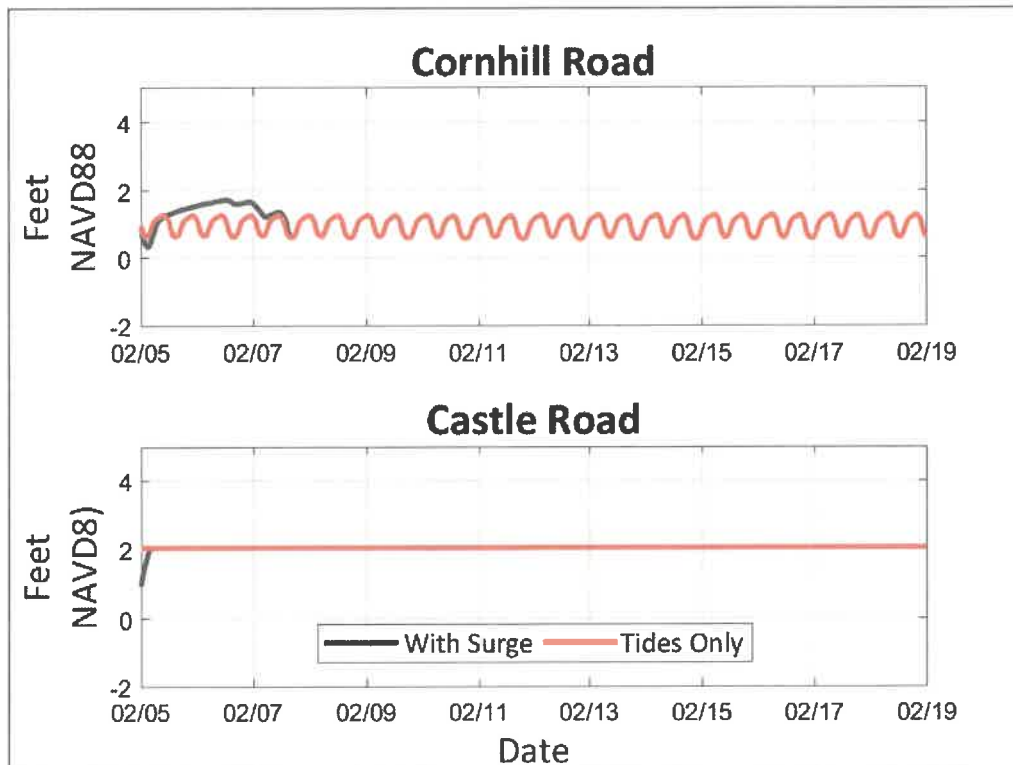
Figure 17. The 10-year storm surge event in Little Pamet River for existing conditions.

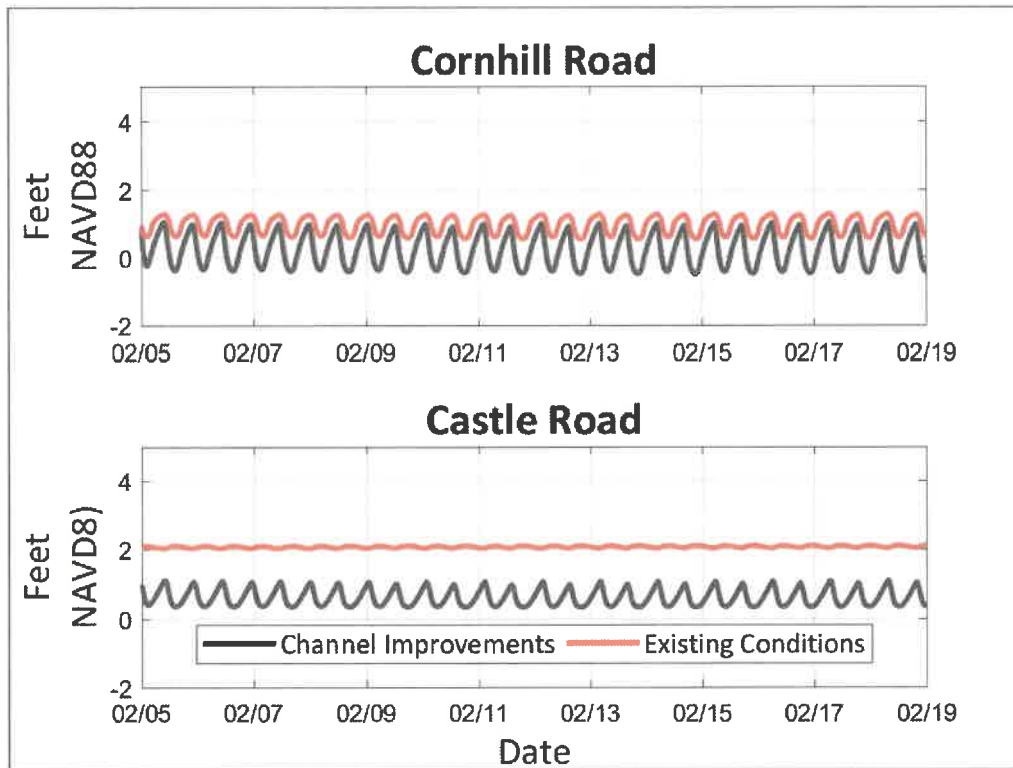
Figure 20. Effects of channel improvements on drainage of the system during typical tides.

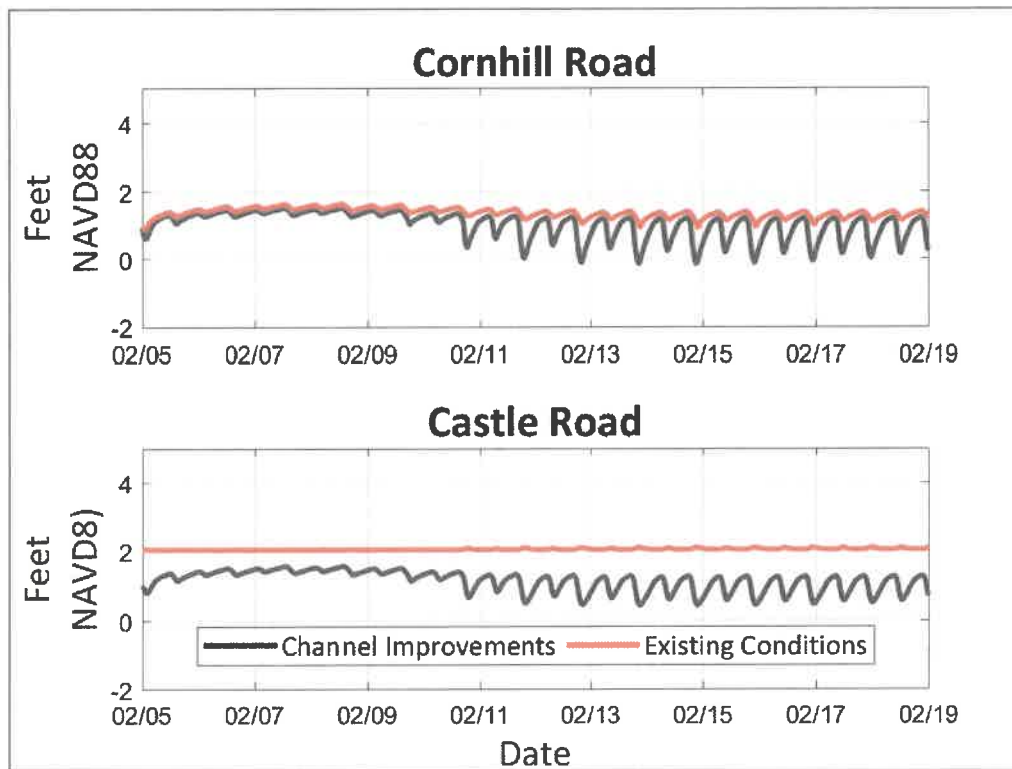
Figure 22. Effects of channel improvements in the Little Pamet River on drainage in the system during typical tides with sea level rise in 2070.

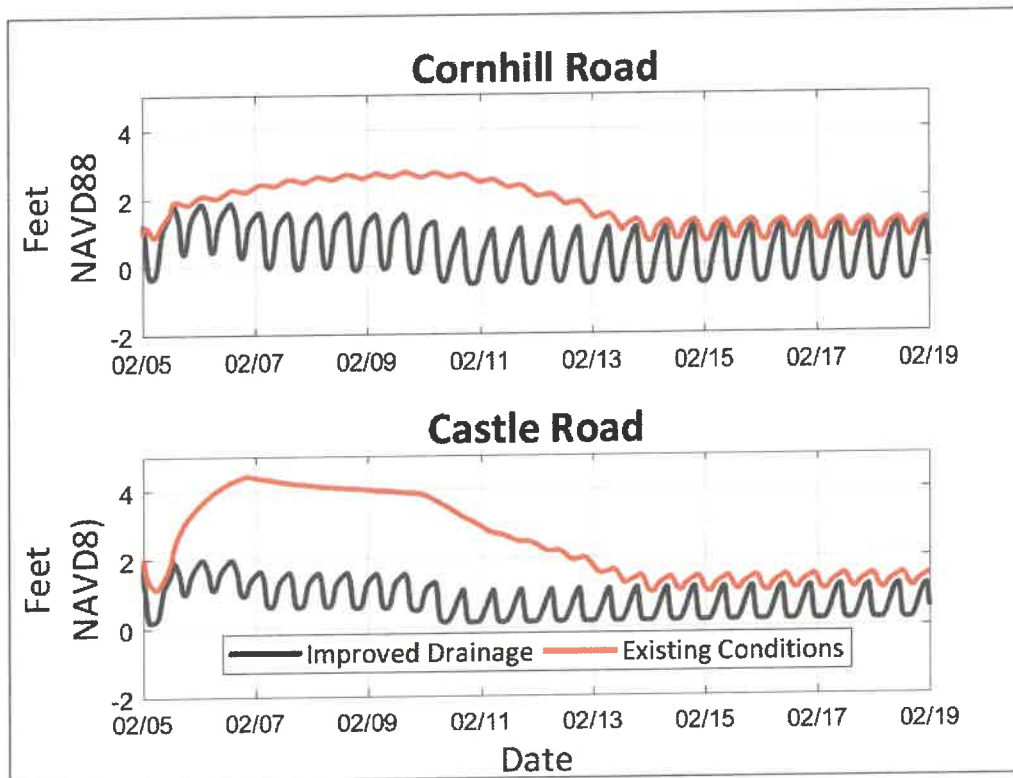
Figure 27. Effects of channel improvements and increased culvert size on drainage in the Little Pamet River during a 100-year rain event.

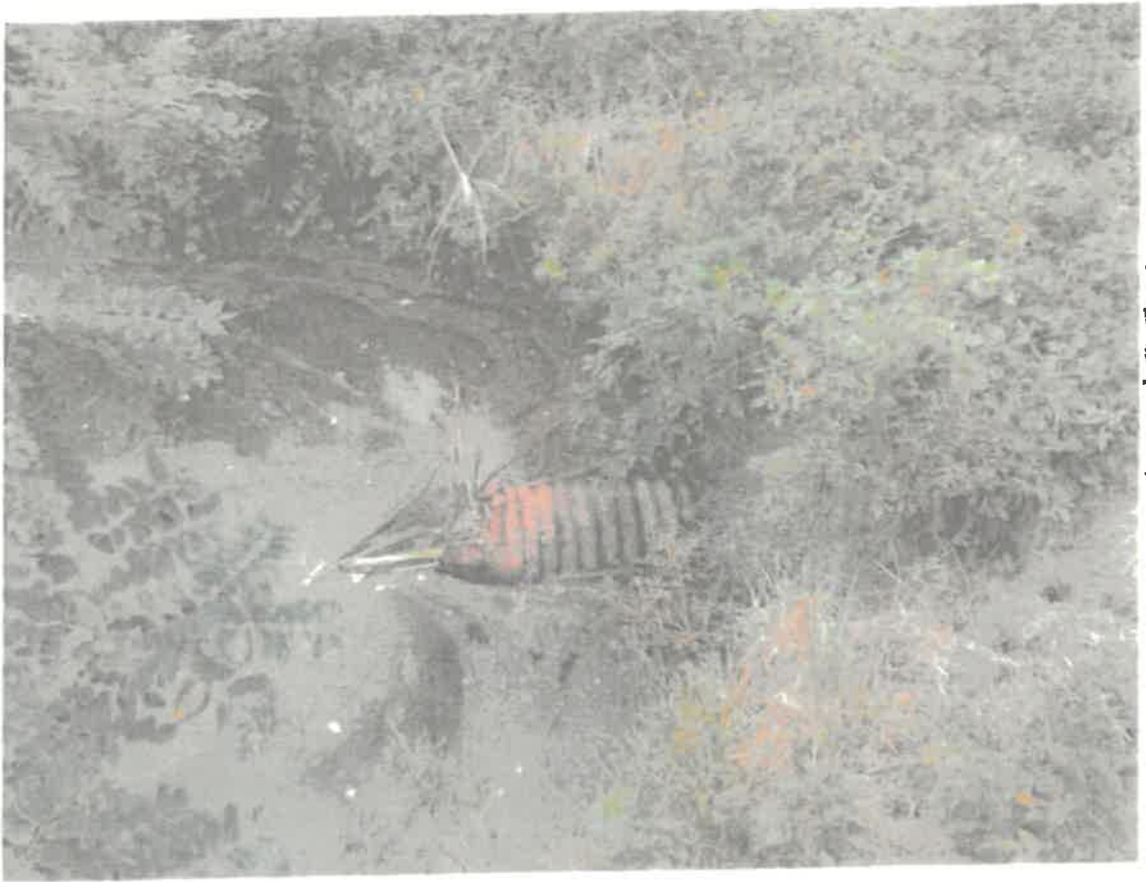
PHOTO #1

On Monday, Paul Morris, Charles Greenhalgh and I met with Roy Okunewski from Coastal Engineering. He provided us with his opinion on the work needed to improve drainage at the culvert at Corn Hill. The existing culvert (Photo #1) has been there since approximately 1978. The existing pipe has a life expectancy of between 10 and 20 years, depending on circumstances. The culvert at this time is only working minimally and is in need of either repair or replacement. The existing damaged metal pipe, 300' long running from the Little Parcel under Corn Hill Road to the Harbor, would be replaced with a 300' plastic ADS pipe, at his suggestion. Along with the dis-pipe replacement is a 5 foot manhole structure to serve as a weir which would adjust the levels of the Little Parcel for better controlled flow. The existing Handwall (Photo #2), located on the inward side (Harbor side) with its clapper valve, would also need to be replaced.

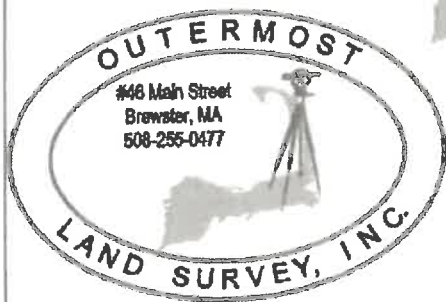
INVERT 24" RCP PIPE
N: 2828216.93 US FT
E: 1042660.34 US FT
ELEV -1.12 NAVD88

BRASS BOLT EAST END OF HEADWALL
N: 2827941.78 US FT
E: 1042597.47 US FT
ELEV 1.65 NAVD88

FLOW LINE AT GAUGE STAKE
N: 2827928.40 US FT
E: 1042595.50 US FT
ELEV -0.74 NAVD88

Sketch Plan of Land
CORN HILL ROAD, TRURO MA
Scale 1"=100' Oct. 20, 2017
ols#654001

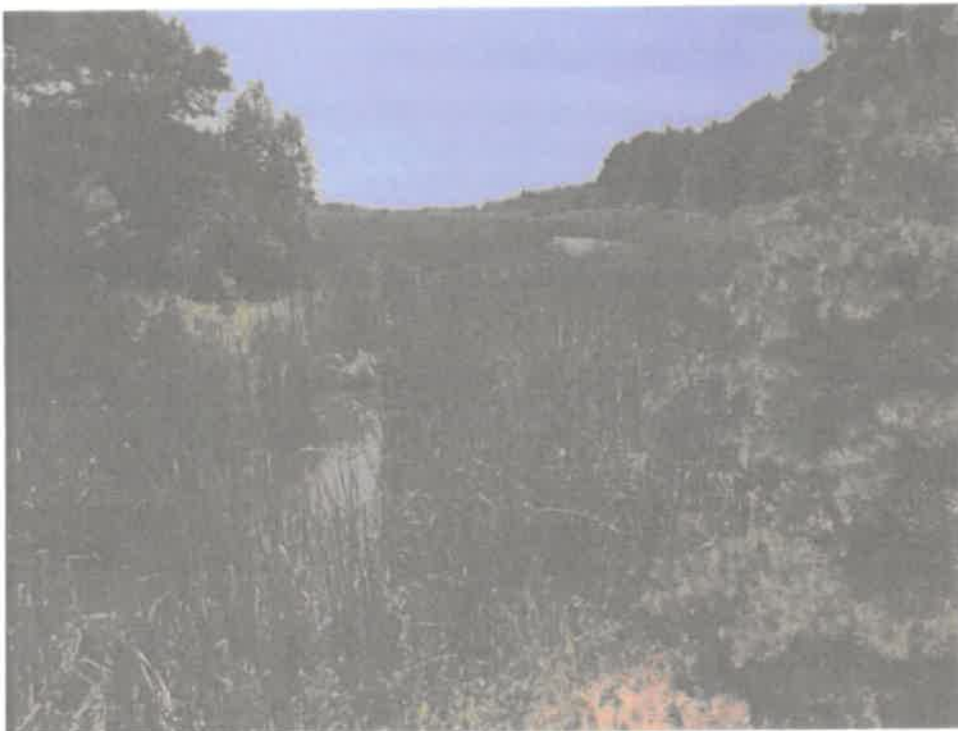
Figure 1. View facing southwest and looking downstream over the lower Little Panet River valley from Castle Road toward Corn Hill Beach. Photo taken 8/3/17.

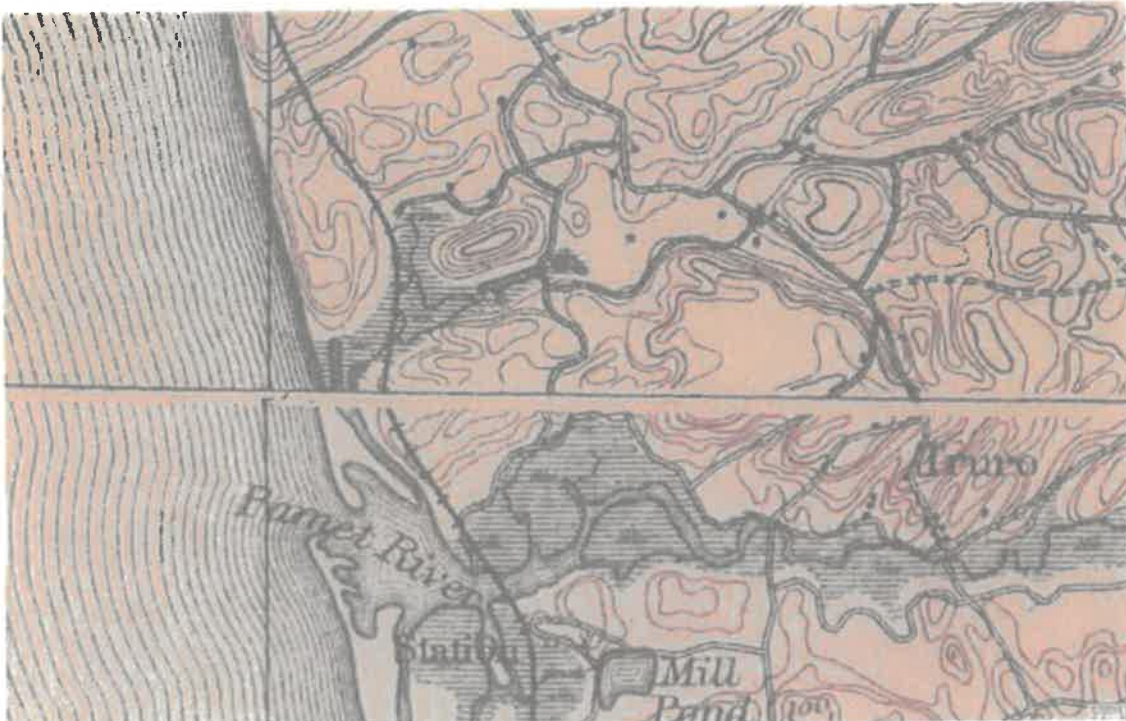
Figure 3. Topographic map of the Pamet River and Little Pamet River area, 1890.

Historically the Little Pamet River flowed from its source in the higher elevations of central Truro to its outlet at Cape Cod Bay. In colonial times it is likely that the wetlands of the lower valley were estuarine and were likely dominated by tidally influenced salt marsh habitat. A topographic map from 1890 depicts the Little Pamet River before Corn Hill Road was constructed, showing only a railroad crossing the valley (Figure 3). On this 1890 map the horizontal blue lines, which extend throughout the valley upstream and downstream of the railroad, indicate areas of wetland or open water. In the lower reaches of the Little Pamet River it is likely that these wetlands were estuarine and included significant areas of salt marsh habitat. The historical upstream extent of estuarine conditions cannot be determined at this point without further field investigations.

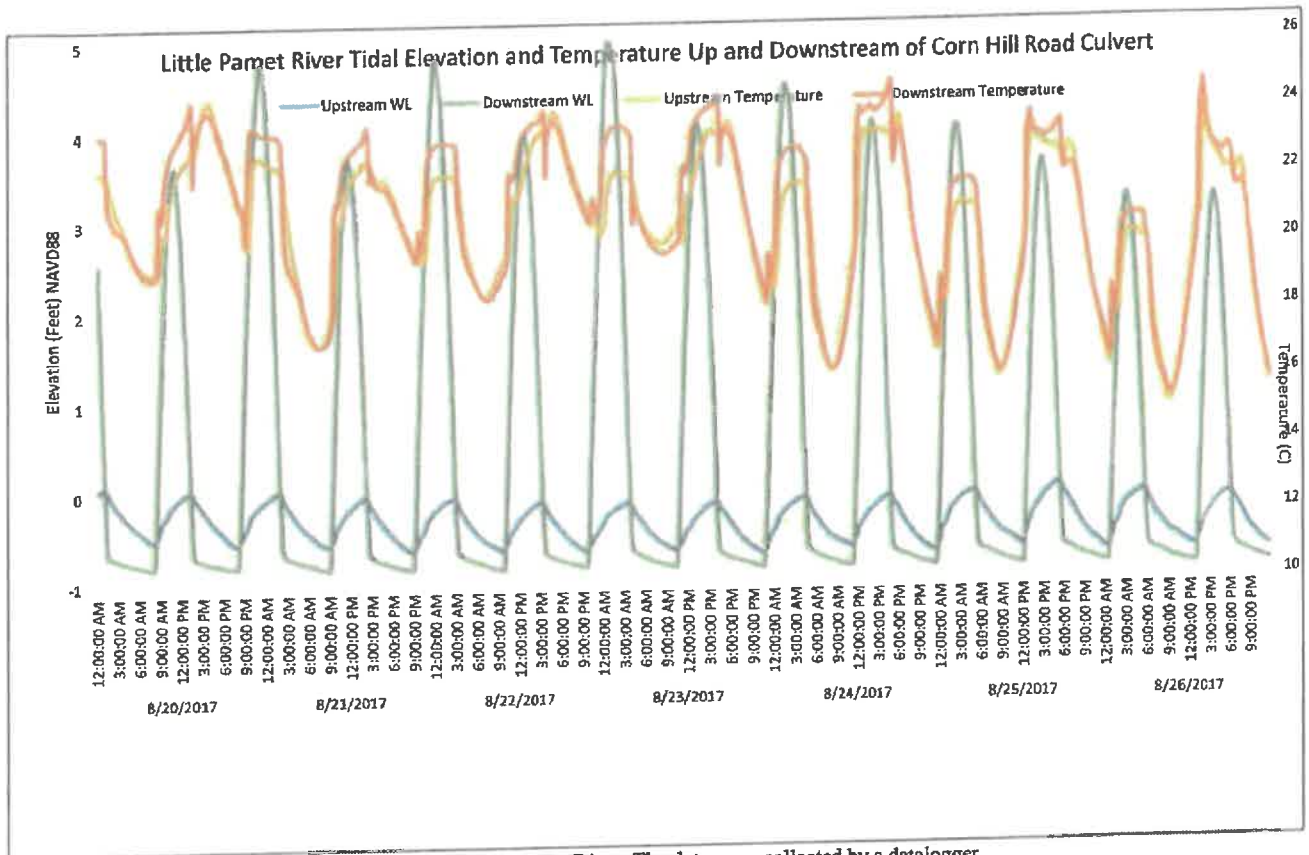
Figure 8. Plot of water level and temperature in the Little Pamet River. The data were collected by a datalogger.

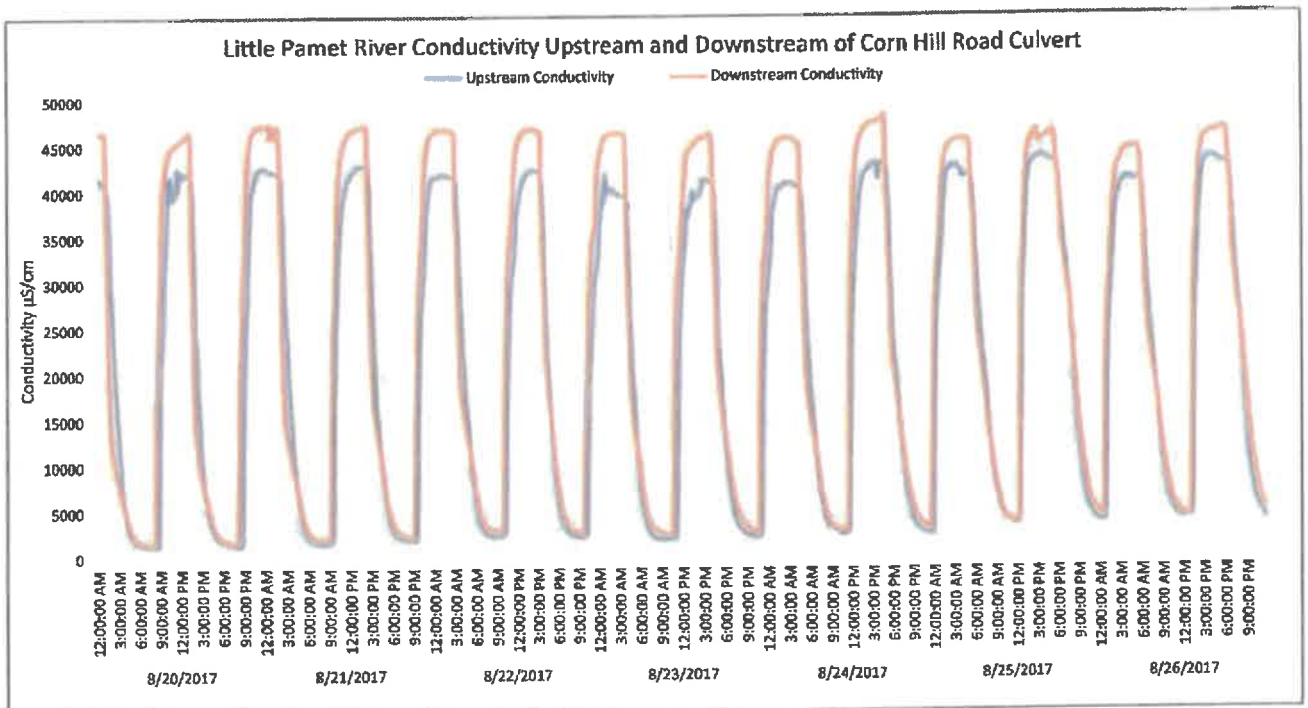
Figure 9. Plot of conductivity in the Little Pamet River.

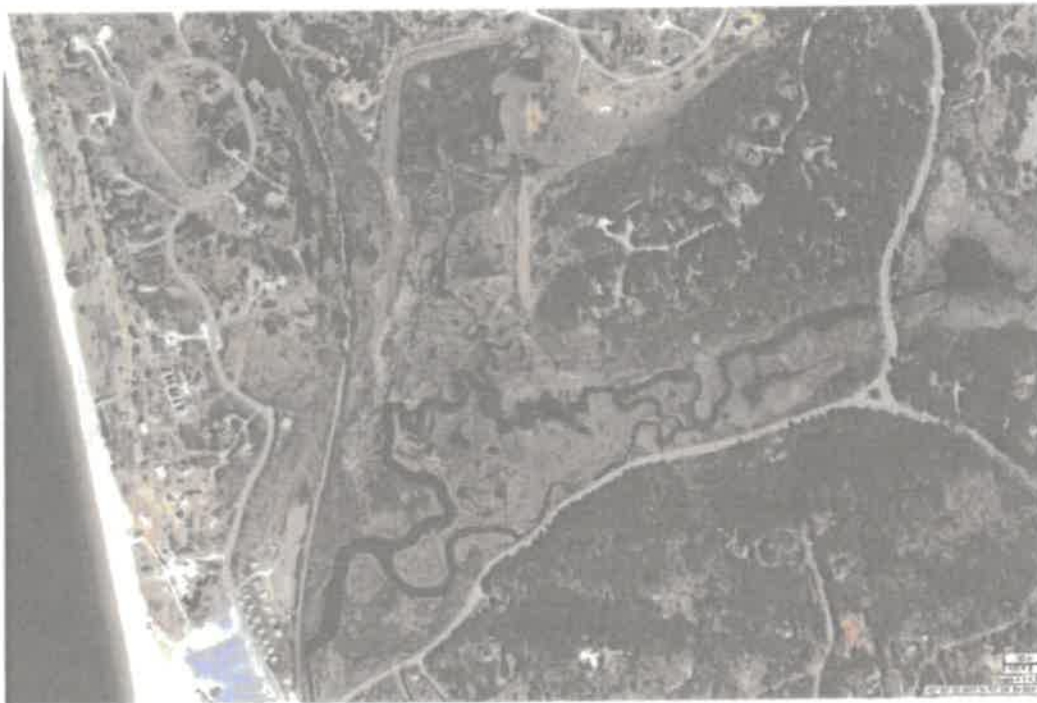
Lower Little Pamet River Valley, 2005.

A cursory review of historical aerial imagery shows the channels within Little Pamet River between Corn Hill Road and Castle Road have been filling in with sediment and/or organic detritus, which has led to changes in vegetation and reduced drainage of the system. Anecdotal information provided by nearby landowners confirm these changes including: 1) the shallowing and disappearance of open water in the river channel, 2) no longer able to navigate the river by kayak, 3) spread of invasive vegetation, 4) loss of avian/terrestrial wildlife, and 5) impeded drainage which has caused flooding of agricultural lands adjacent to the marsh.

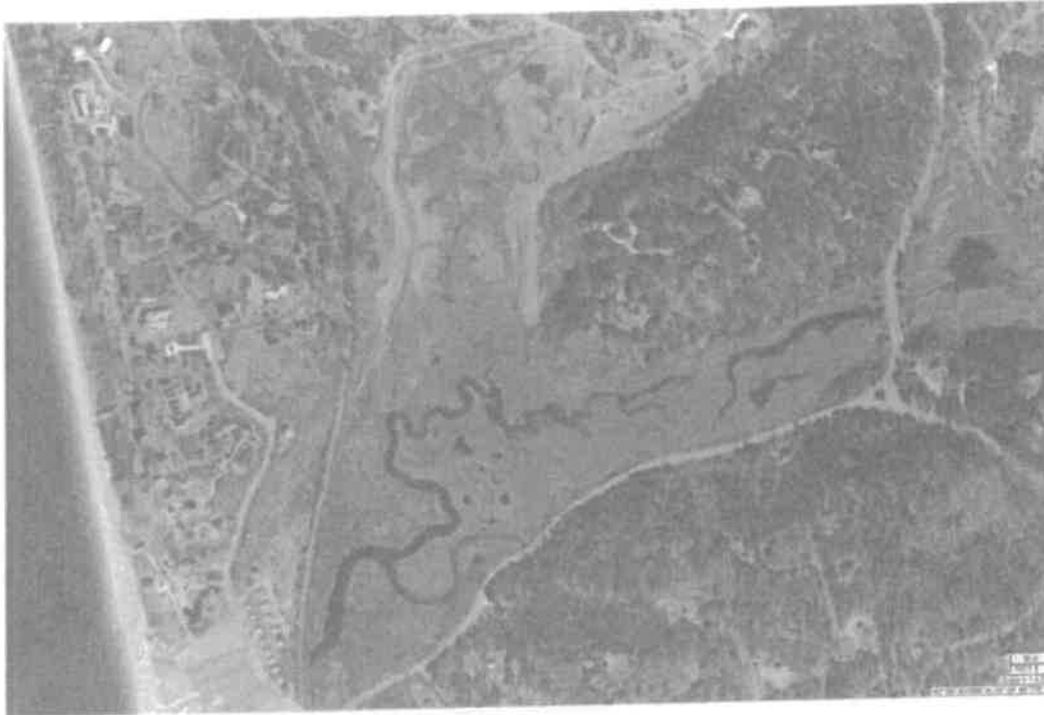
Lower Little Pamet River Valley, 2008.
