MEMORANDUM

FROM Matt Shultz, PE, Adam Finkle, PWS, and Zac Duval
Woods Hole Group
107 Waterhouse Road
Bourne, MA 02532
Direct Phone: (508) 495-6259

Little Pamet River, Truro, MA— Sediment & Vegetation Assessment and Restoration of the Little Pamet River System

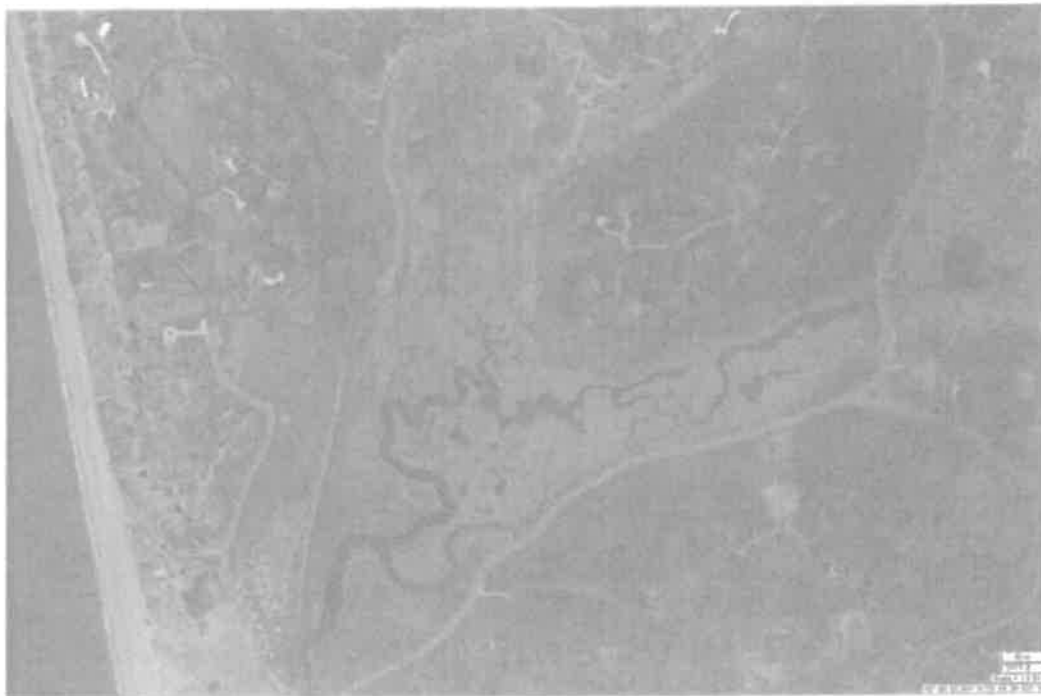
Lower Little Pamet River Valley, 2011.

A cursory review of historical aerial imagery shows the channels within Little Pamet River between Corn Hill Road and Castle Road have been filling in with sediment and/or organic detritus, which has led to changes in vegetation and reduced drainage of the system. Anecdotal information provided by nearby landowners confirm these changes including: 1) the shallowing and disappearance of open water in the river channel, 2) no longer able to navigate the river by kayak, 3) spread of invasive vegetation, 4) loss of avian/terrestrial wildlife, and 5) impeded drainage which has caused flooding of agricultural lands adjacent to the marsh.

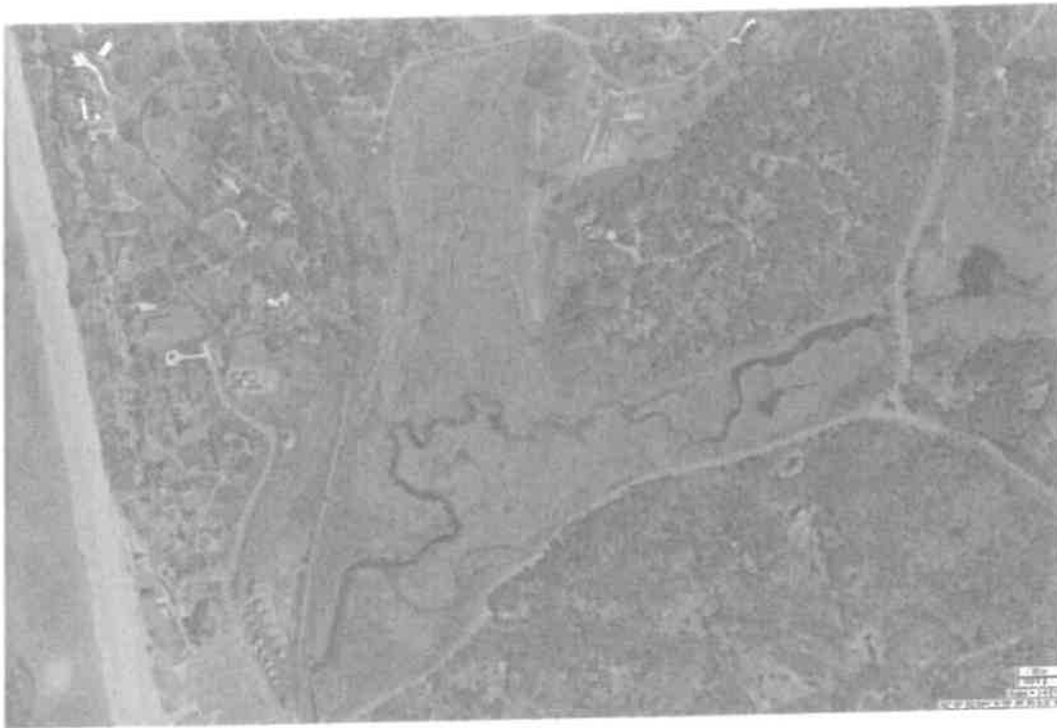
Lower Little Pamet River valley, 2013.

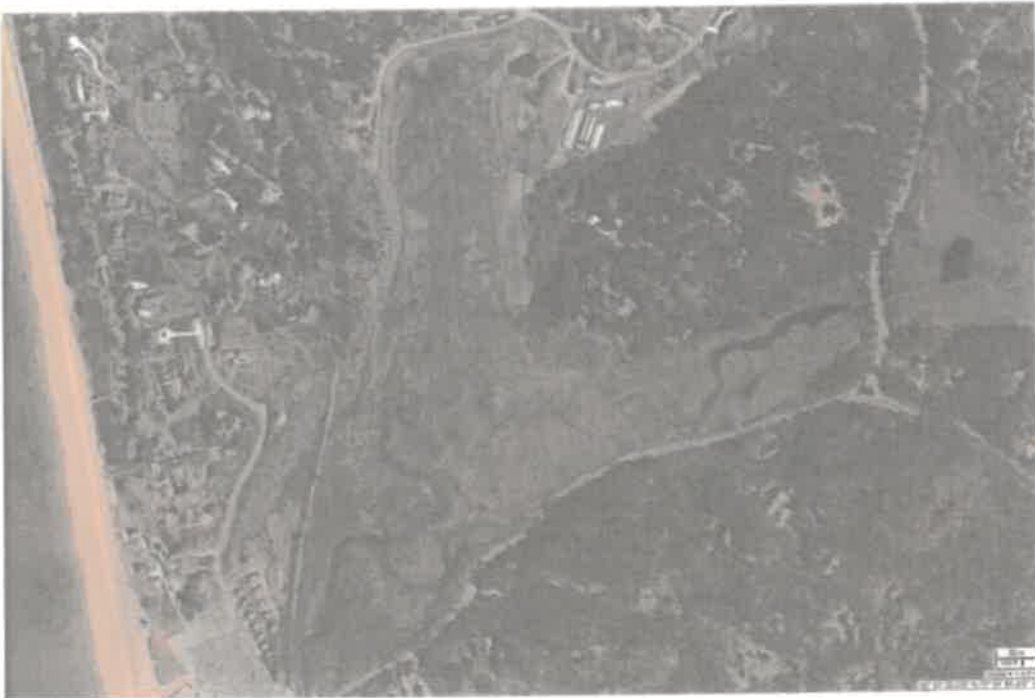
Lower Little Pamet River Valley, 2016.
